Tree Damage Caused by Radiofrequency Radiation

Key Observations from 2005 to 2025 in Germany

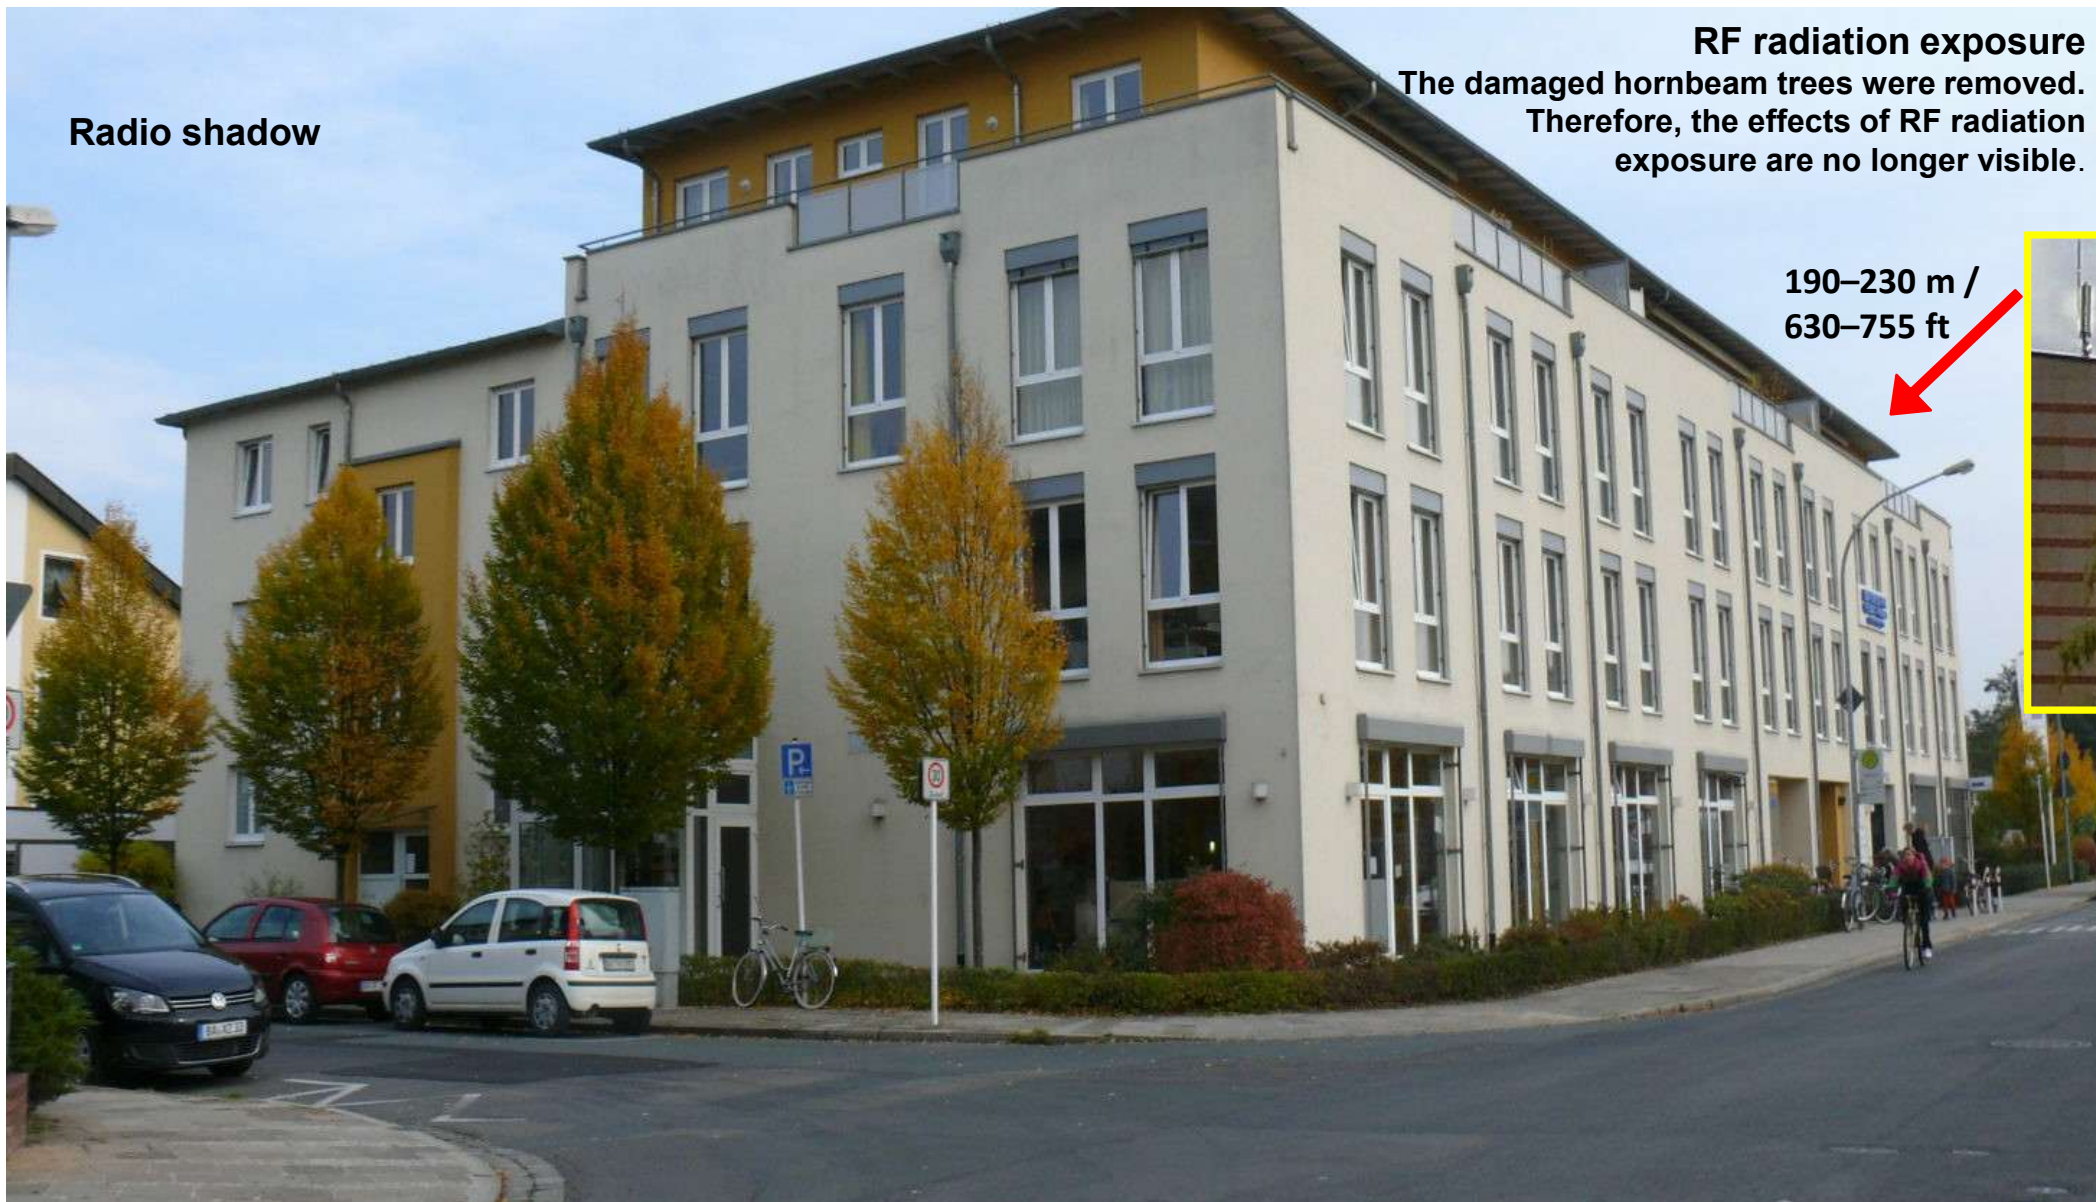
28 OCT 2015 Intersection of Schlüsselstraße and Mußstraße. Hornbeam trees (view from the northwest). The hornbeam trees on Mußstraße were removed due to growth abnormalities. Many trees near the base station of the concert hall were damaged, including those by the Regnitz River. Nevertheless, the number of antennas was increased from 6 to 21 in January 2015.

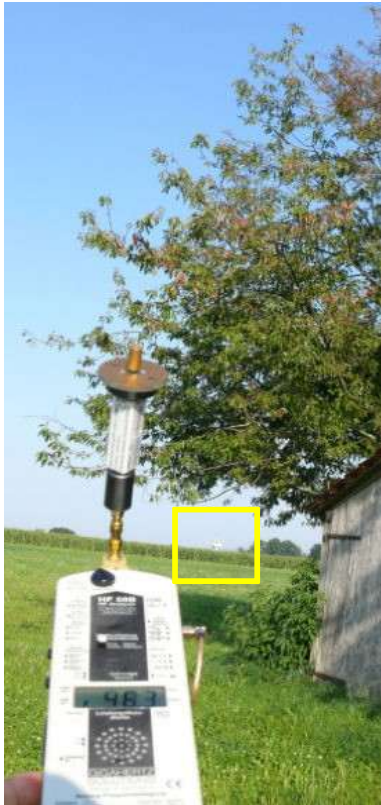
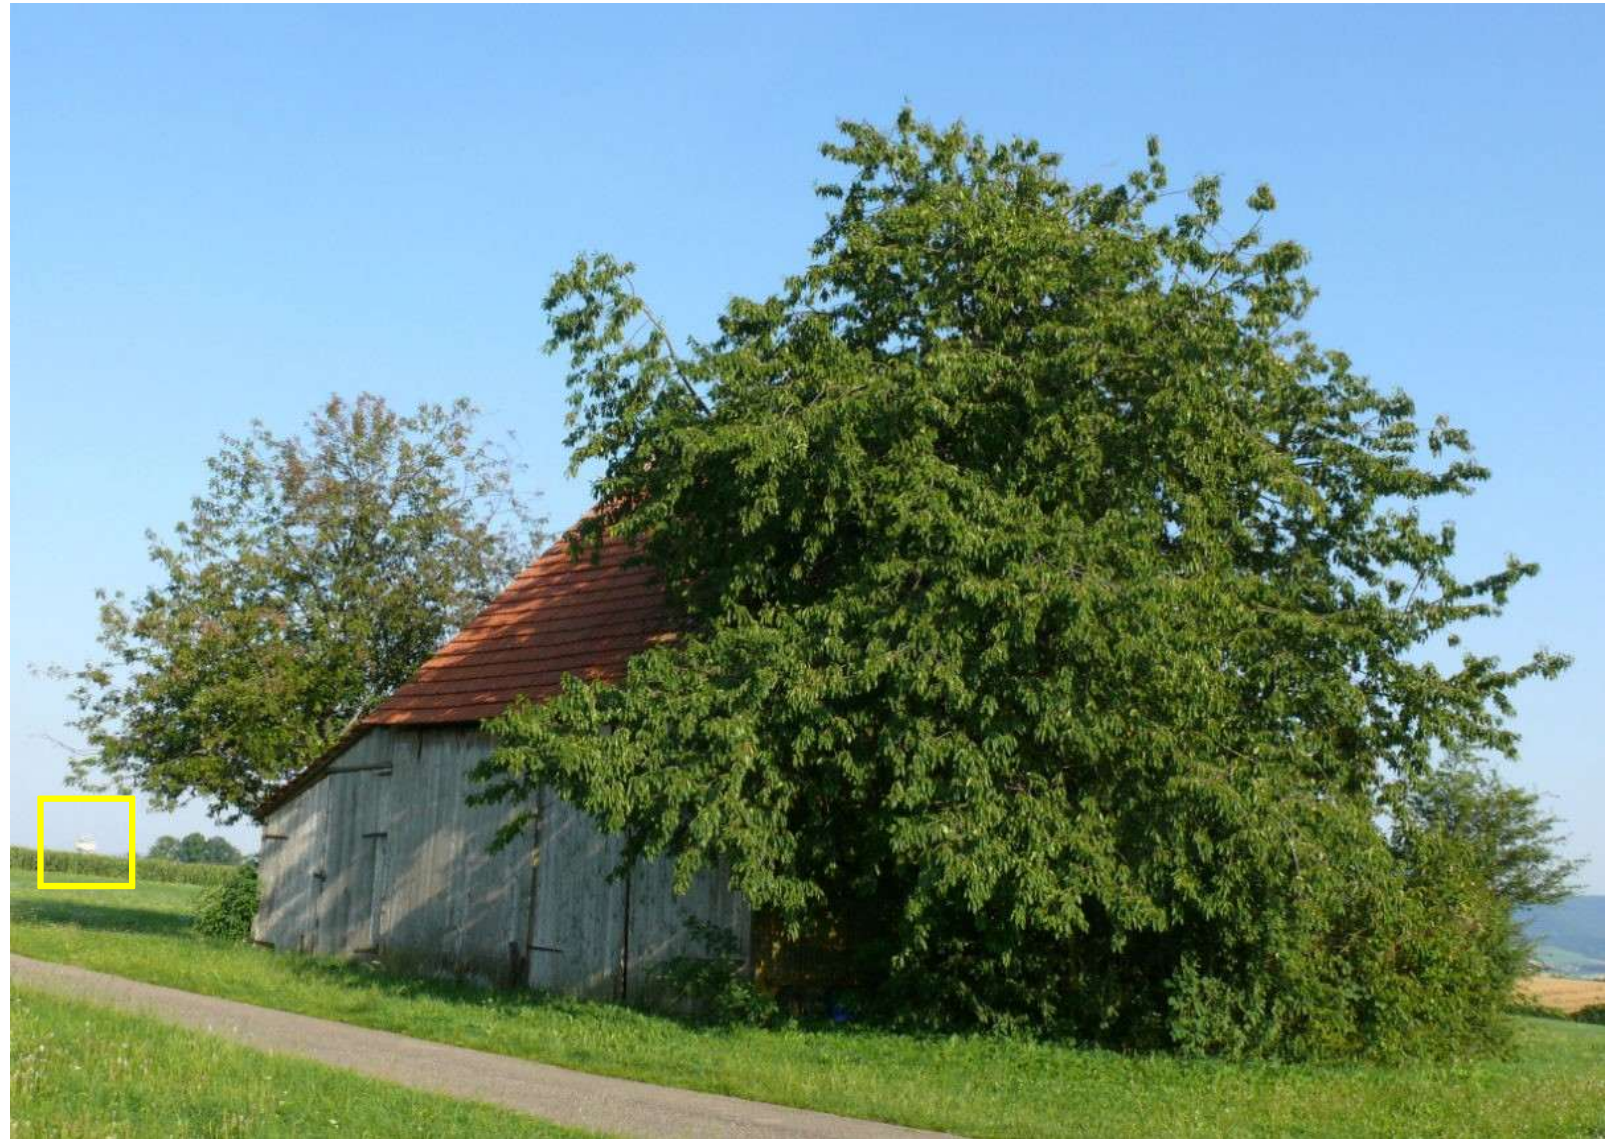
24 JUL 2012 Iggingen. Two cherry trees (view from the west). The cherry tree on the right is shielded from RF radiation by the tree on the left and the hut. The distance to the base station is about 1 km (0.6 mi). Measurement at the tree on the left: **48 $\mu\text{W}/\text{m}^2$**

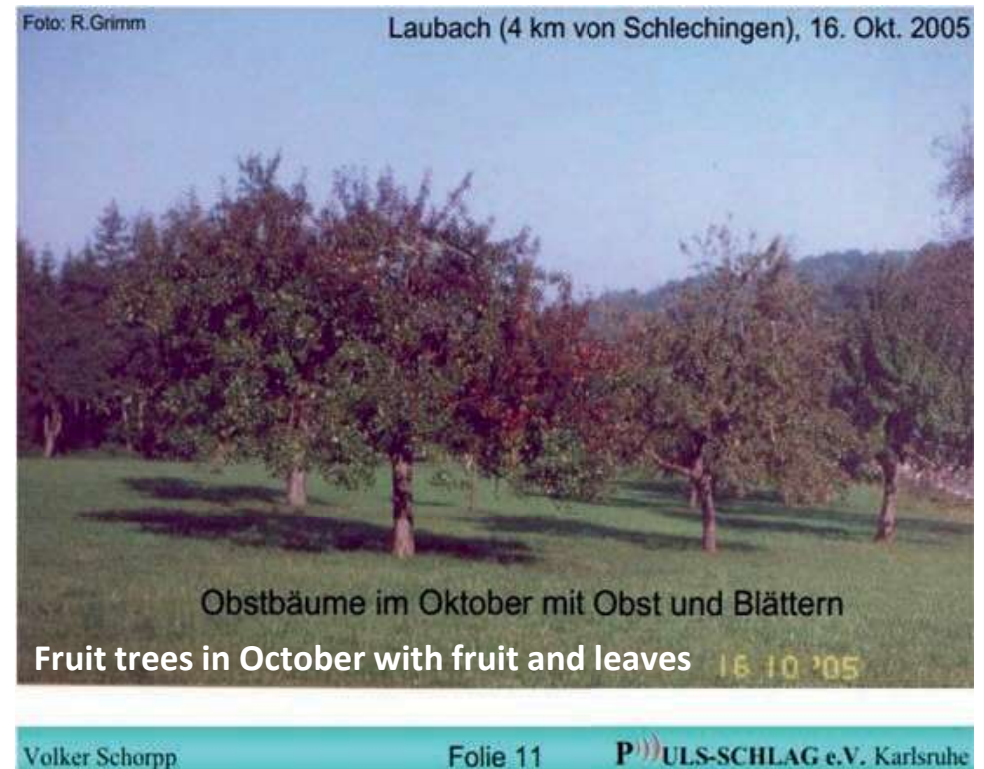
Fruit trees **without** a direct line of sight to a mobile phone base station

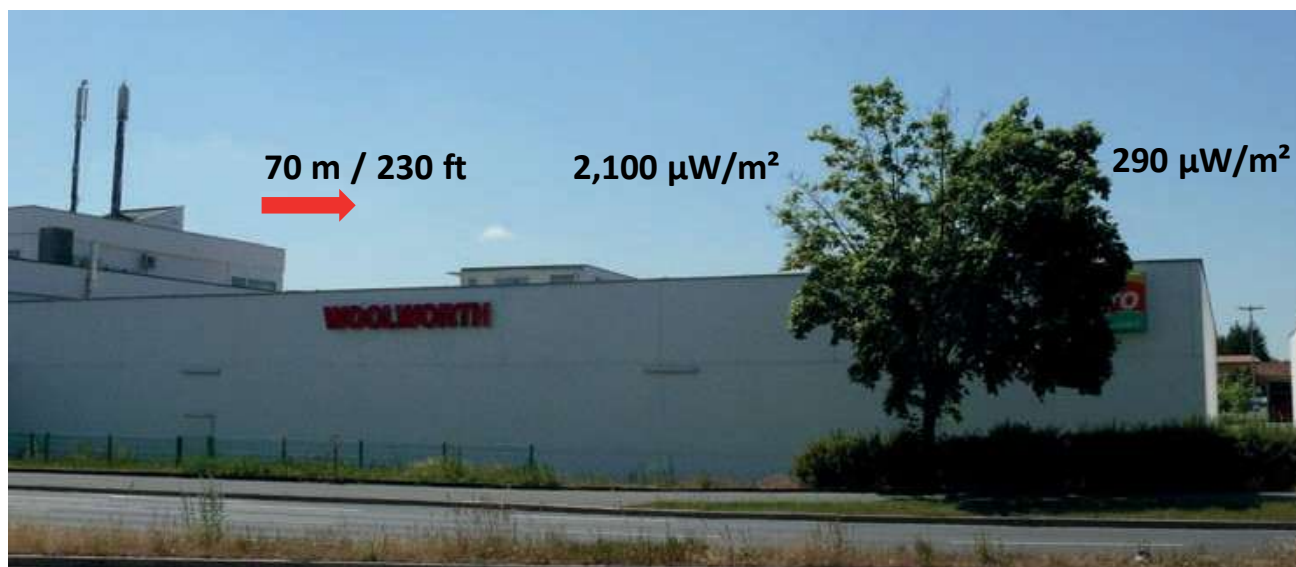
04 JUN 2015 Bamberg, Berliner Ring. Maple tree No. 3 in Group 1 from the study "Radiofrequency Radiation Injures Trees Around Mobile Phone Base Stations." Measurements were carried out using the broadband RF Analyzer HF59B with the omnidirectional antenna UBB27_G3 (27–3300 MHz) from Gigahertz Solutions. In 2021, we also began using the Safe and Sound Pro II RF Meter (200 MHz – 8 GHz) from Safe Living Technologies. For this study, we often took measurements at a height of 6 m (20 ft) using a telescopic rod.

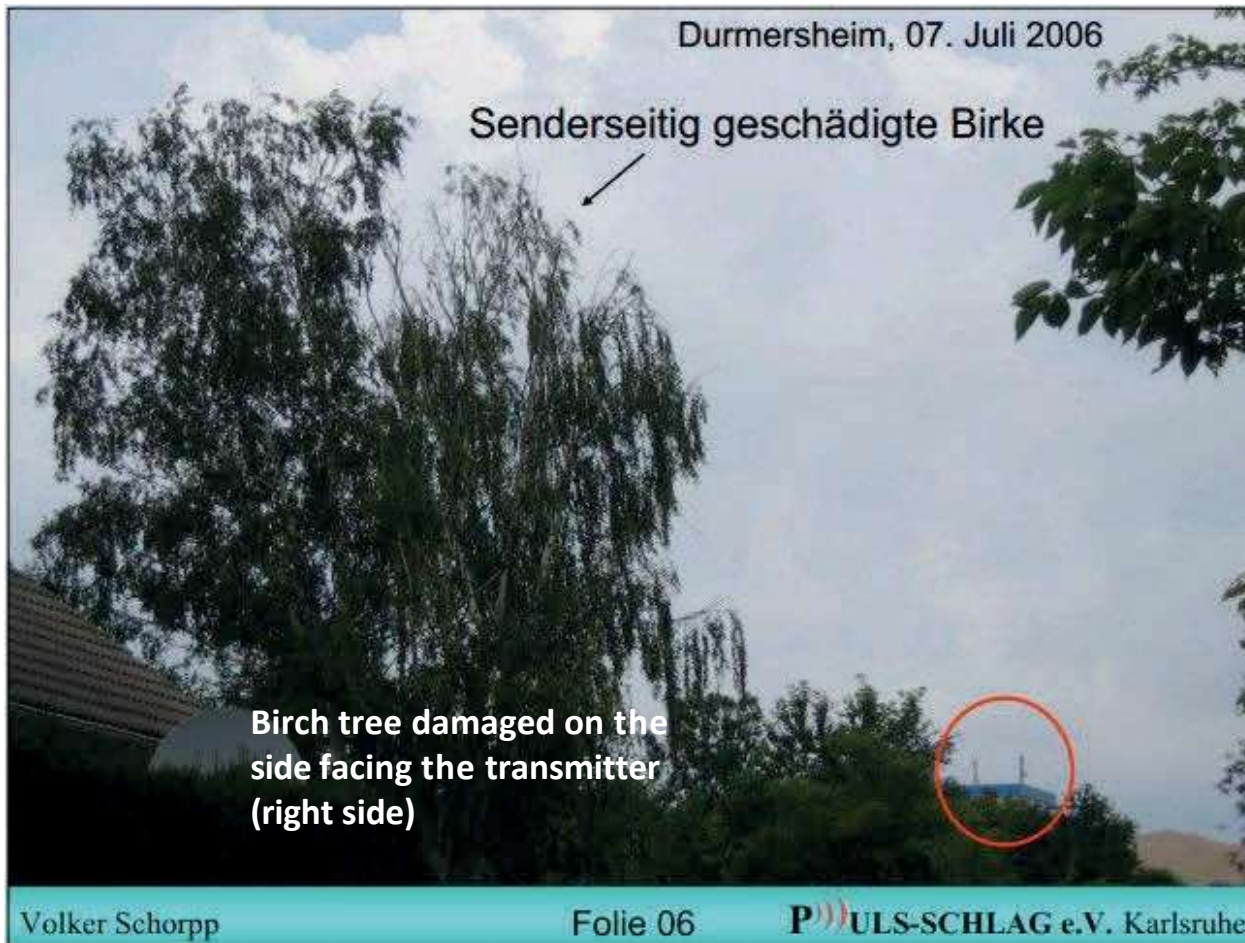
On August 2, 2006, **Volker Schorpp**, a physicist and electrical engineering PhD, presented this image in a short talk at the “Gesundheitliche Auswirkungen der elektromagnetischen Felder des Mobilfunk – Befundberichte“ **[Health Effects of Radiofrequency Electromagnetic Fields From Mobile Phone Base Stations – Case Reports]** workshop of the German Federal Office for Radiation Protection in Oberschleissheim/Neuherberg. Schorpp provided evidence of a causal link between tree and forest damage and chronic exposure to RF radiation from sources such as mobile phone base stations, radar, microwave radio systems, and terrestrial radio and television transmitters.

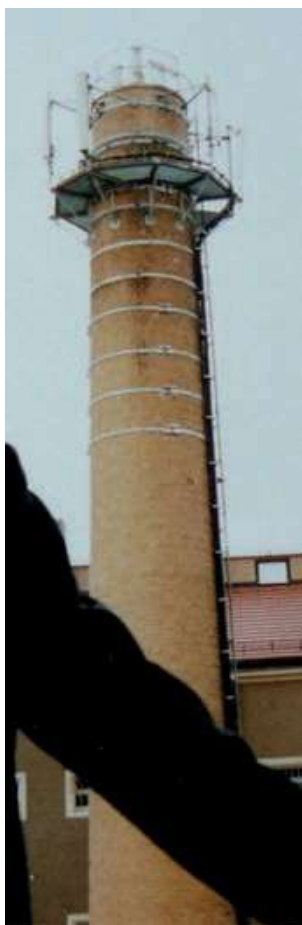
A mobile phone base station is mounted at the courthouse chimney.

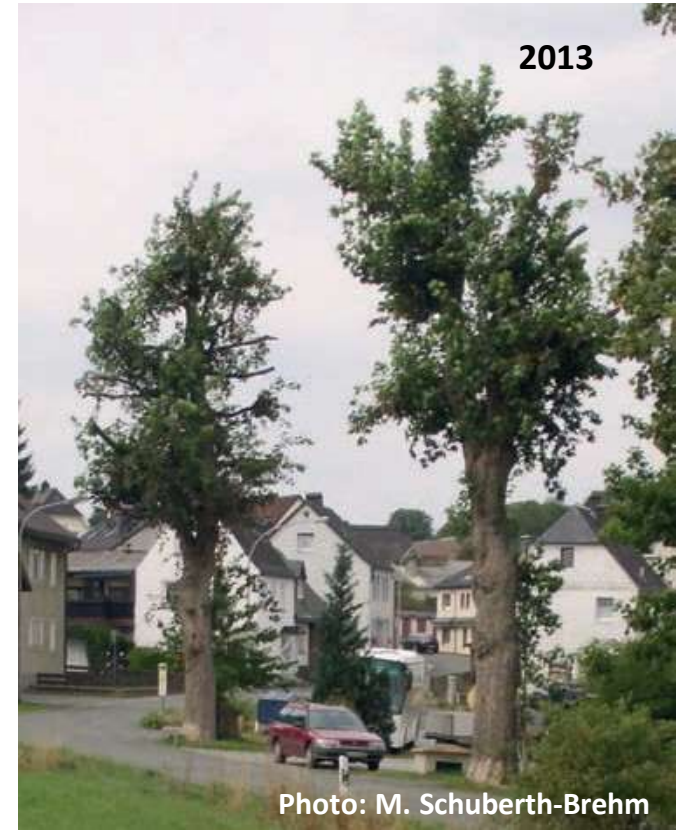
Two sycamore trees (view from the southeast), after the trees were cut back

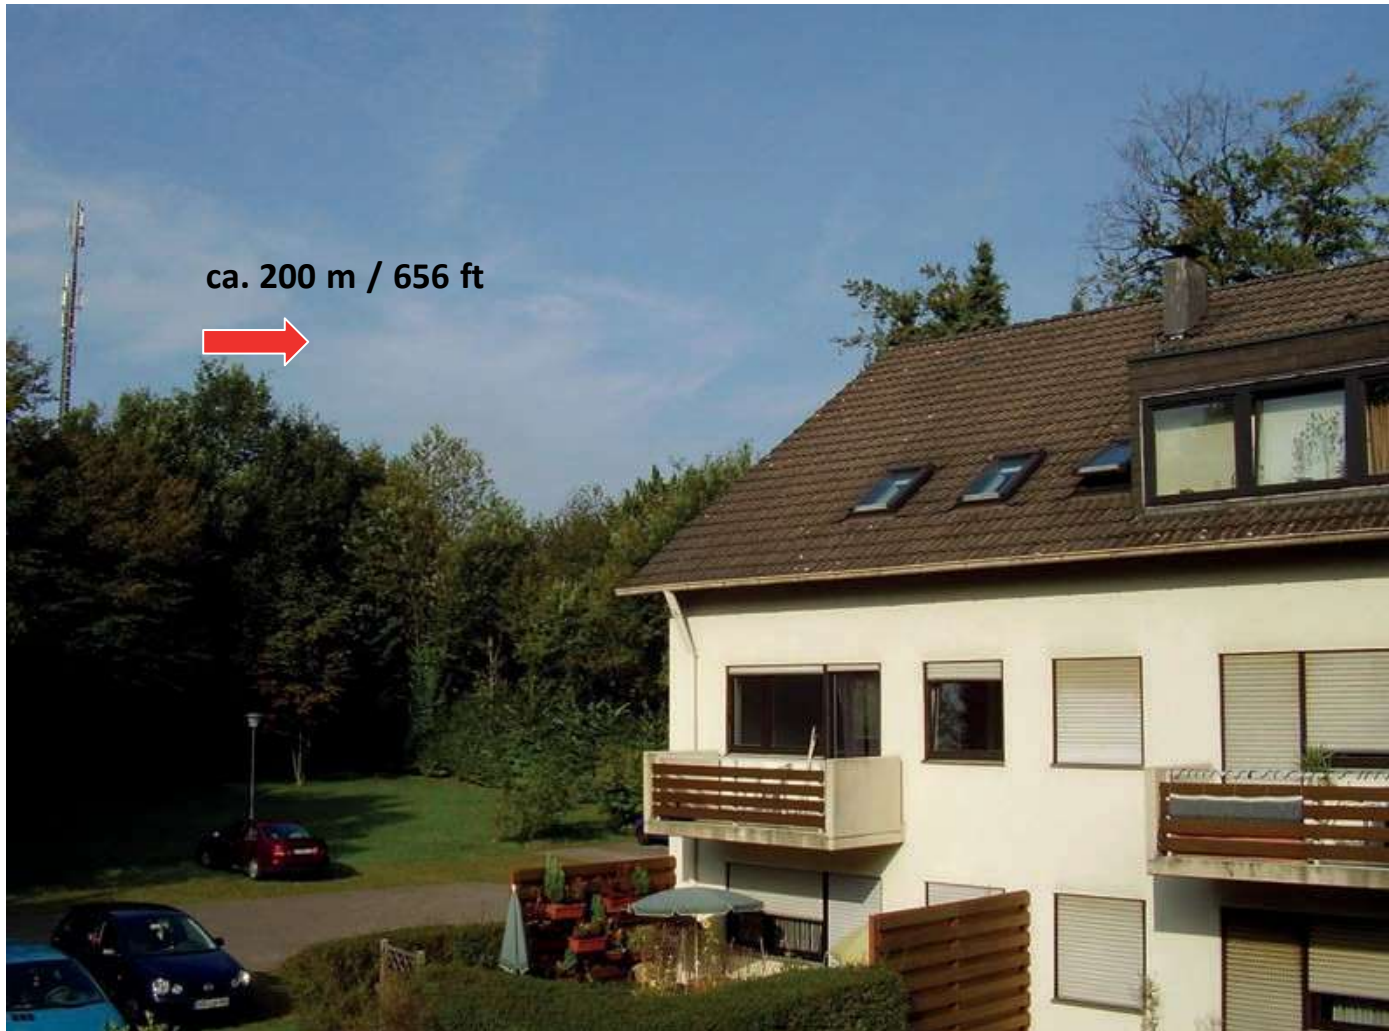
15 SEP 2007 St. Ingbert, Am Mühlental, mobile phone base station, Exit "St. Ingbert West" and beech tree damaged only on one side (distance ca. 200 m / 656 ft).

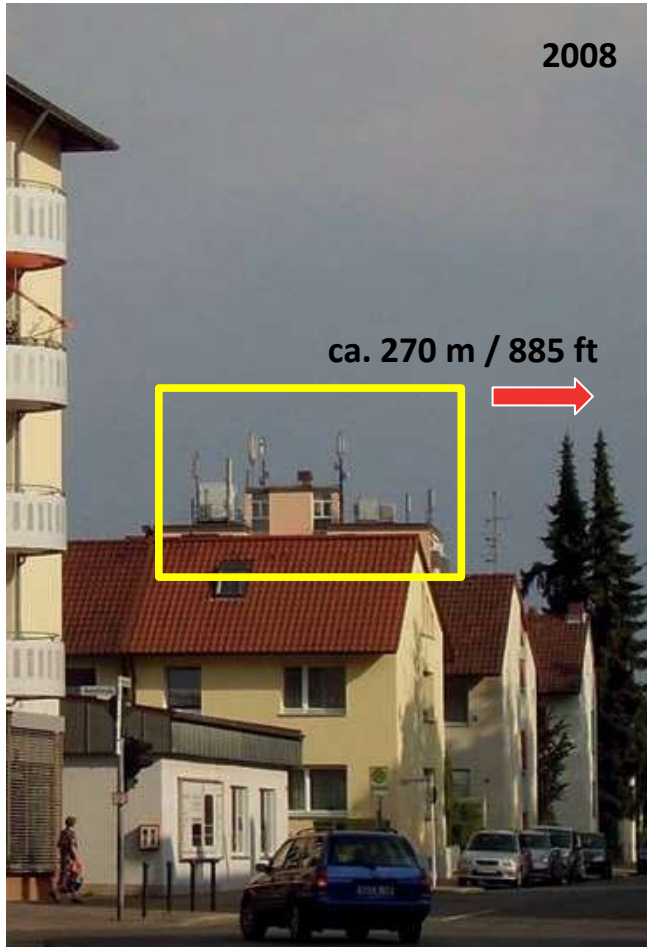
Bamberg, mobile phone base station at Hauptsmoorstr. 26 a: installation height 26.6–31.1 m (87.3–102 ft), 18 sector antennas

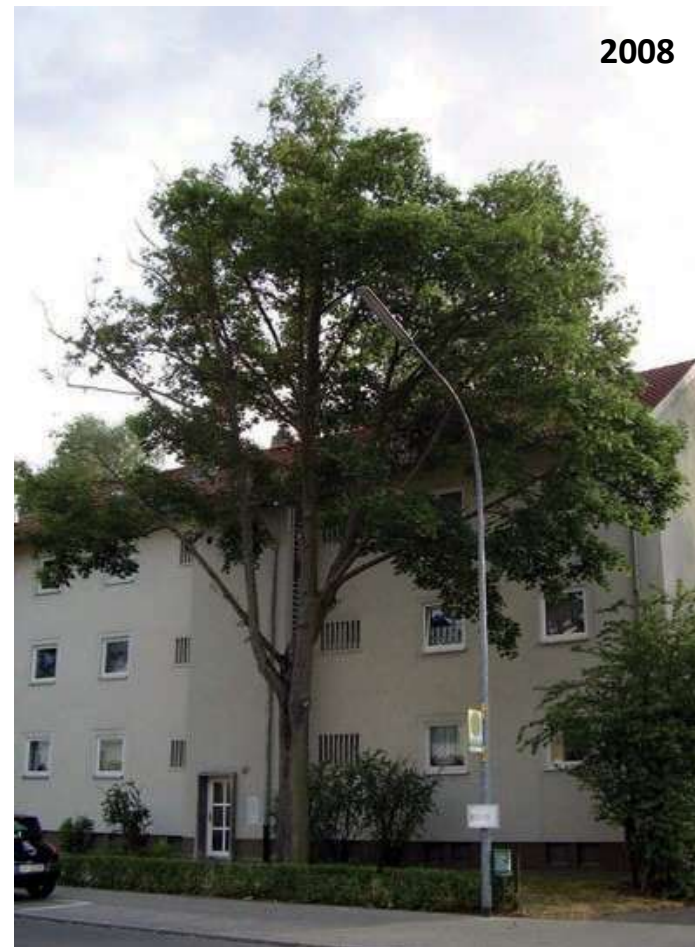
08 JUL 2008 Maple tree (view from the northeast), damaged only on one side. It had already been cut back.

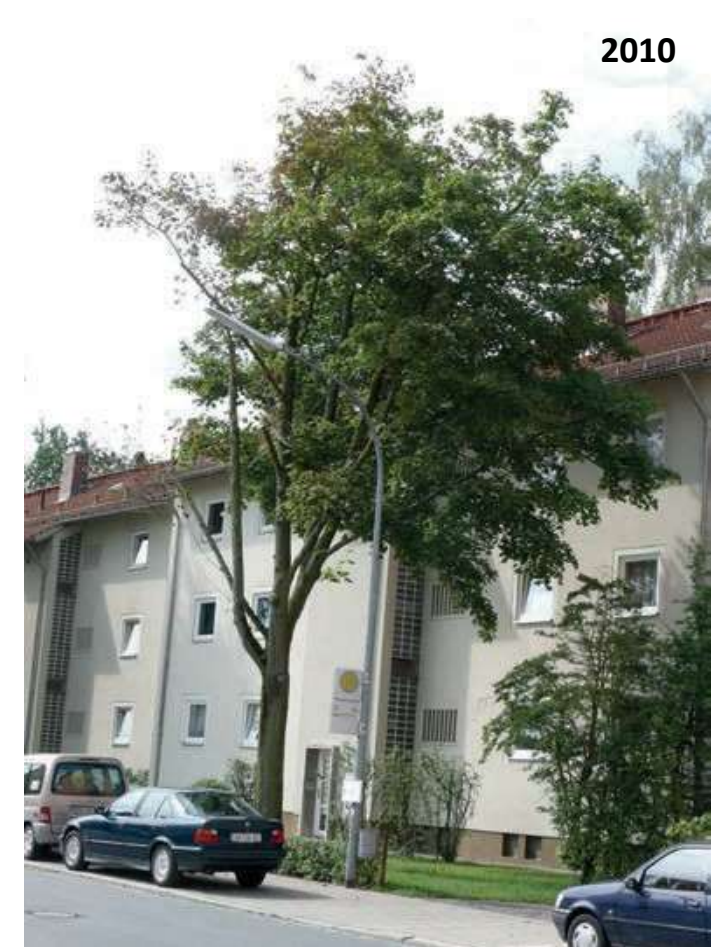
07 AUG 10 The damage worsened, so the tree was cut back again. It was cut down in winter 2010/2011.

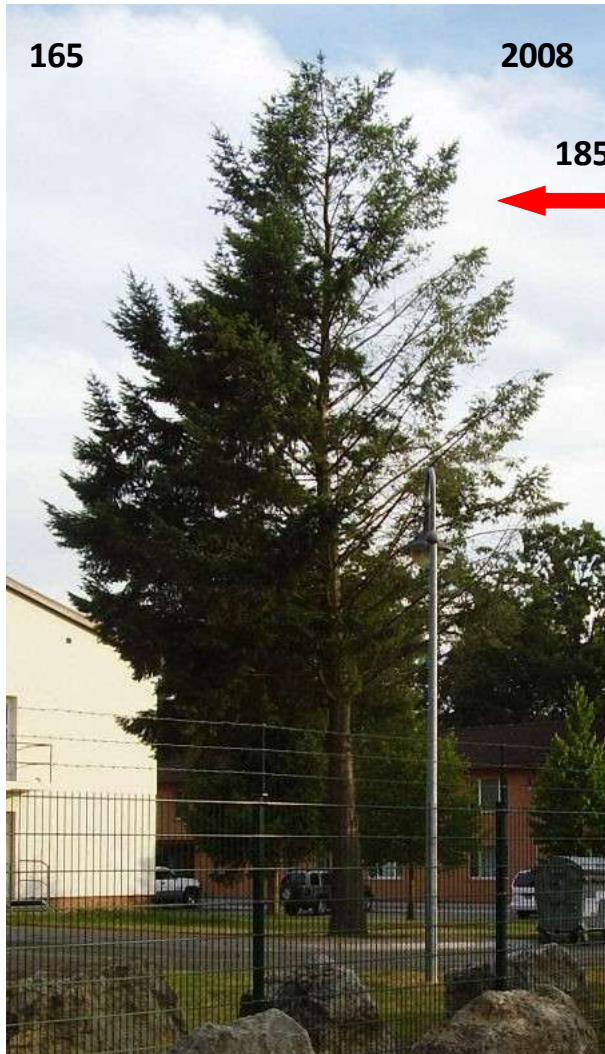
08 JUL 2008 Föhrenstraße 233 c.
Conifer (view from the northeast)

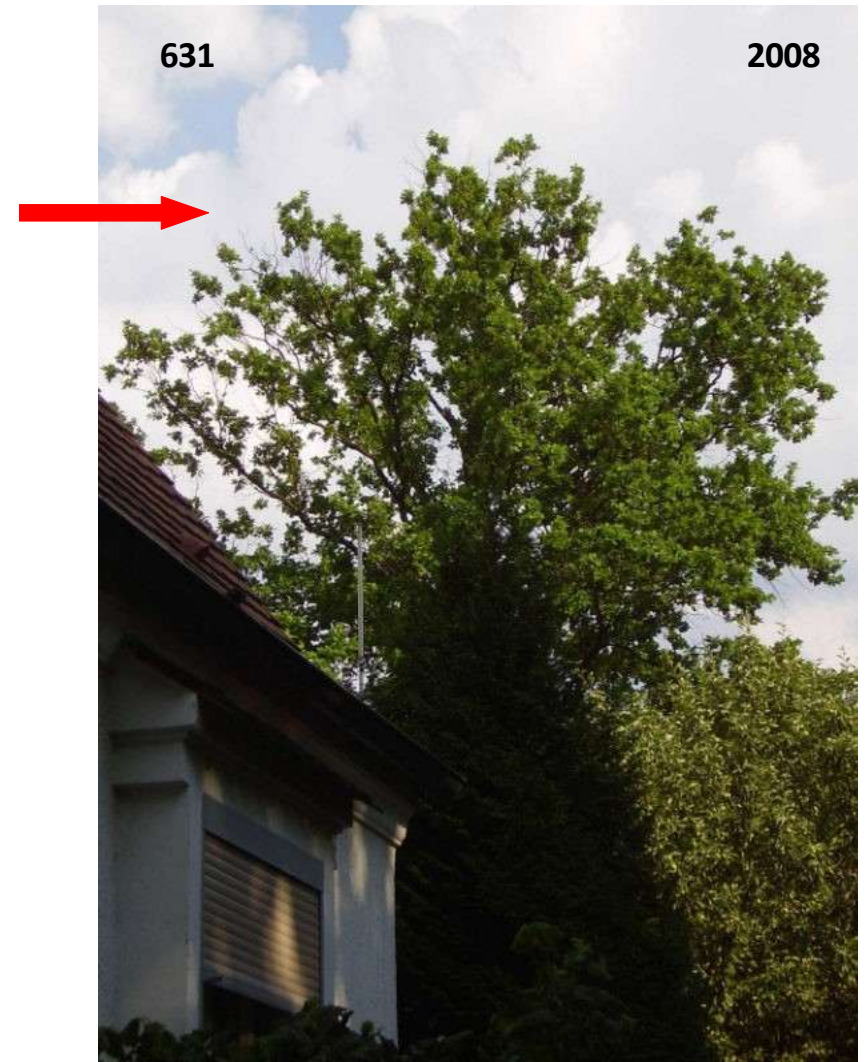
08 JUN 2008 Heimfriedweg. Oak tree (view from the
south)

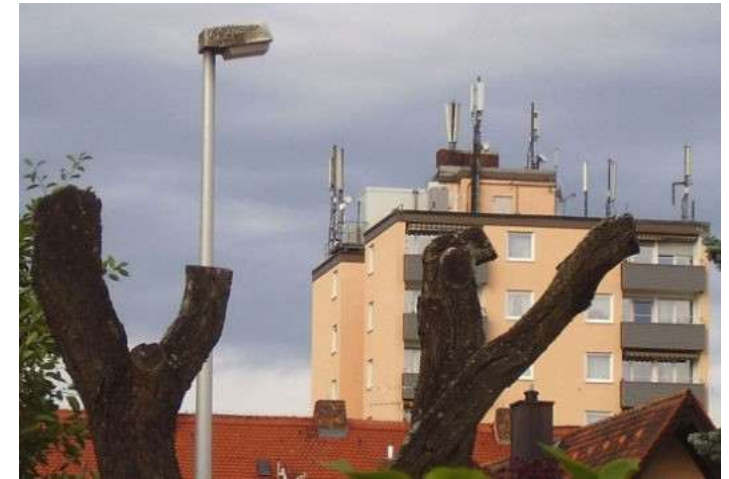
Bamberg, Market Gardeners' District

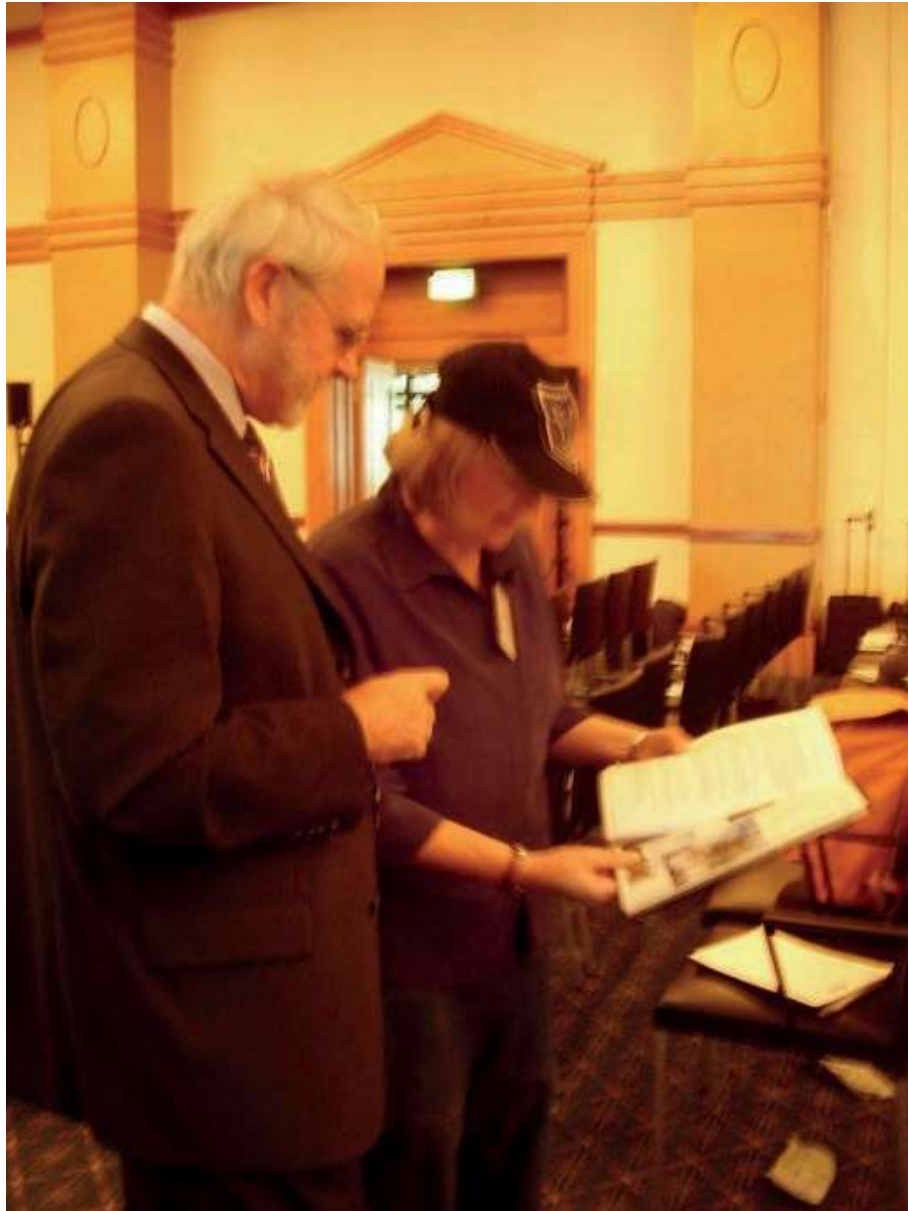
Ms. E. Weber of Munich showed her documentation of damaged trees near the mobile phone base station at Von-Kahr-Straße 61 in Munich to Prof. Dr. W. Weiss of the German Federal Office for Radiation Protection (BfS).

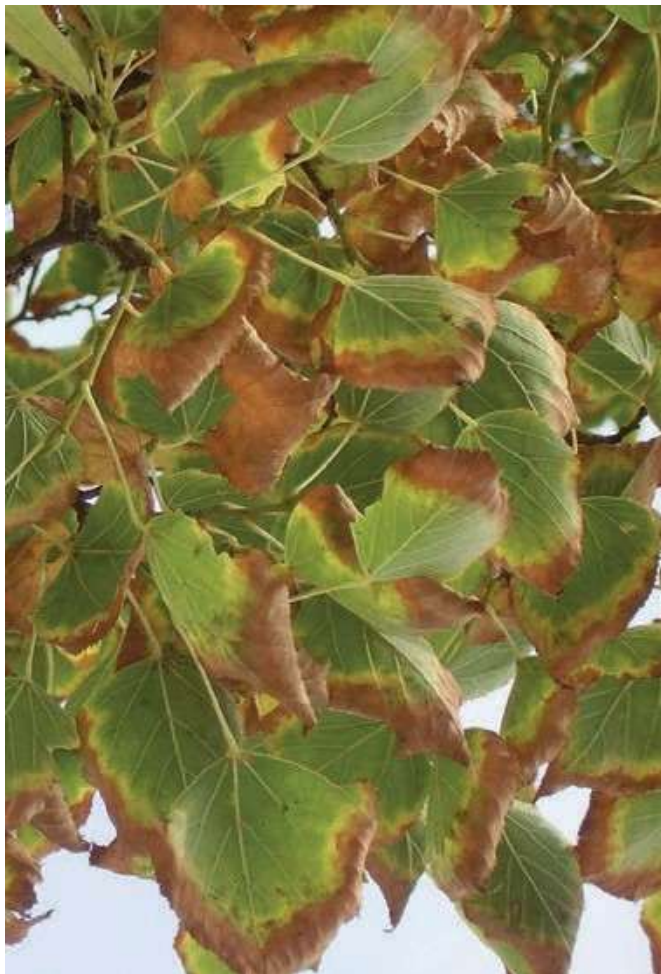
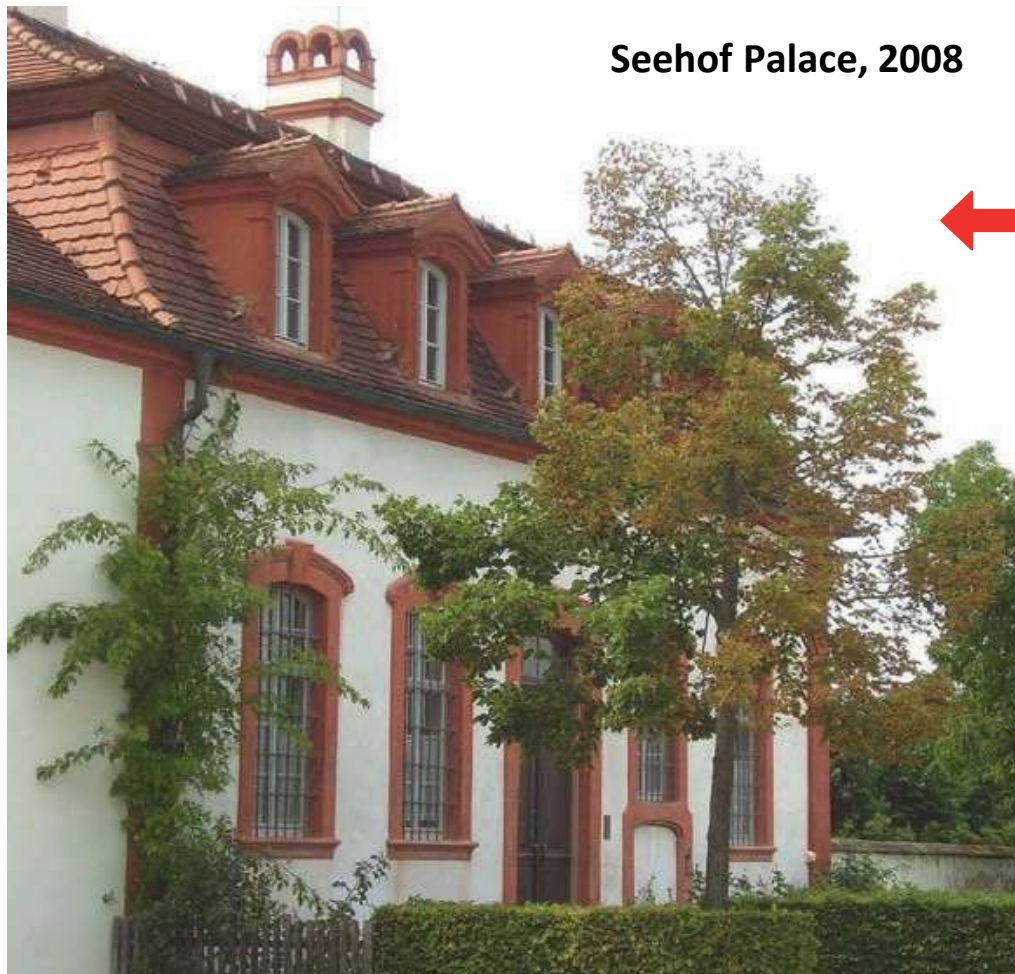
As a Munich resident affected by mobile phone base station radiation, Ms. Weber attended the public event in Berlin on June 17 to 18, 2008, where the results of the German Mobile Telecommunication Research Programme (DMF) were presented. During a break, she showed Prof. Dr. W. Weiss and Prof. Dr. A. Lerchl – a member of the German Commission on Radiological Protection since 2009 – her photos of the damaged trees near the mobile phone base station at Von-Kahr-Straße 61 in Munich.

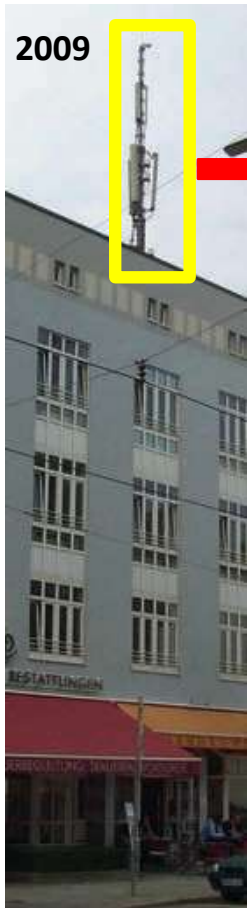
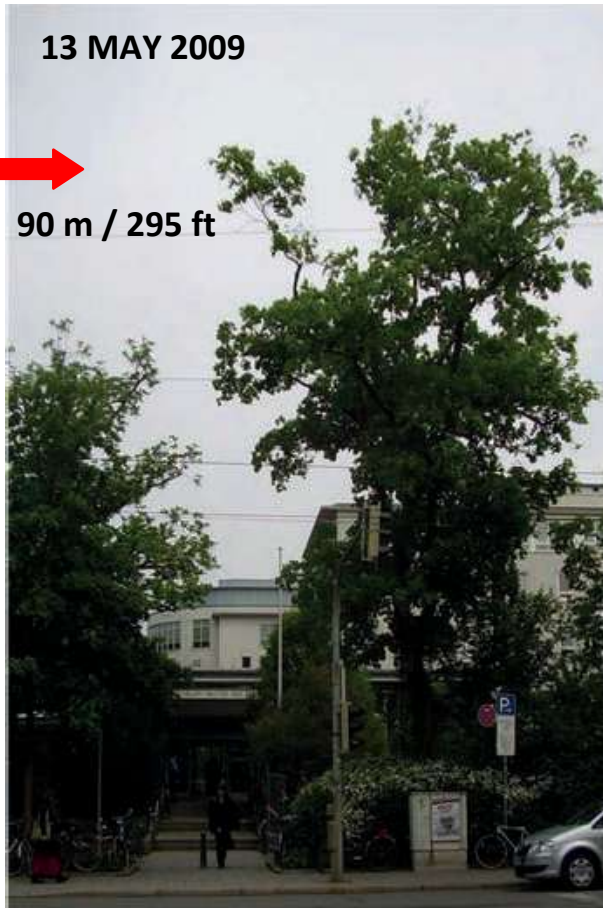
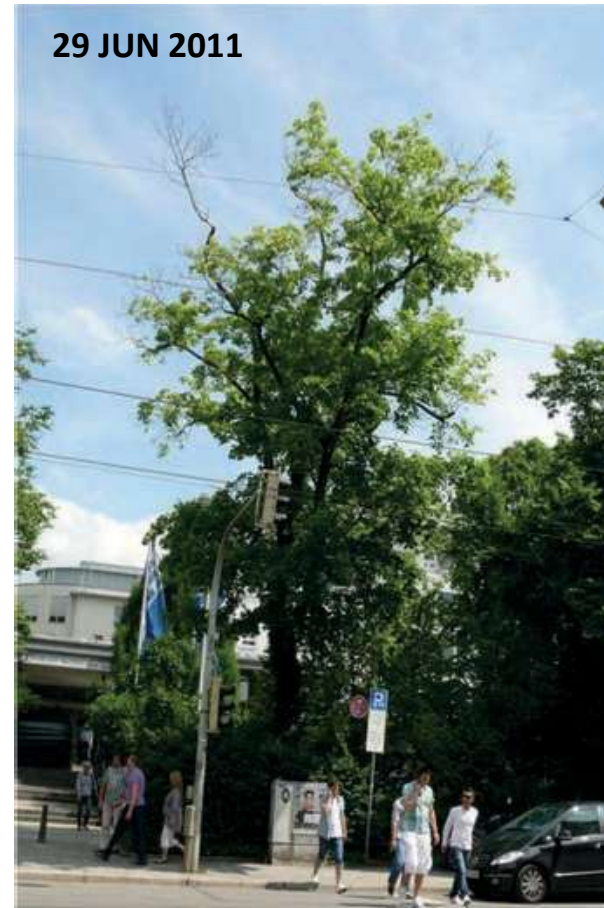
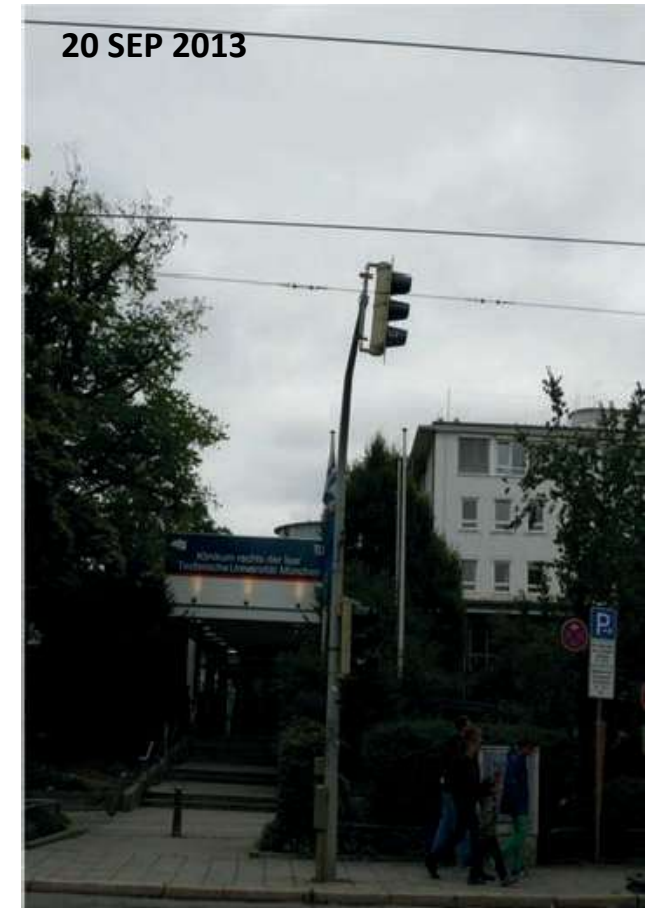
Base station on Ismaninger Straße: 6 antennas

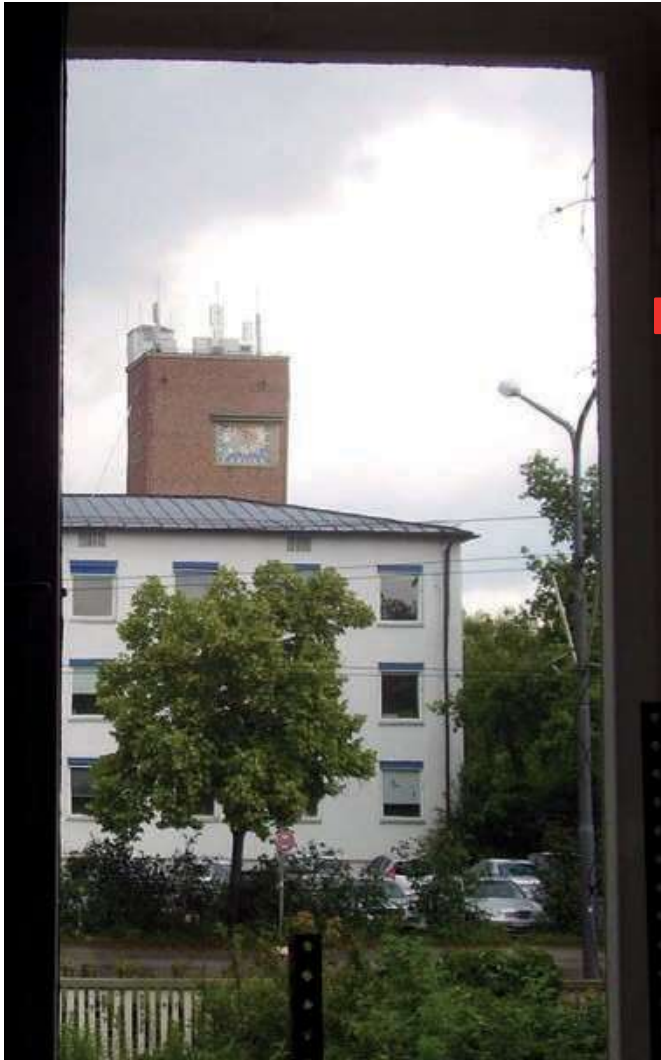
ca. 330 m / 1,080 ft

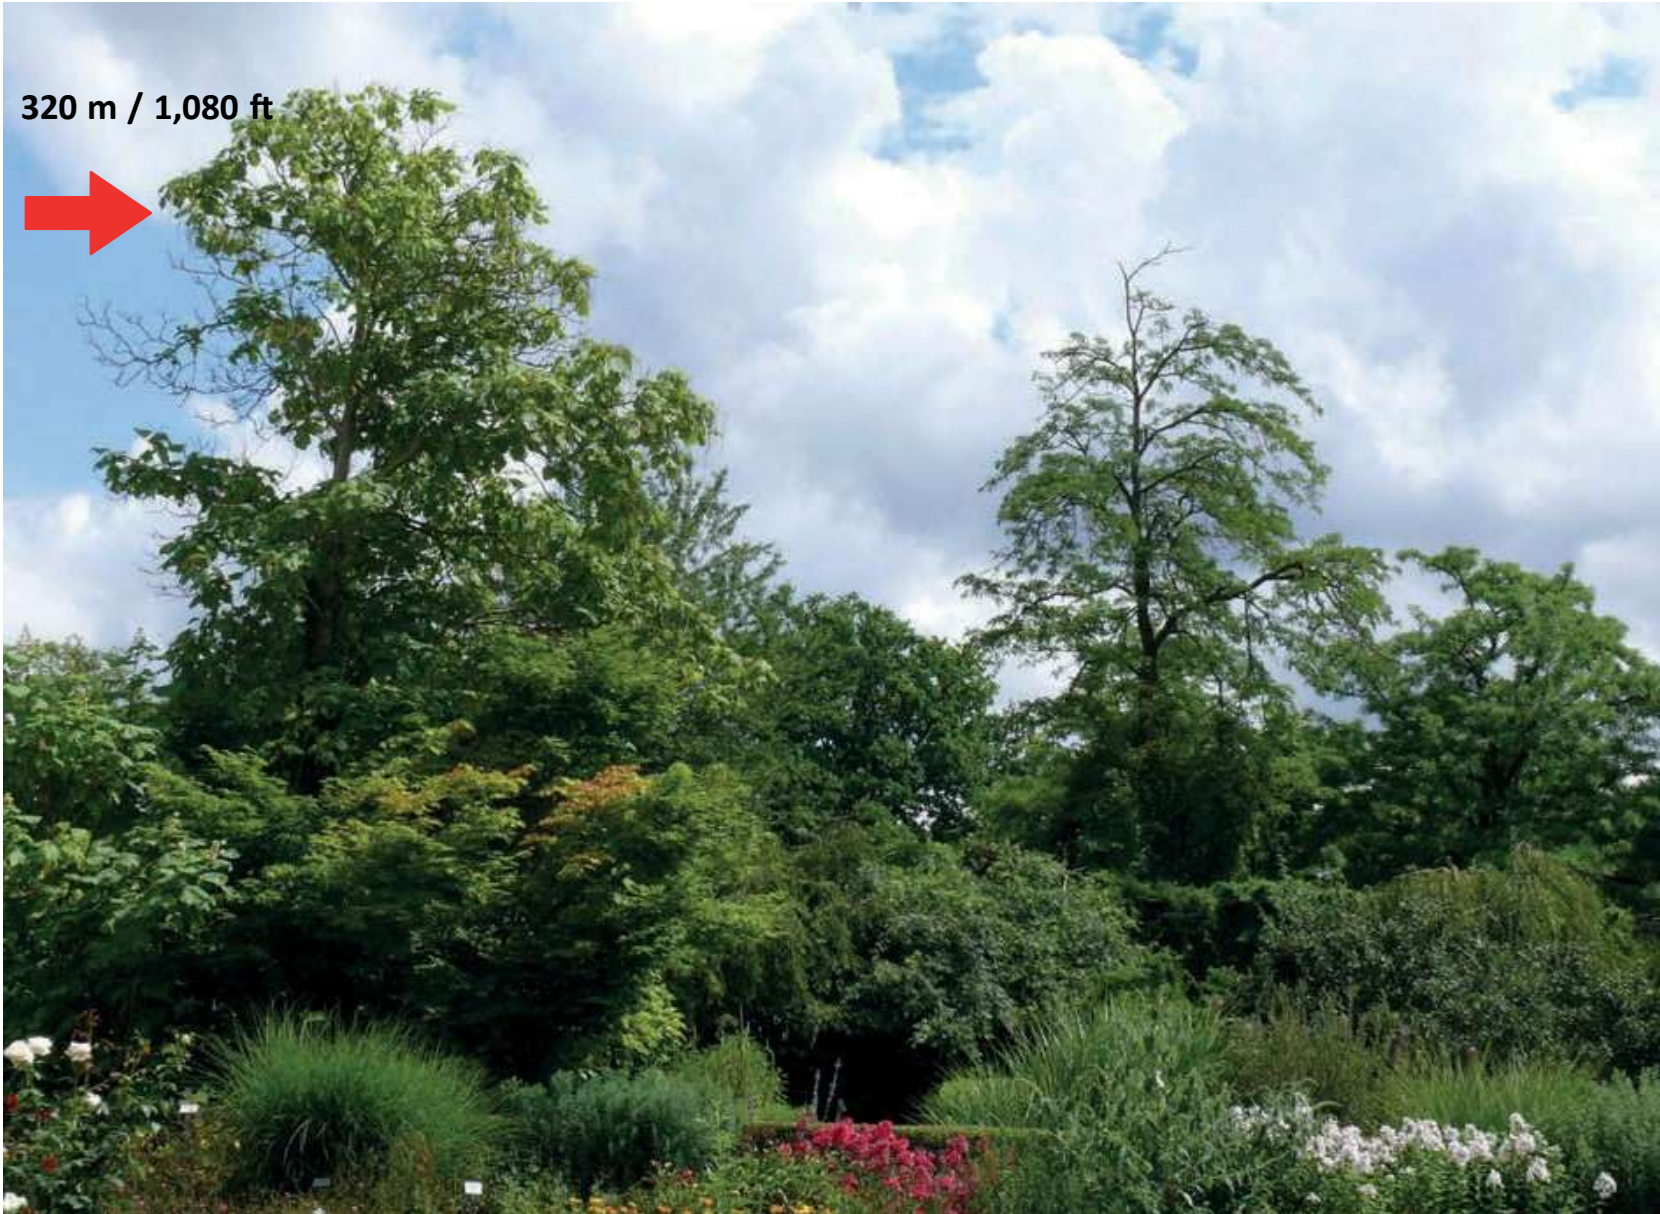
Munich, Botanical Garden, 2012

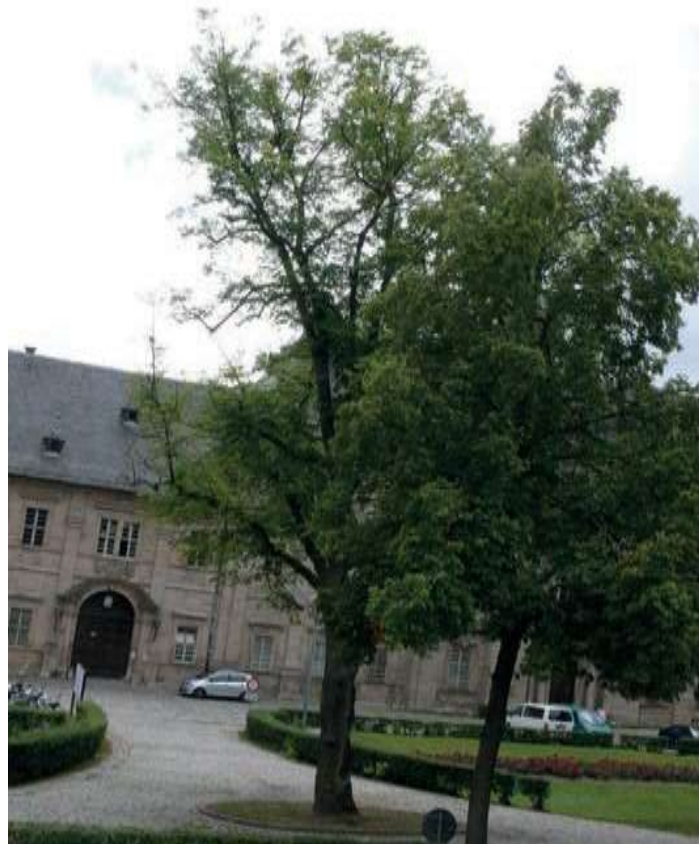
06 AUG 2012 The damage to the crown is increasing.

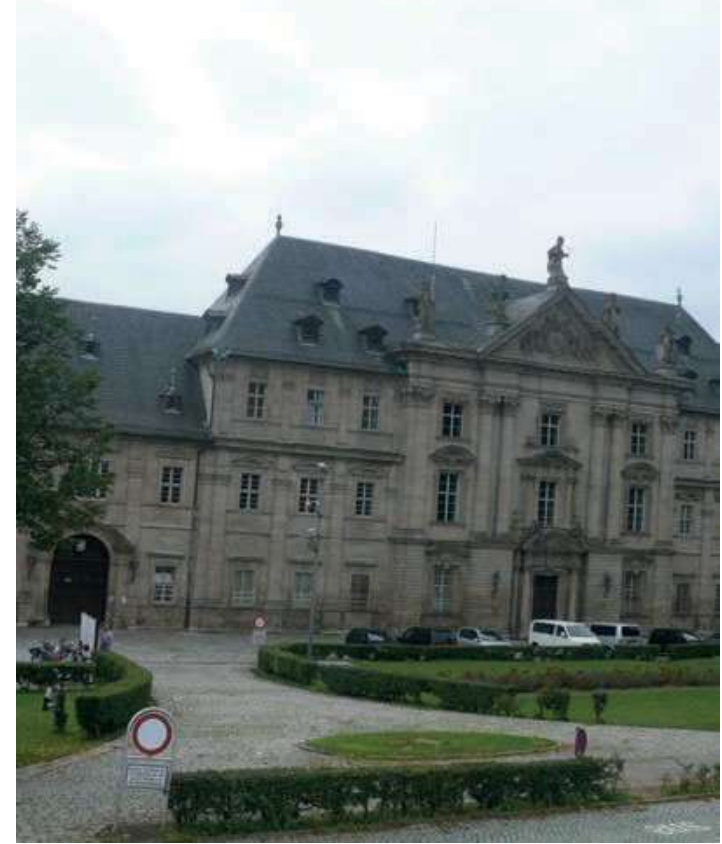
05 SEP 2014 The linden tree was cut down.
