Tree Damage Caused by Radiofrequency Radiation

Key Observations from 2005 to 2025 in Germany

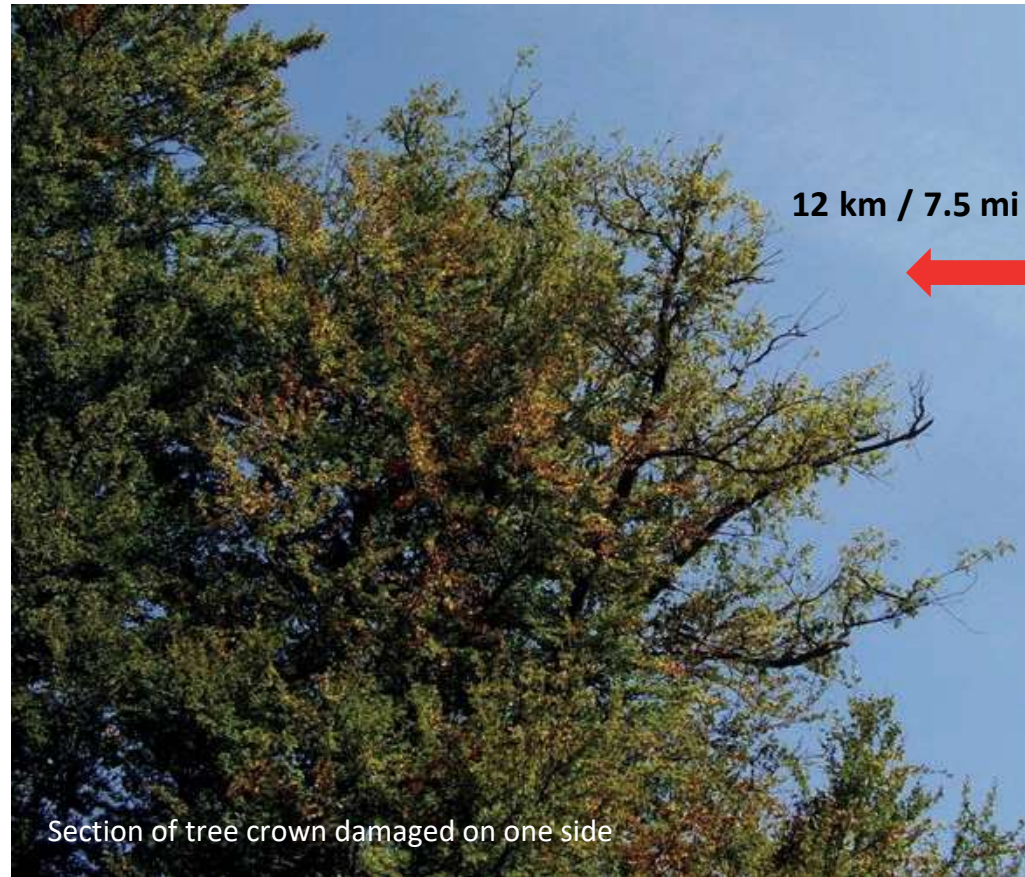
Section of tree crown damaged on one side

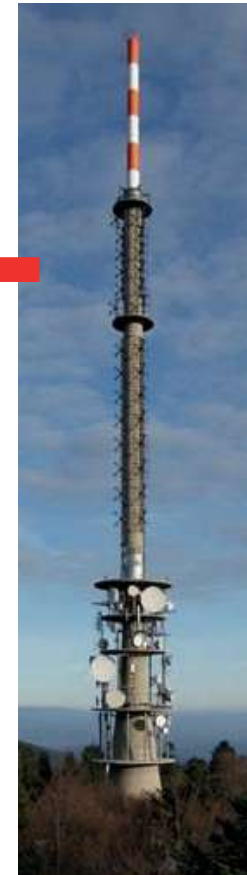
09 NOV 2008
Photo from
Wikipedia,
see photo
credits

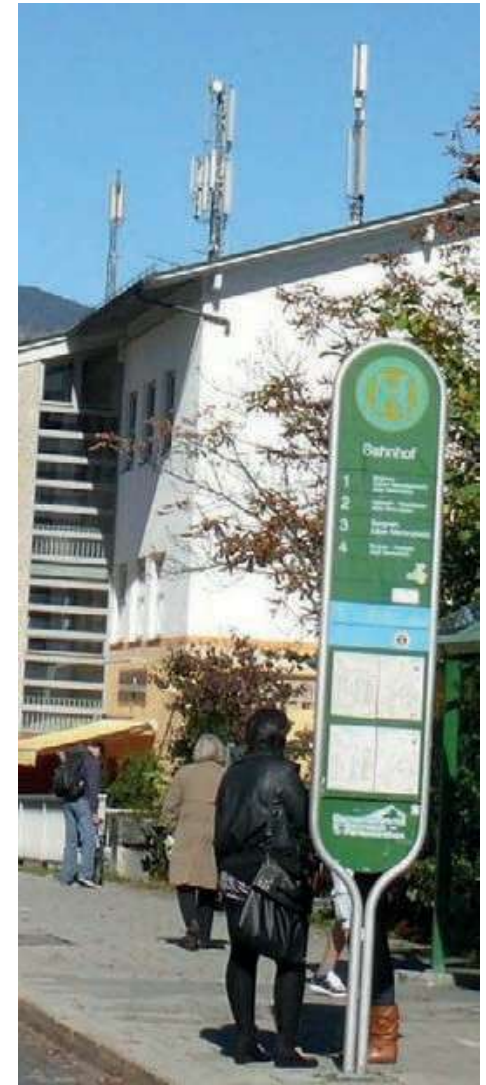
Mobile phone base station
Bahnhofstraße

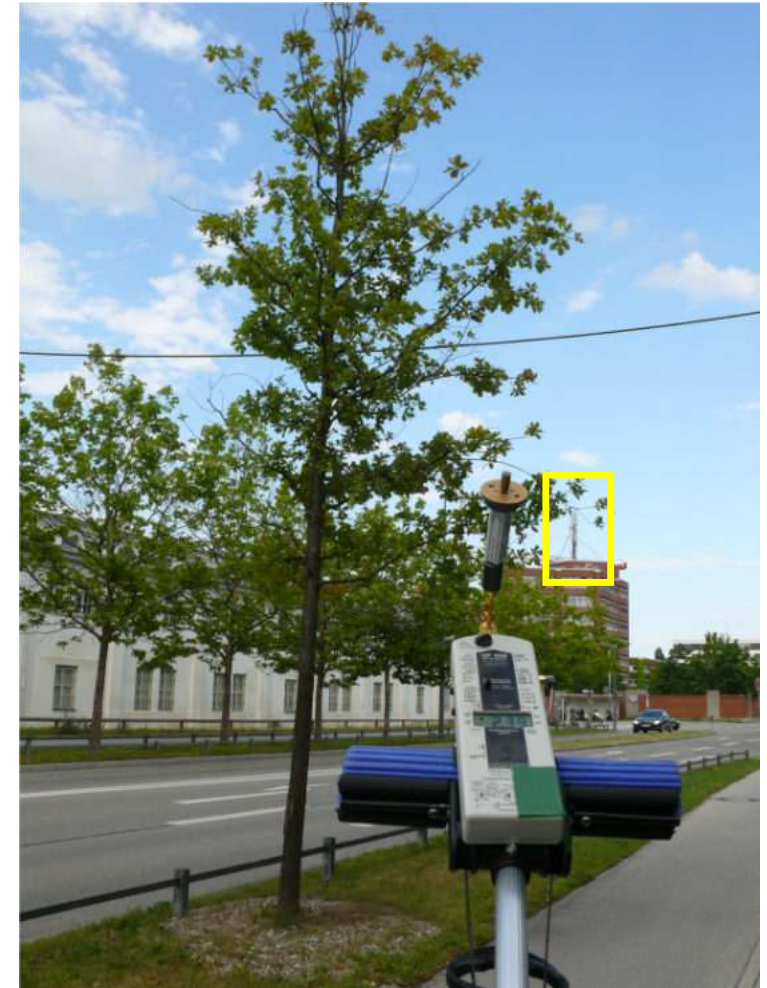
03 AUG 2012 Oak tree (view from the southwest). Distance to the base station: ca. 190 m / 620 ft Measurement: **2,390 $\mu\text{W}/\text{m}^2$**

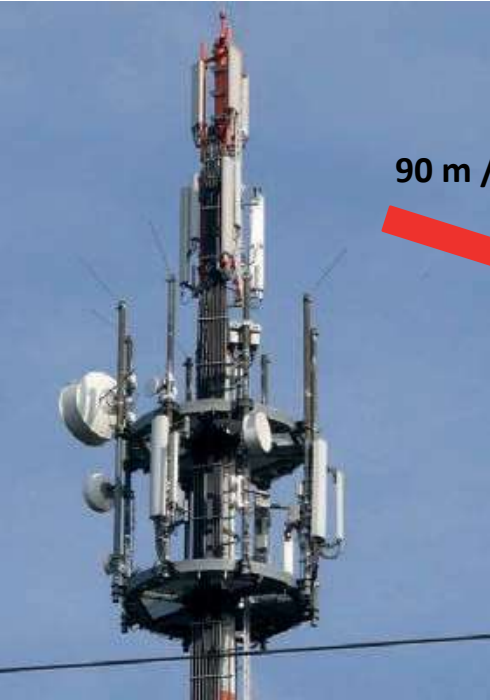
Site certificate No. 620798, accessed in August 2013: installation height 18.99–21.09 m (62.3–69.2 ft), **6 sector antennas** (2 x 90°, 2 x 210°, 2 x 330°)
Site certificate No. 620798, accessed on April 26, 2017: installation height 18.5–20.9 m (60.7–68.6 ft), **15 sector antennas** (5 x 90°, 5 x 210°, 5 x 330°)

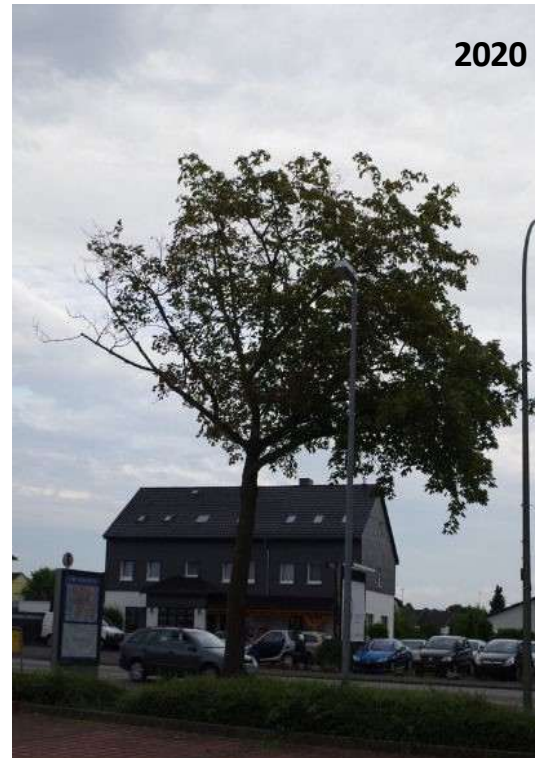
17 AUG 2020 The crown damage is
worsening on the north side.
Measurement 2020: 1,100 $\mu\text{W}/\text{m}^2$

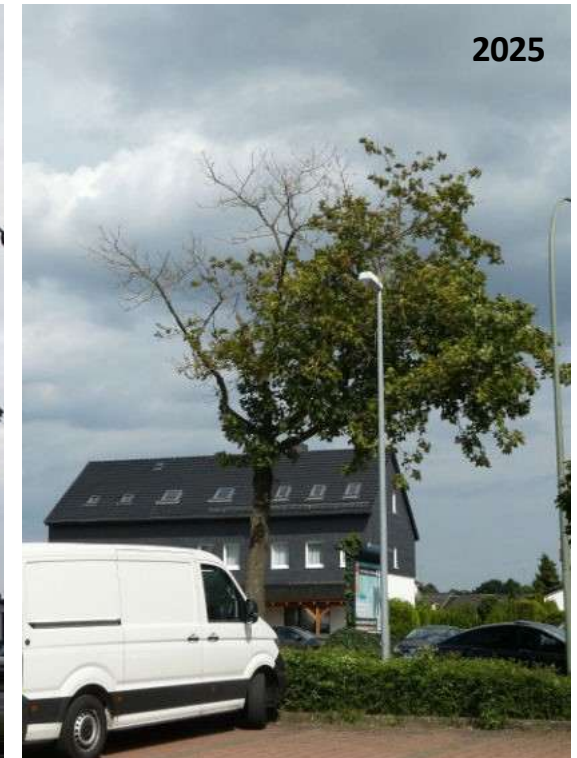
14 JUL 2025 The northern half is bare.
Pruning has been carried out. Since
2023, the measured RF radiation levels
have risen significantly.
Measurements fluctuate between
20,000 and 100,000 $\mu\text{W}/\text{m}^2$.

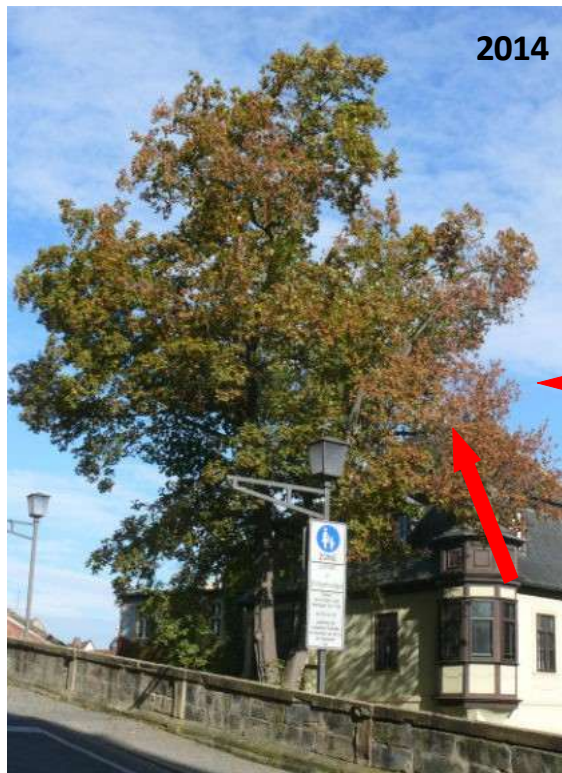
09 OCT 2014 Karolinenstraße.
The crown is becoming more damaged.

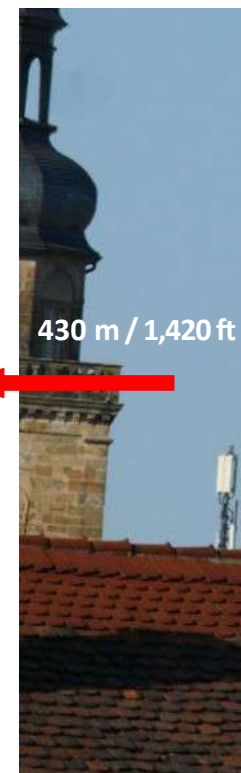
Base station Grüner Markt (view from the southwest)

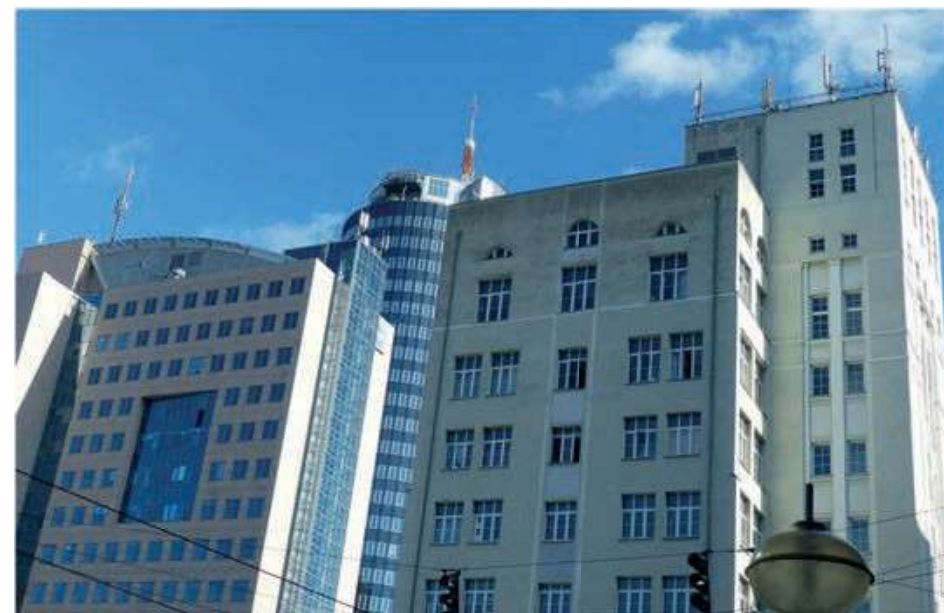
Three mobile phone base stations: Leutragraben, Ernst- Abbe-Platz, and JenTower. Numerous trees along the Leutra stream have sustained major damage.

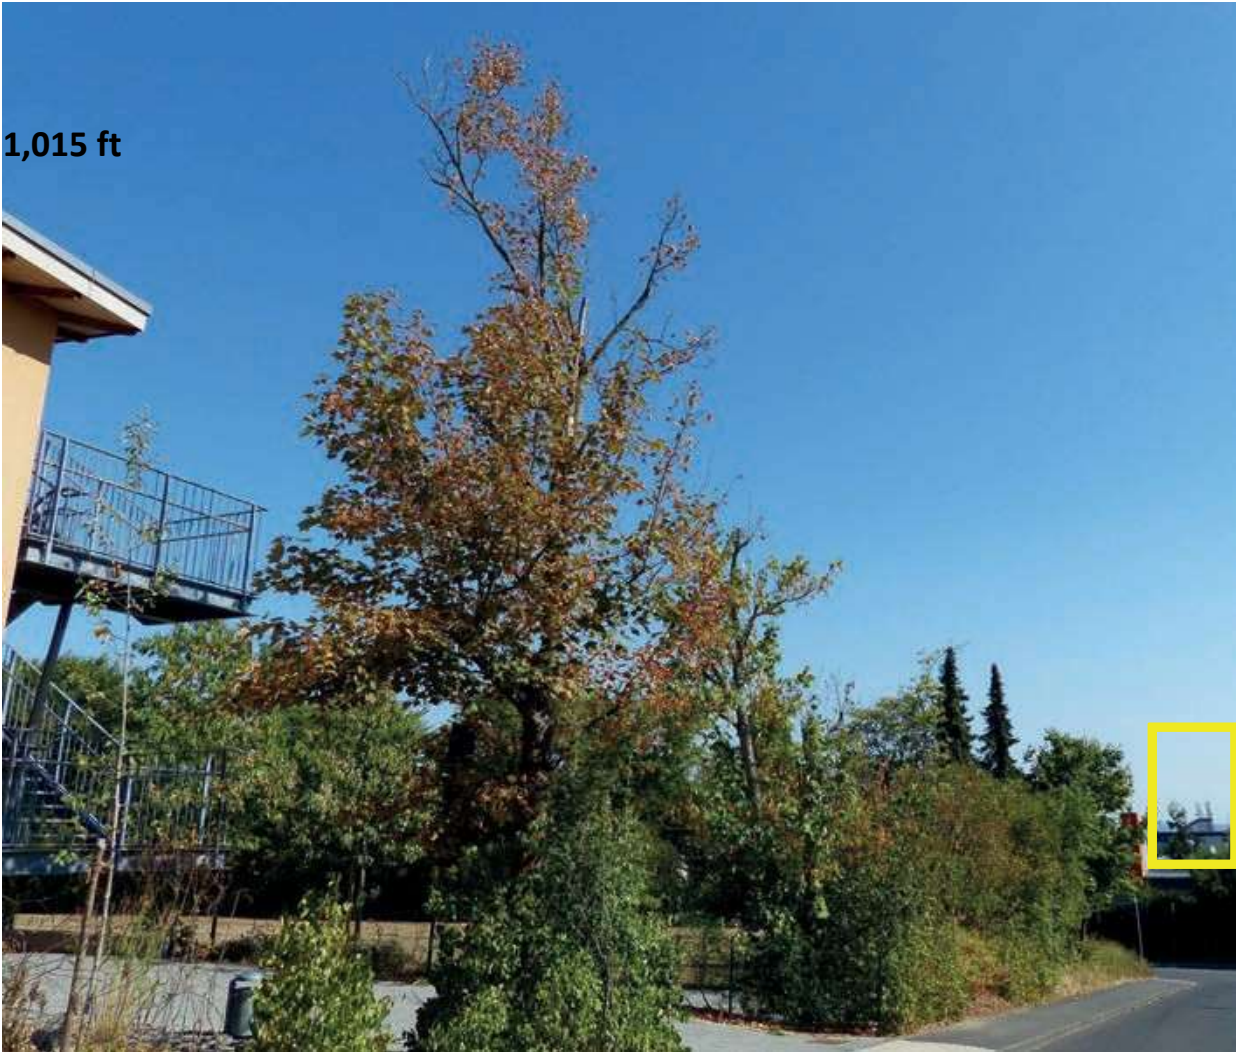
07 AUG 2018 Ringastraße, Waldorf school. Sycamore tree (view from the southeast), advanced damage. The damage on the left and right side is still different.

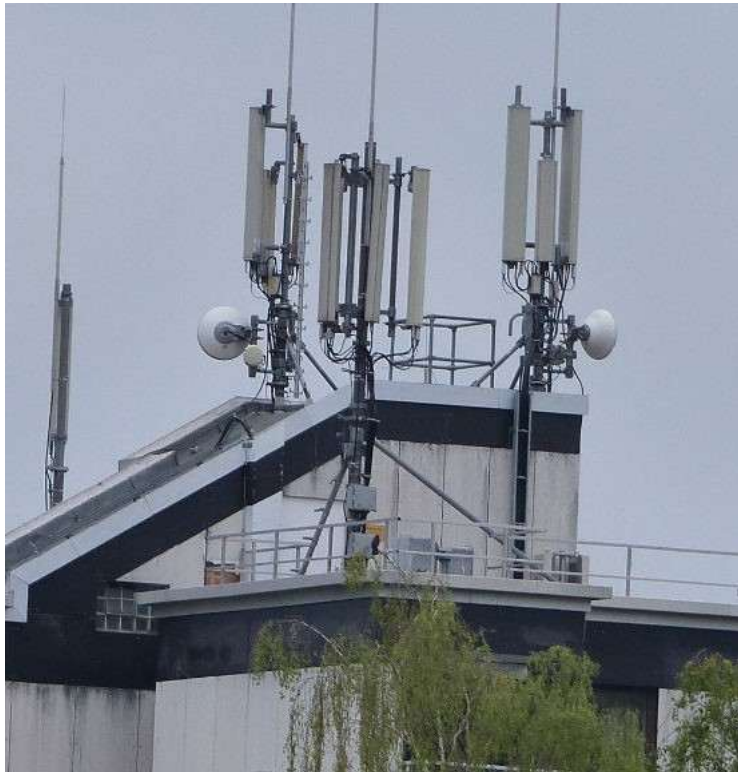
Mobile phone base station at Hunrodstraße

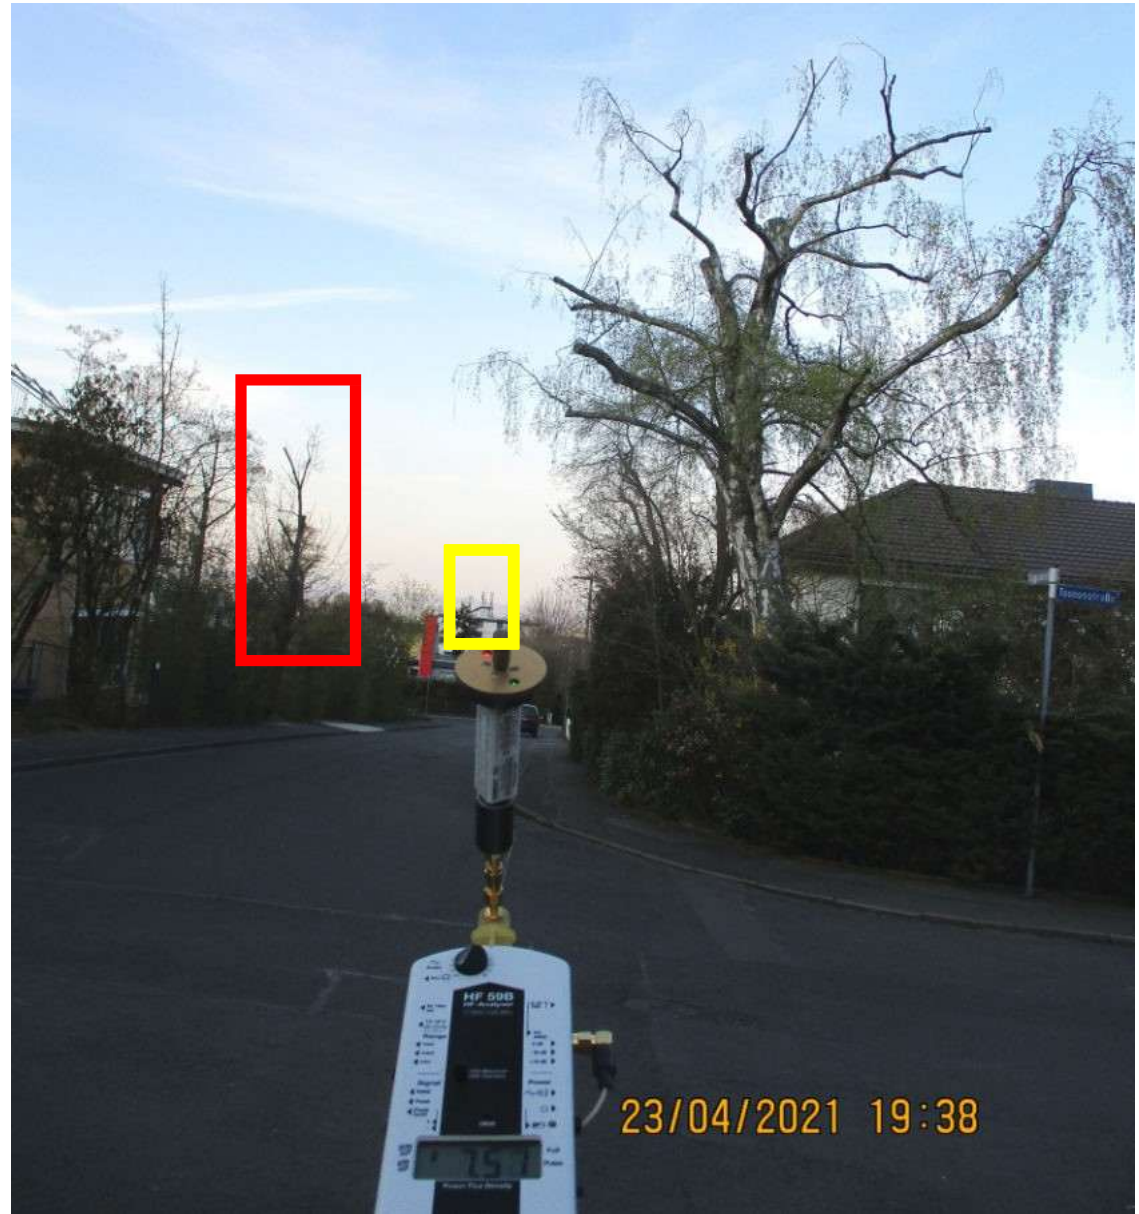
23 APR 2021 Intersection of Ringaustraße and Taunusstraße. Sycamore tree from the previous image (marked red). Birch tree heavily pruned due to crown damage (view from the southwest). Distance to base station: ca. 340 m (1,115 ft)
Measurement: **7,570 $\mu\text{W}/\text{m}^2$**

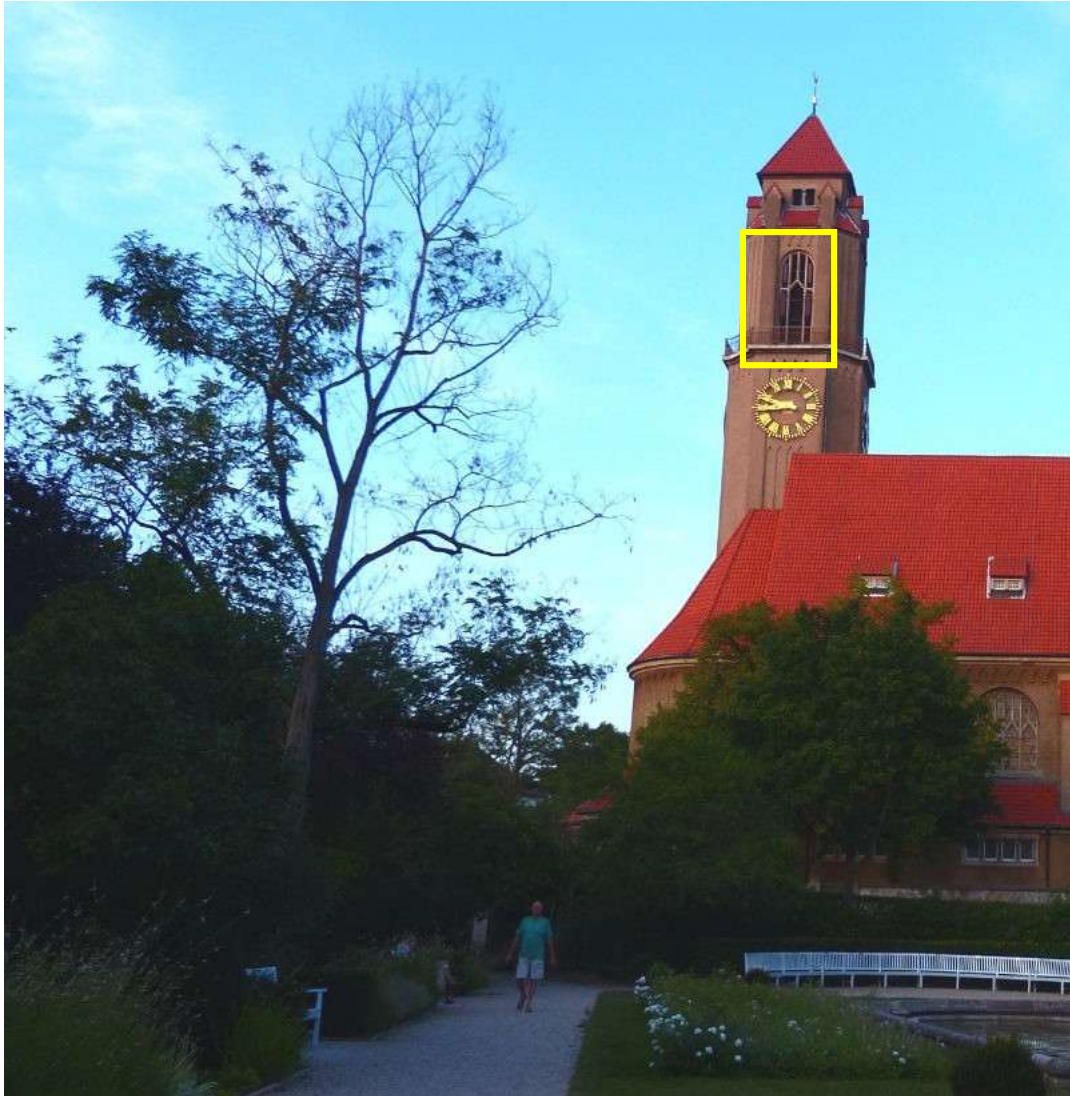
25 JUL 2019 Darmstadt, St. Paul's Church (view from the west). Locust tree. The mobile phone base station in the church steeple radiates in all directions: north, east, south and west. We observed damaged trees in all directions. The measurement was taken in front of the administrative building of the Protestant Church of Hesse and Nassau: **3,370 $\mu\text{W}/\text{m}^2$** .

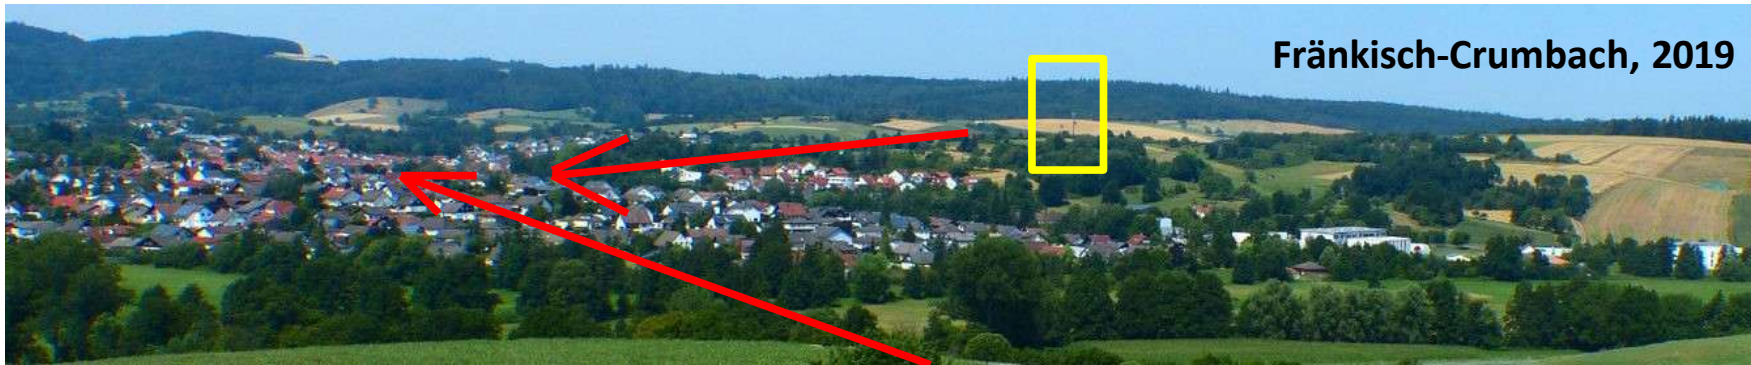
Fränkisch-Crumbach, 2019

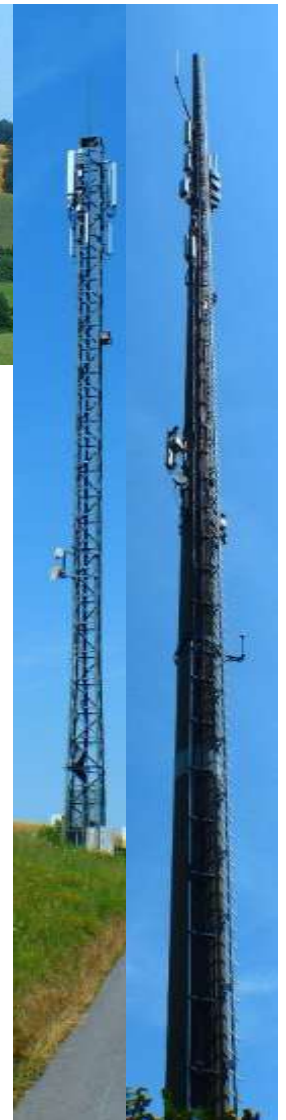
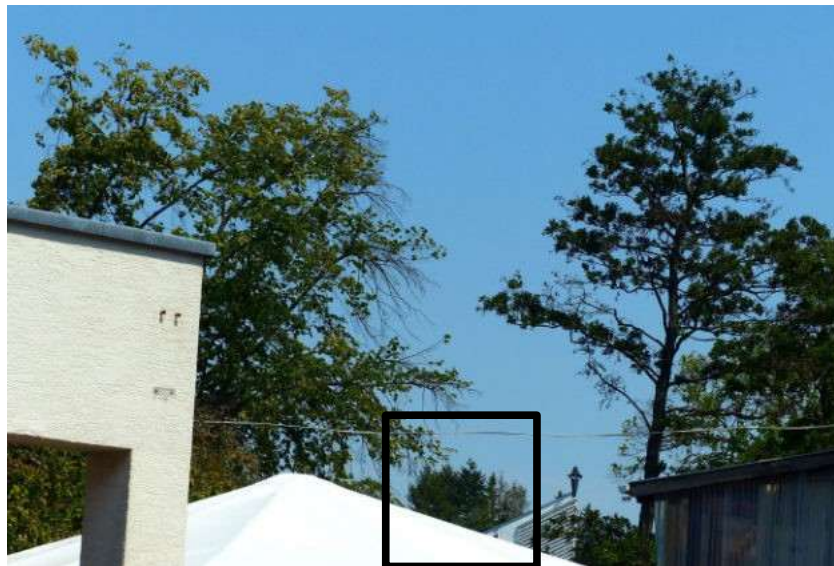
26 JUL 2019 This is a view from Erbacher Str. 30 of the damaged treetops facing Jahnstraße (view from the southwest). There is a direct line of sight to the base station in the north, which is 520 m (1,706 ft) away. Nearby measurements were around **400 $\mu\text{W}/\text{m}^2$** .

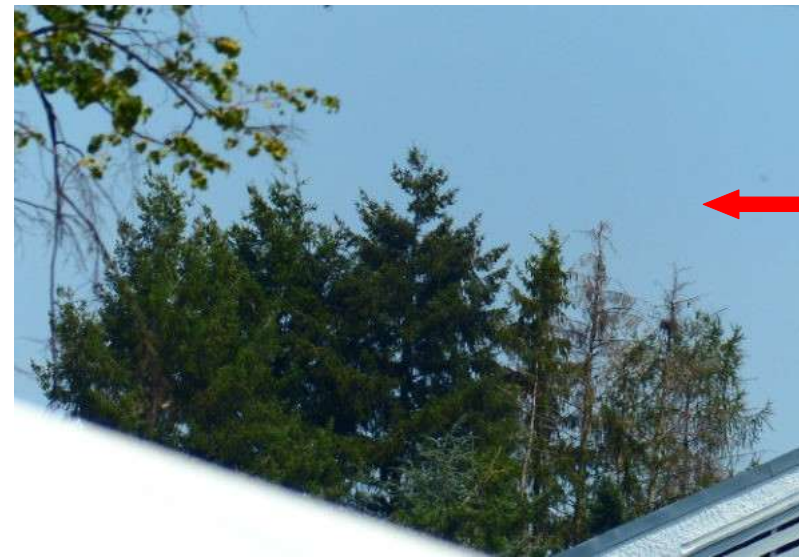
26 JUL 2019 This is a close-up of a group of conifers in the background of the photo on the left. RF radiation from mobile phone base stations strikes the trees from the east.

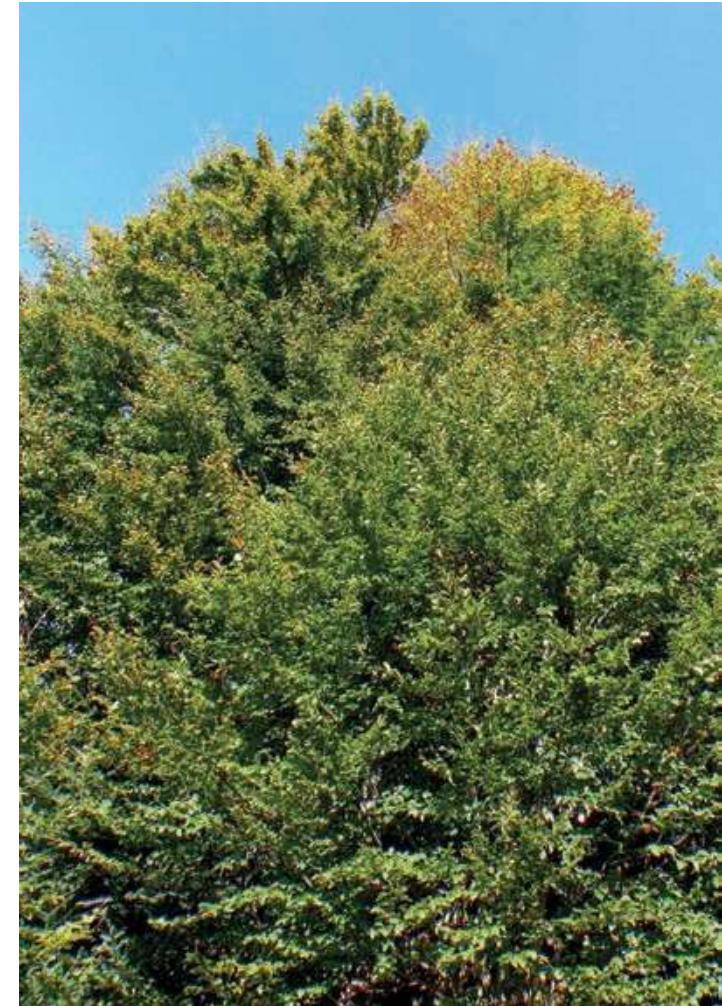
25 OCT 2019 Southeast of Freiburg-Günterstal.
Beech tree

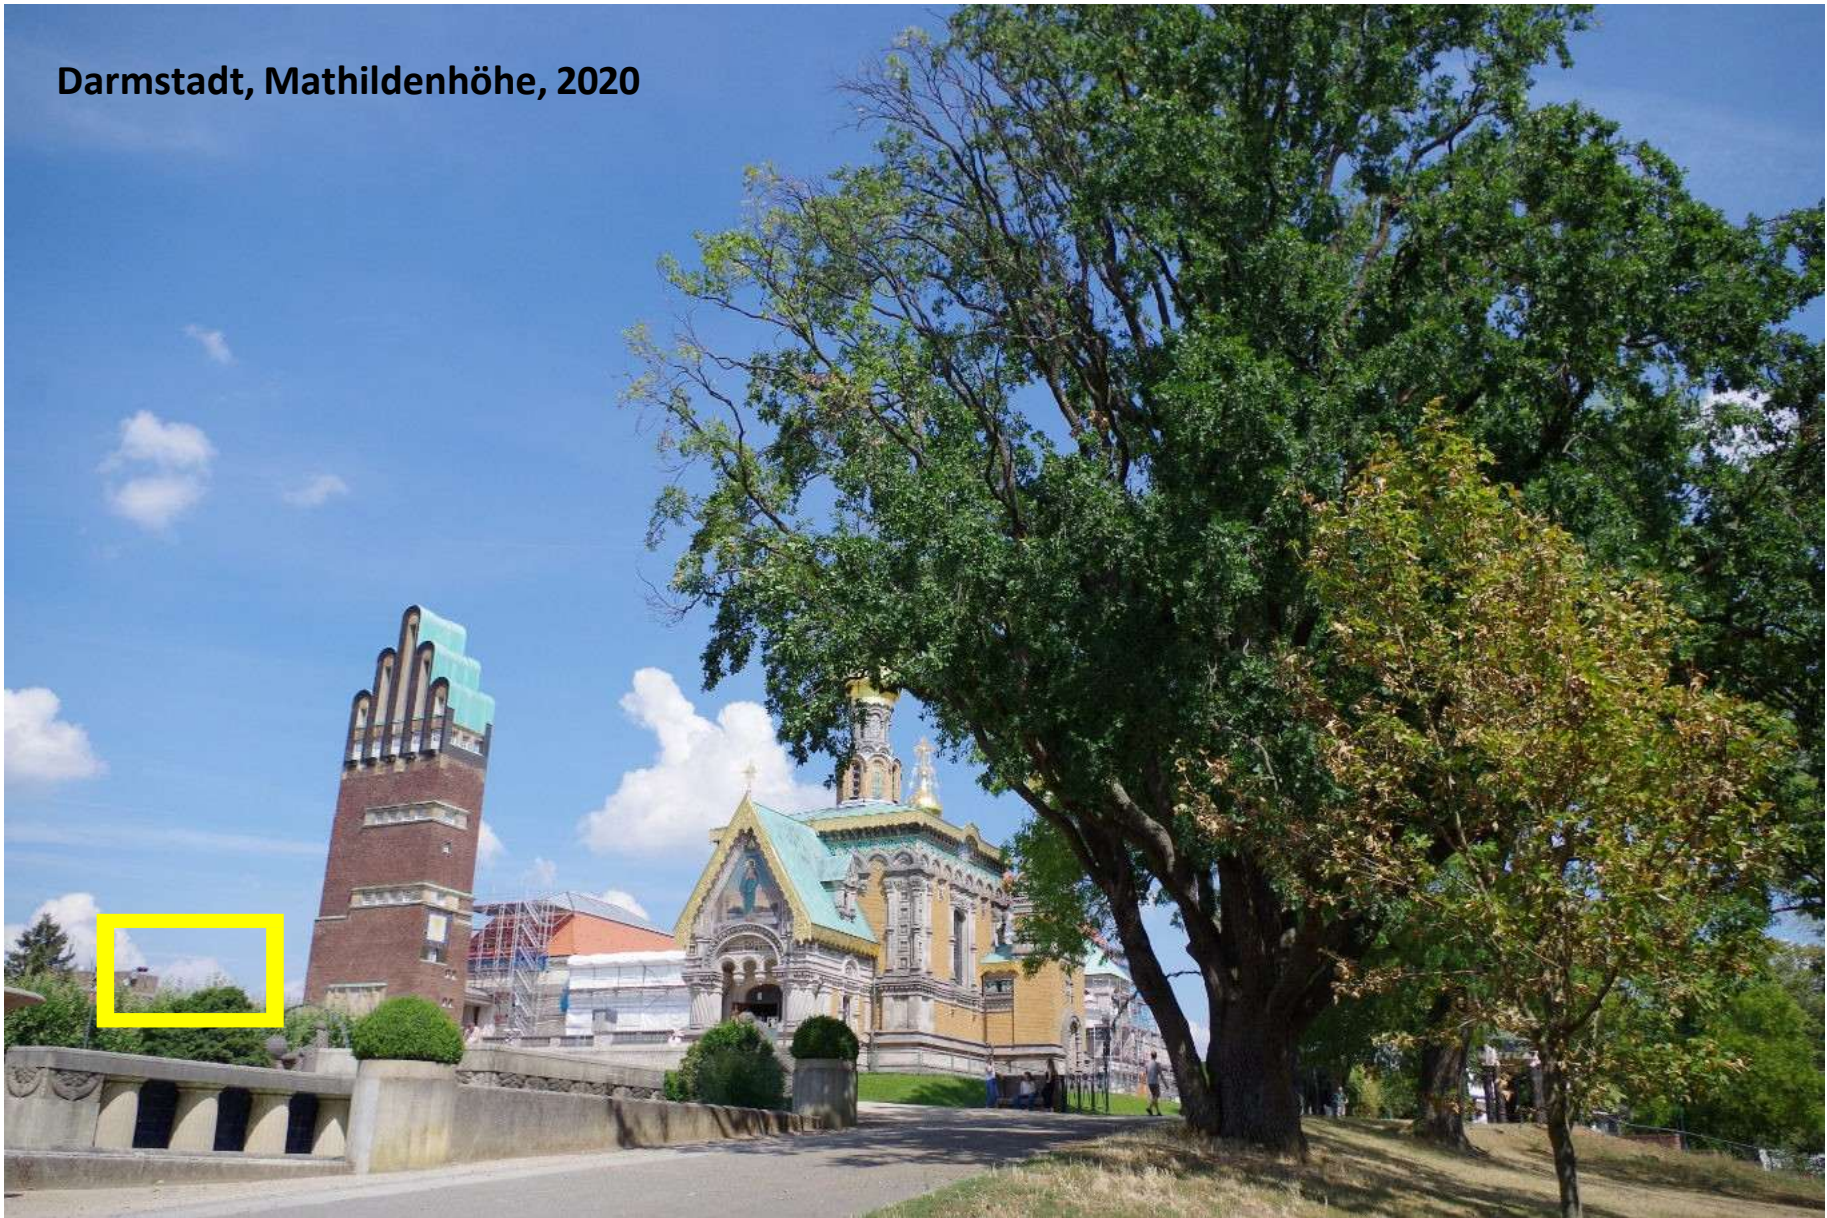
16 AUG 2020 Darmstadt, Mathildenhöhe. Oak tree (view from the southwest). There is a direct line of sight from the damaged north side of the oak tree to the mobile phone base station on Dieburger Straße, which is about 260 m (853 ft) away. Measurement at the Russian Chapel: **620 $\mu\text{W}/\text{m}^2$** . Many other trees in the park were also showing signs of damage.

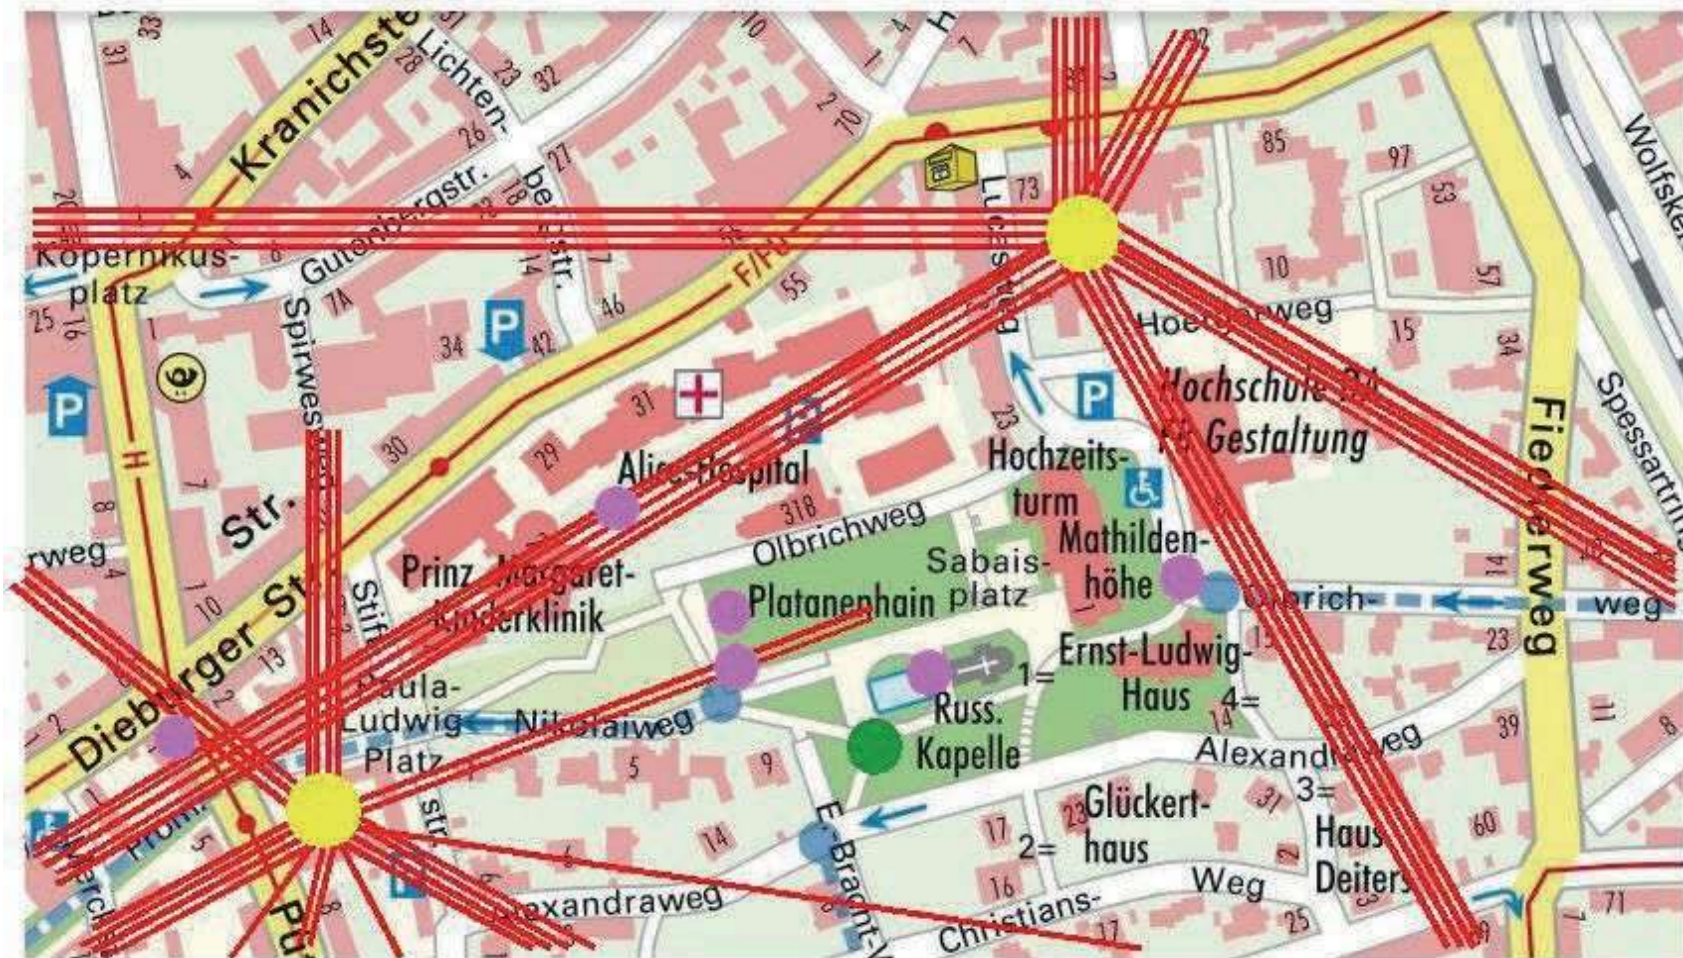
Section of the city map <https://stadtatlas.darmstadt.de/>. Added items: location of mobile phone base stations (yellow) with the main beam directions (red), measurement sites (purple), and the location of the oak tree (green).

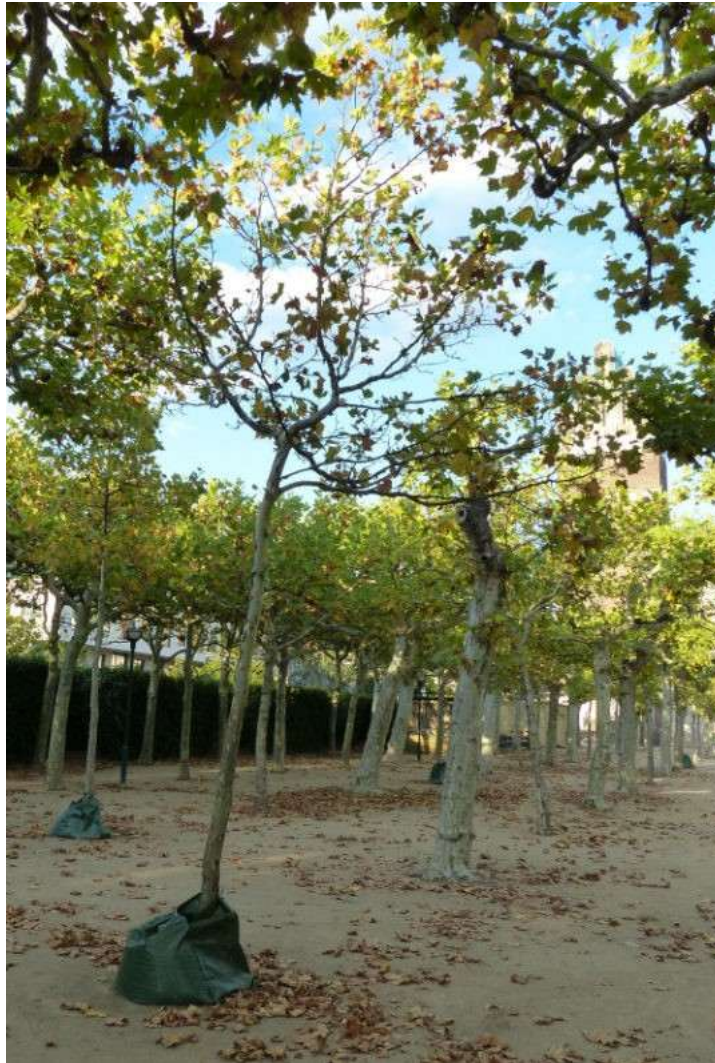
02 SEP 2019 Despite being irrigated, the replanted plane tree has already lost many leaves. Assuming soil compaction is the sole cause of the damage, trenches are being dug for aeration and irrigation as of January 2022. Unfortunately, it is feared that the plane trees will not thrive despite these efforts.

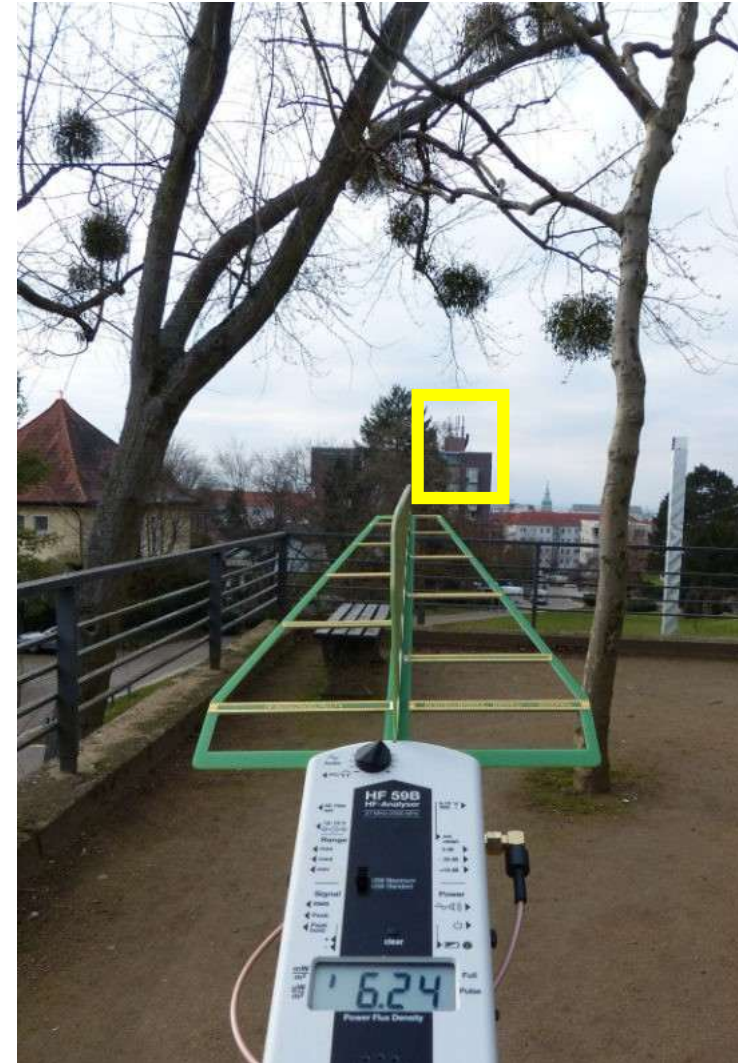
23 JAN 2020 The measurement was taken at the southwest corner of the plane tree grove: **6,240 $\mu\text{W}/\text{m}^2$** .

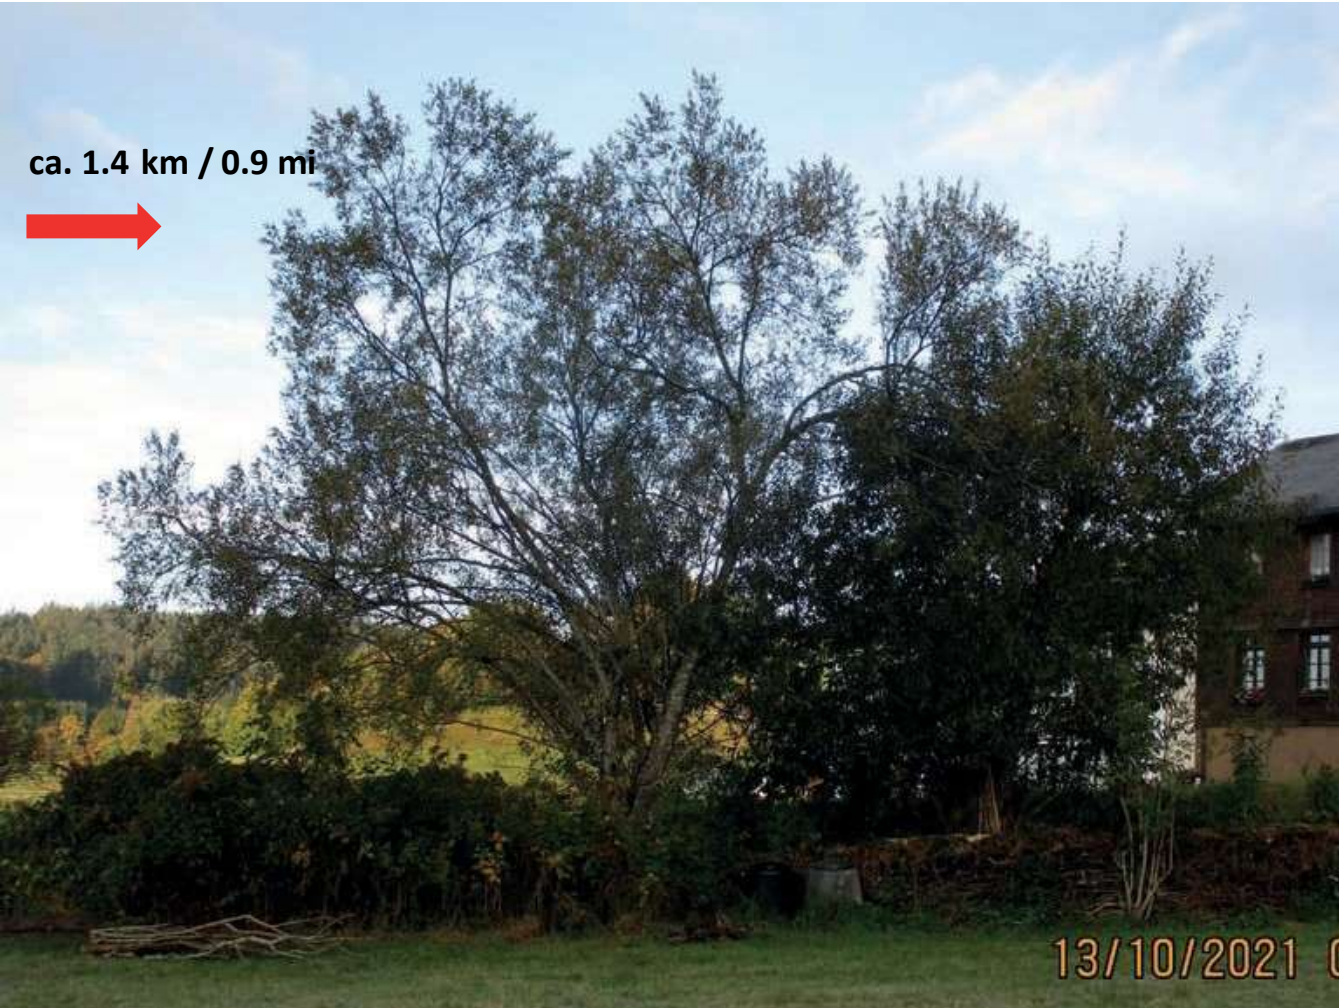
13 OCT 2021 Ibach. Willow trees, south of the town hall, on the east side of the street (view from the east). The willow tree facing south has sparse foliage, while the one facing north has dense foliage. Quite a few conifers and deciduous trees between Unteribach and Oberibach showed signs of damage on one side of their crowns.

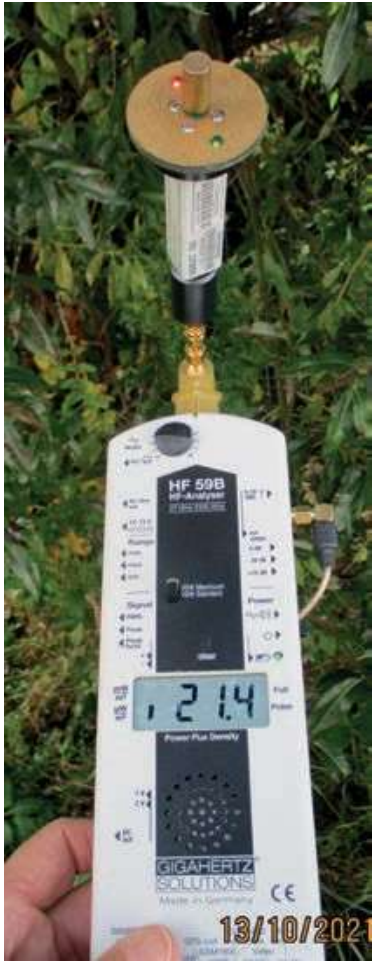
Measurement on the north side: **21.4 $\mu\text{W}/\text{m}^2$**

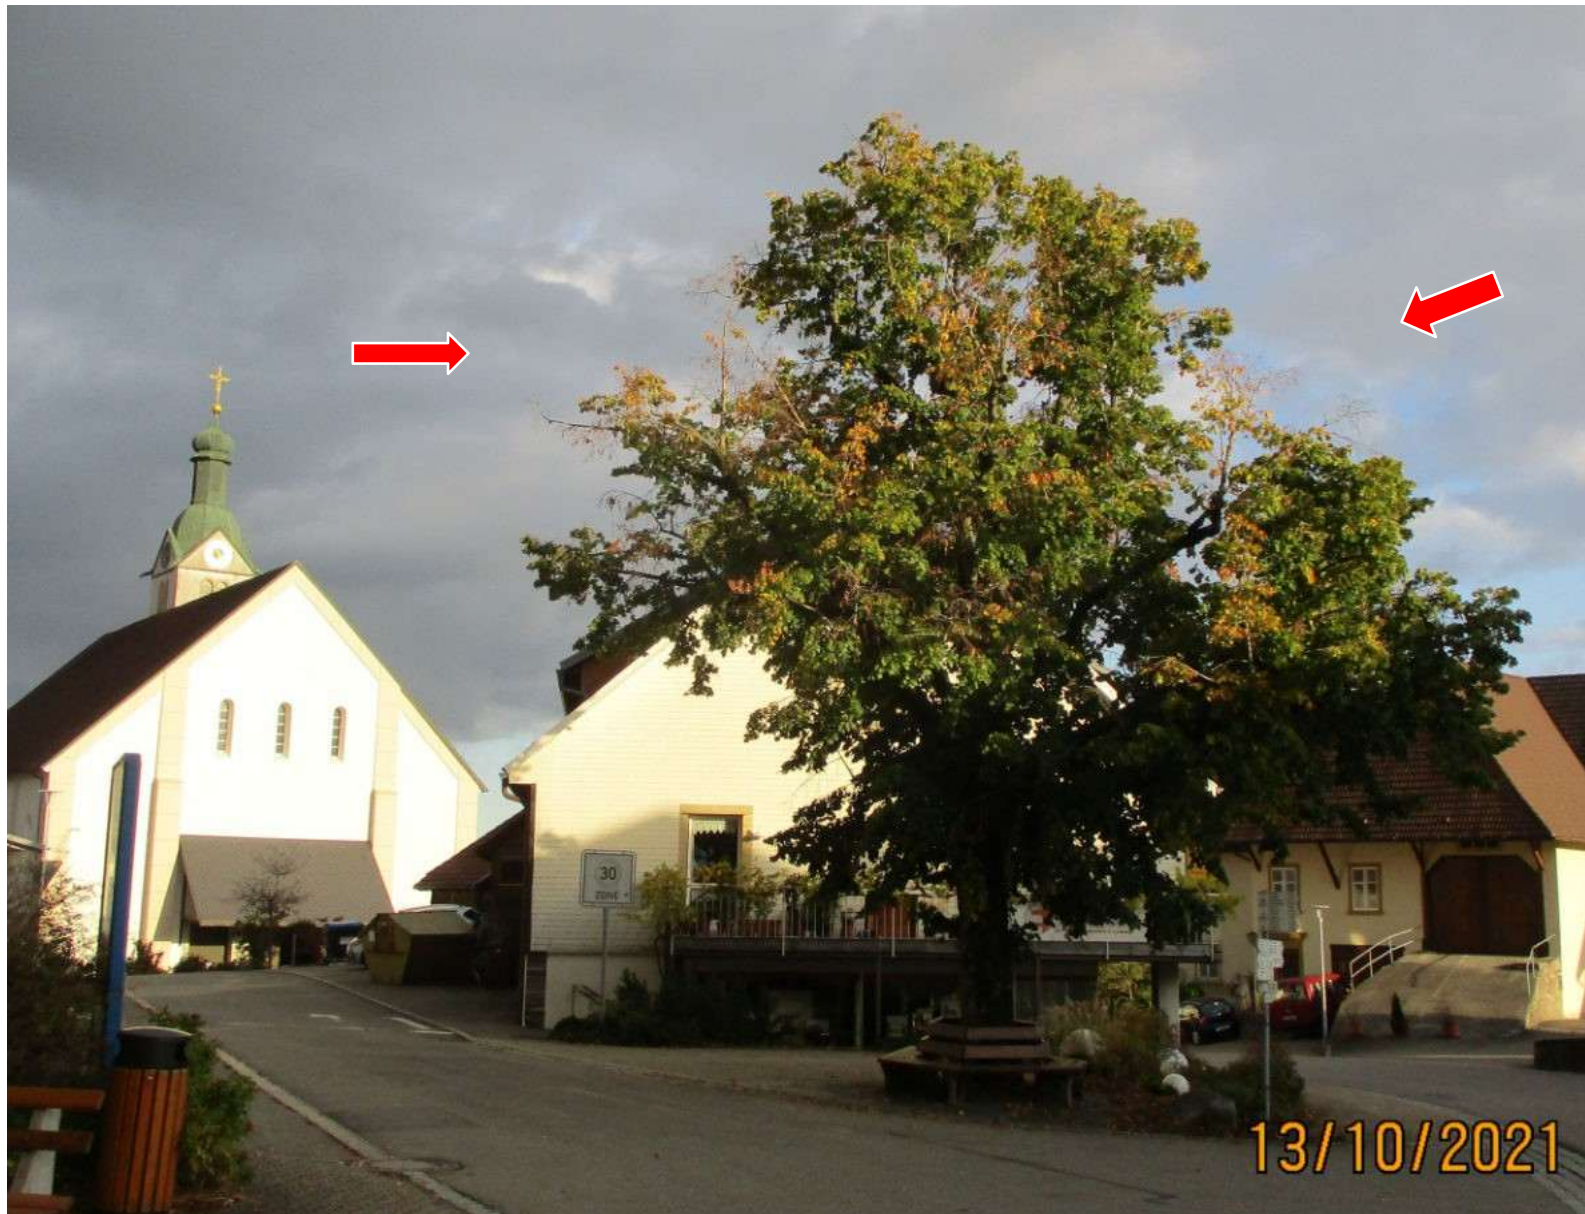
13 OCT 2021 Görwihl, Kirchstraße and Hauptstraße. Linden tree (view from the west). There is crown damage on the north and south sides. The tree's canopy is exposed to RF radiation from base stations in Görwihl and Etwihl.
