Tree Damage Caused by Radiofrequency Radiation

Key Observations from 2005 to 2025 in Germany

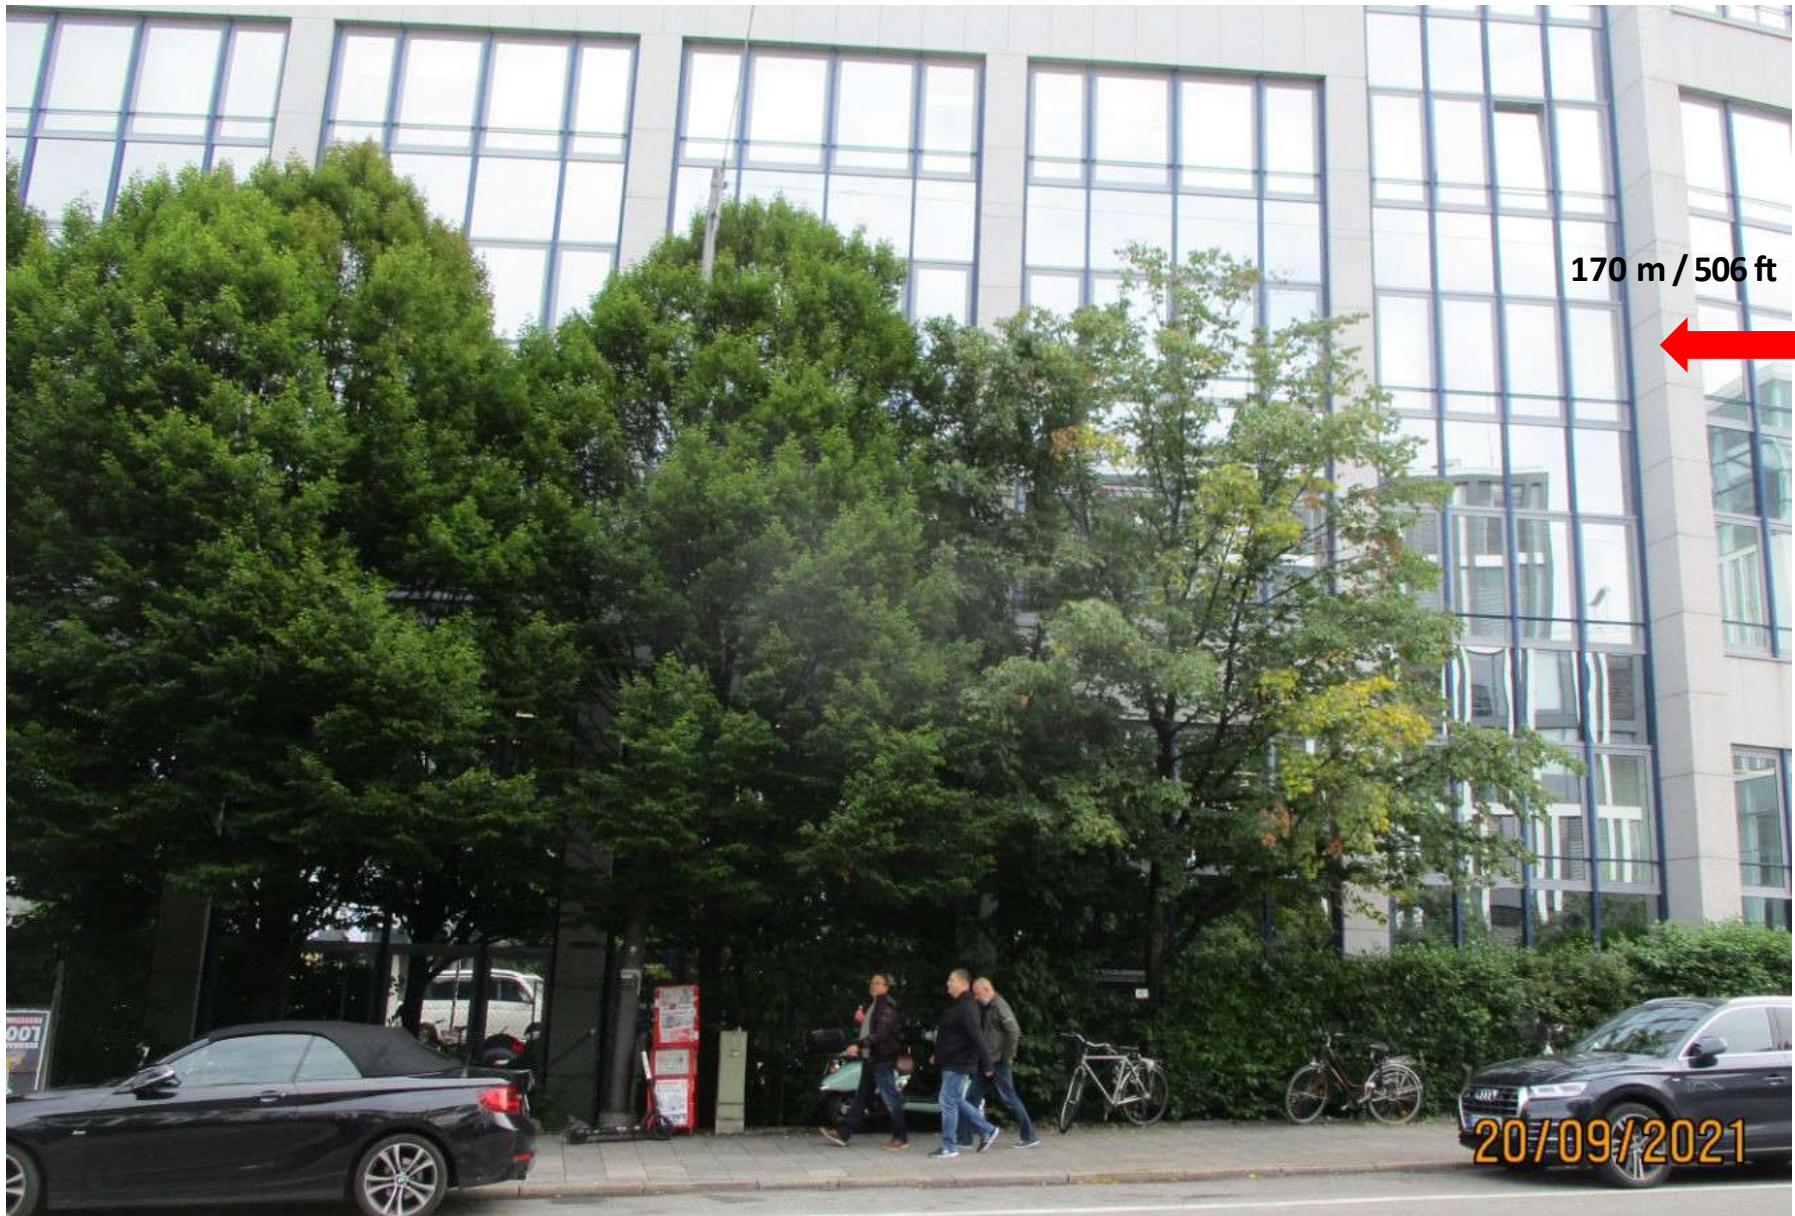
20 SEP 2021 Munich, Hacker Bridge. Three hornbeam trees (view from the west)

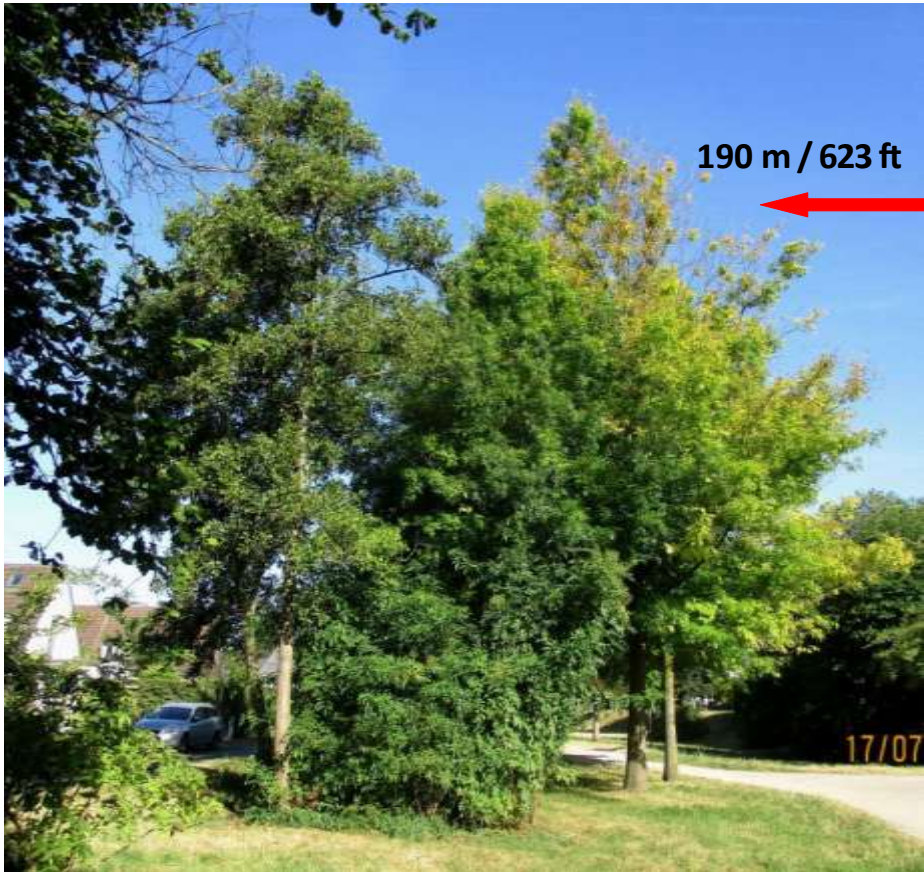
17 JUL 2022 Röntgenring playground and park.
Oak tree, alder tree, and hazelnut tree (view from the southeast).
The crowns of all three trees show damage on their northeast
sides, which face the transmitter.

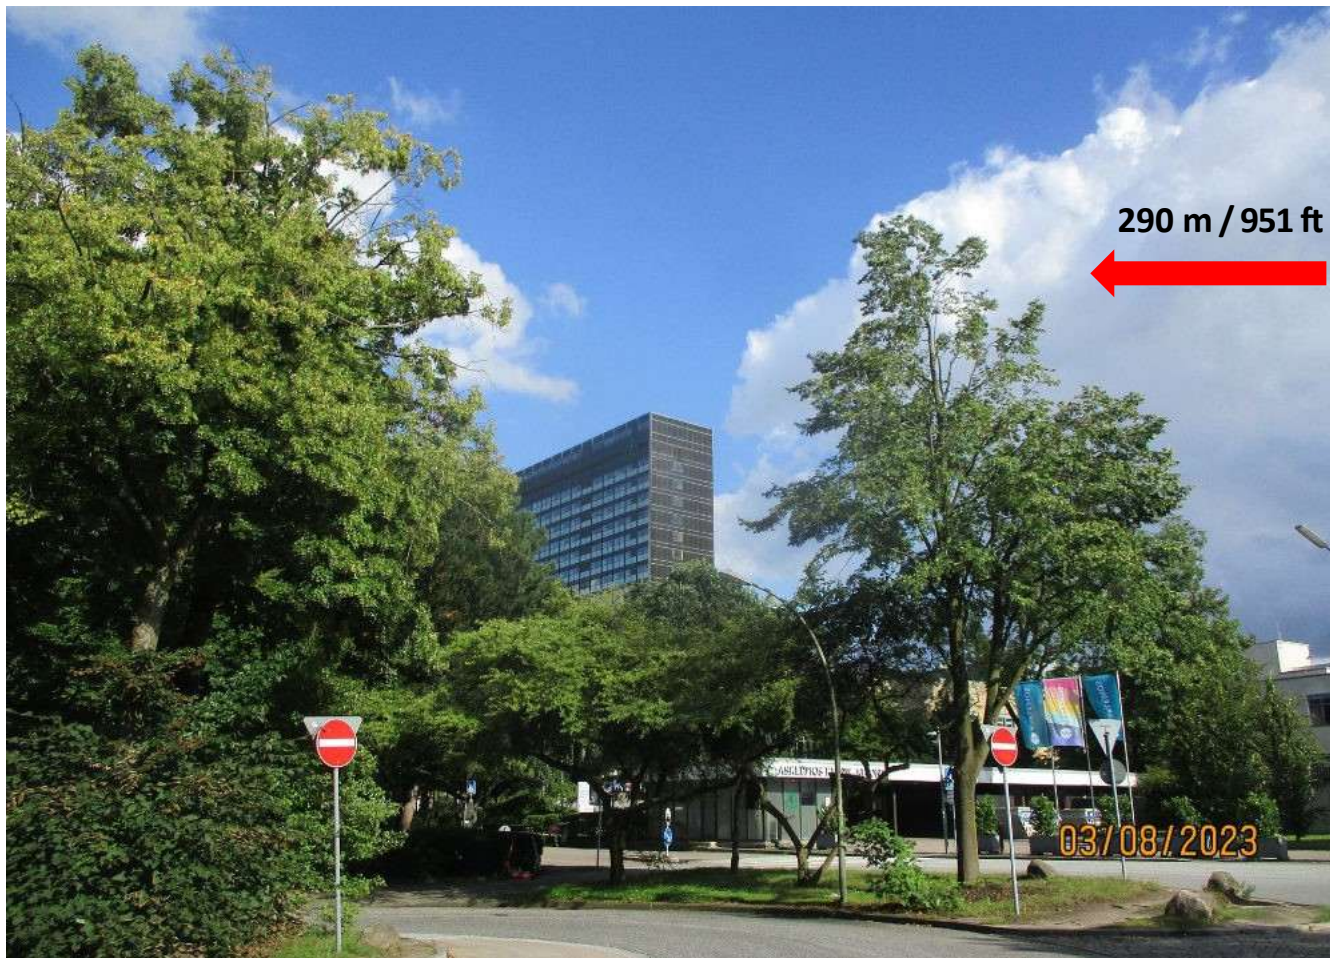
03 AUG 2023 Asklepios Clinic Altona, main entrance (view from the west).
Two linden trees: each is damaged on one side only.
There is a direct line of sight to the Helmbrook base station to the south.
Measurement on September 30, 2023: **77,300 $\mu\text{W}/\text{m}^2$**

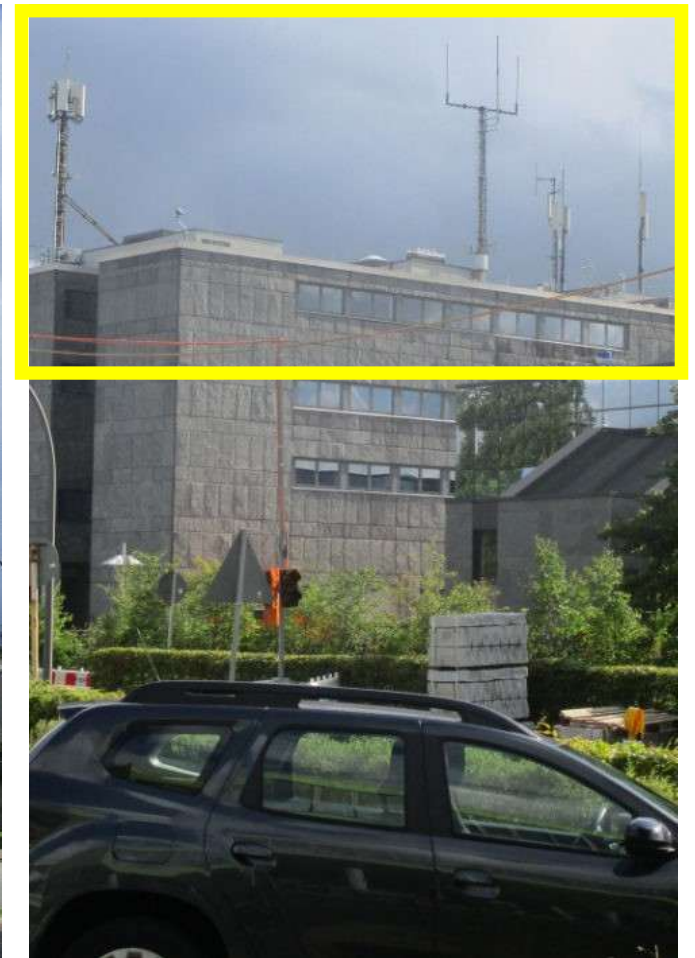
Site certificate No. 870124140, Helmbrook, with
36 sector antennas and 2 other transmitters.

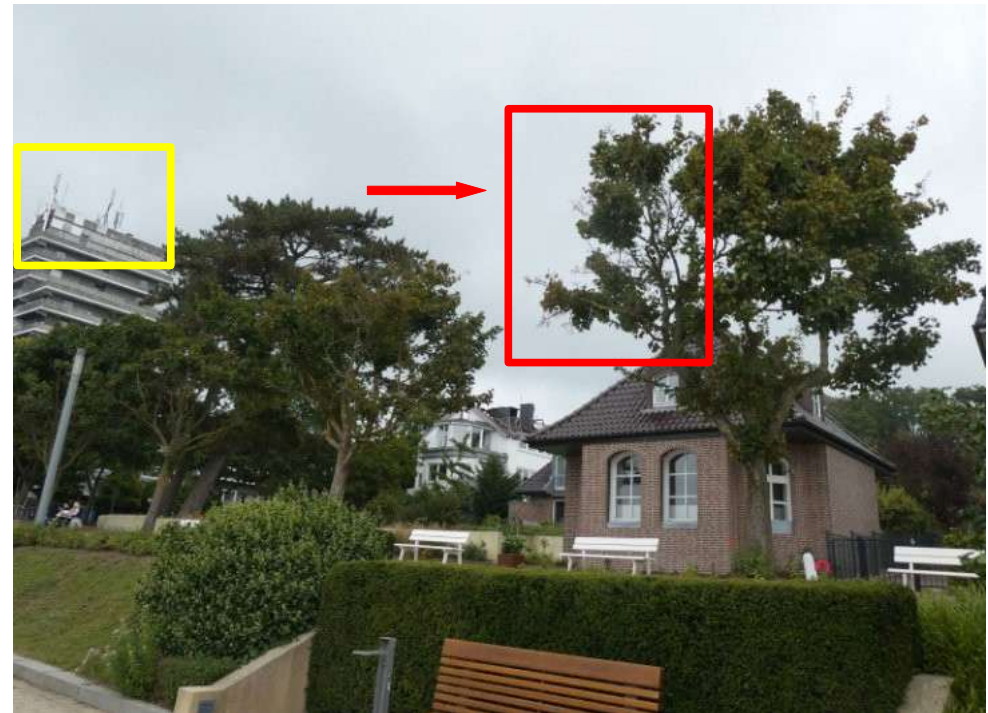
10 SEP 2025 Mobile phone base station at Diekseepromenade 2. The maple tree on the right (red) has different sides (view from the southwest). The maple tree has already been pruned. The northern part of the crown (on the left) shows signs of damage again. Diekseepromenade and Plöner Straße run south from the base station. Many of the trees along the promenade and this street show crown damage on their northern side. Pruning has often already been carried out.
Measurements along the promenade: **2,000–21,000 $\mu\text{W}/\text{m}^2$**

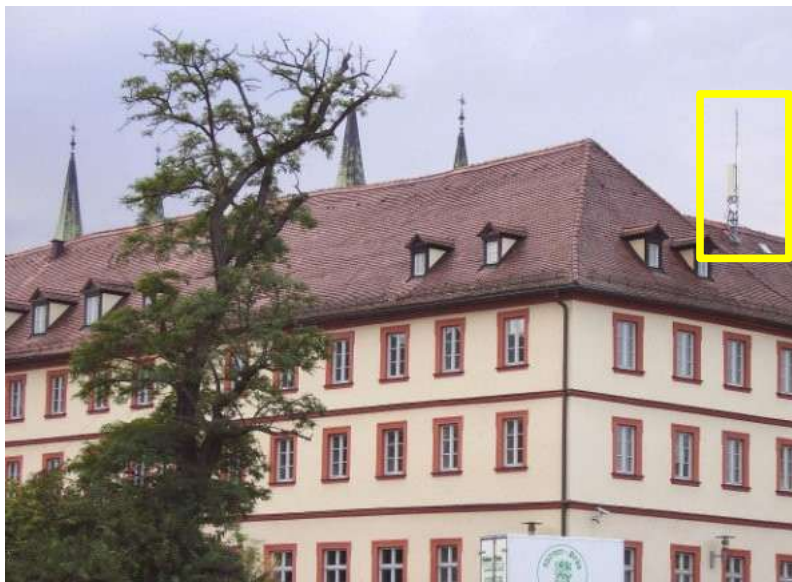
12 AUG 2006 Mobile phone base station at Schranne 3, Land Surveying Office. Locust tree (view from the southeast). In addition, the tree was affected by RF radiation from the base station at Schützenstraße 23 in the southeast. The tree was cut down in 2011 due to a steady increase in damage over time.

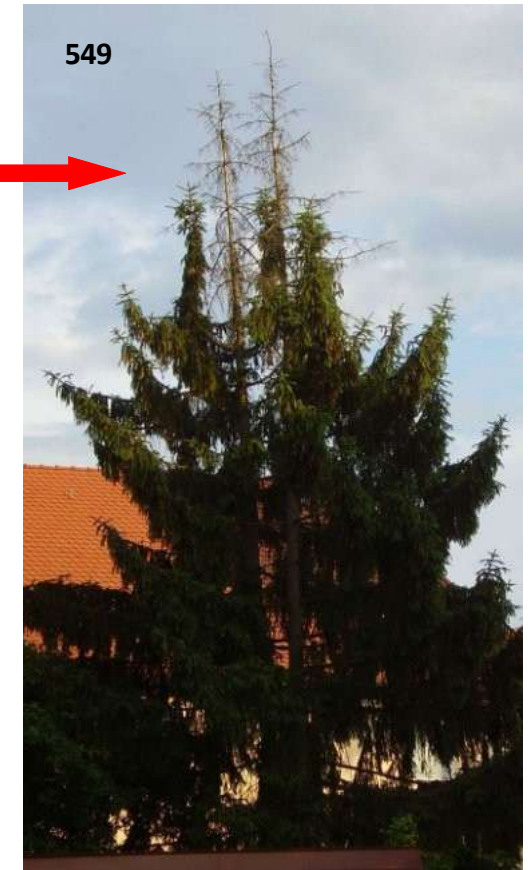
08 JUN 2008 Stauffenbergstraße. Spruce tree

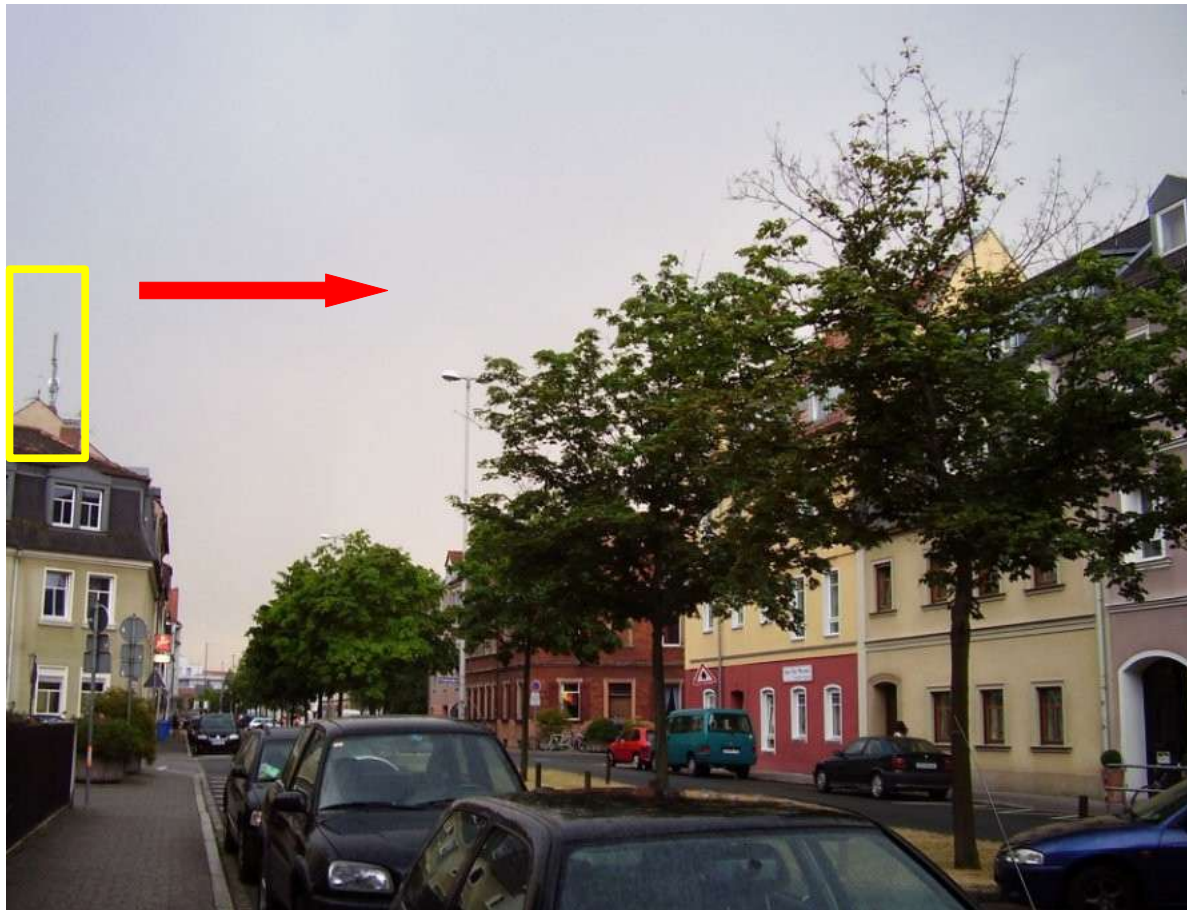
02 JUL 2008 Werner-von-Siemens-Straße. Maple tree

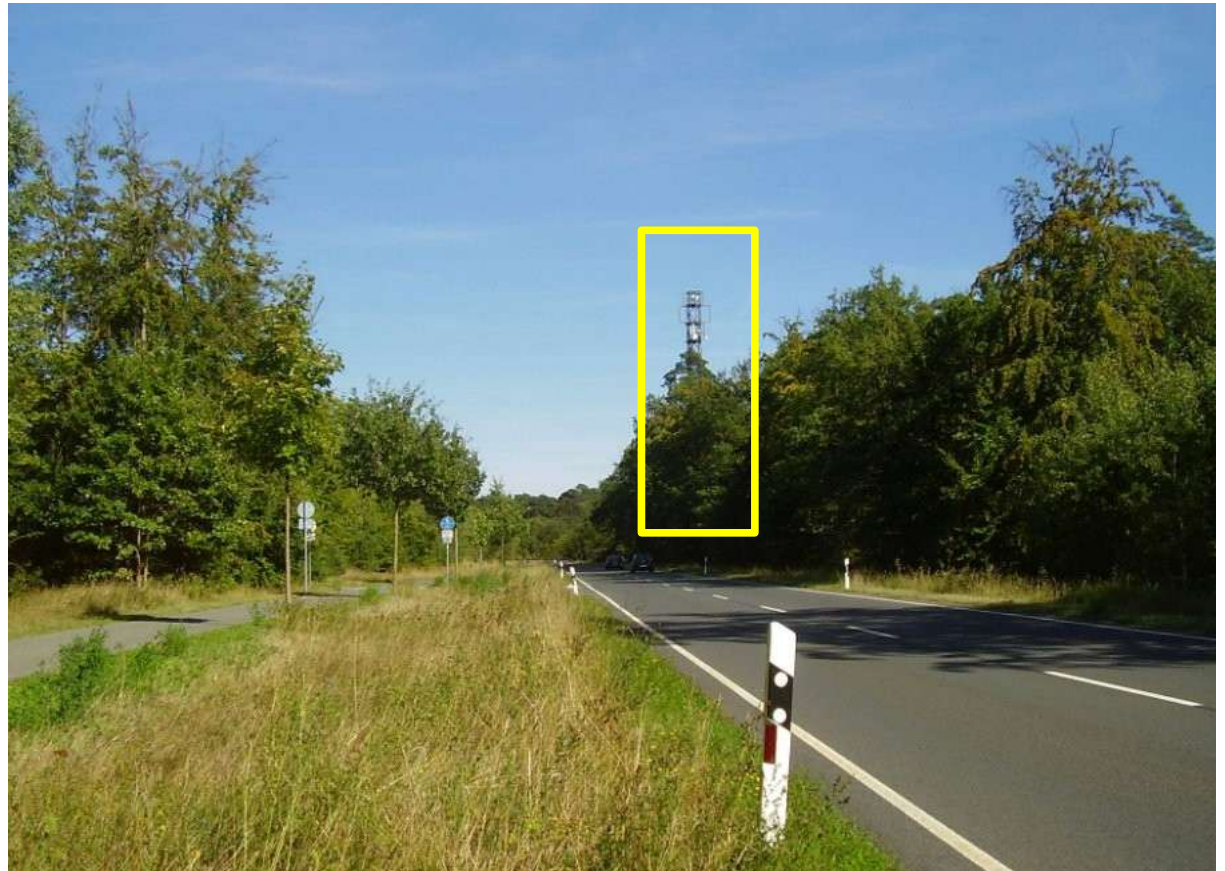
31 AUG 2009 Geisfelder Straße, 1 km (0.6 mi) to the east of Bamberg, Hauptsmoor Forest. Beech trees (view from the west). There was visible evidence of crown damage in the upper thirds of the beech and oak trees on both sides of the road.

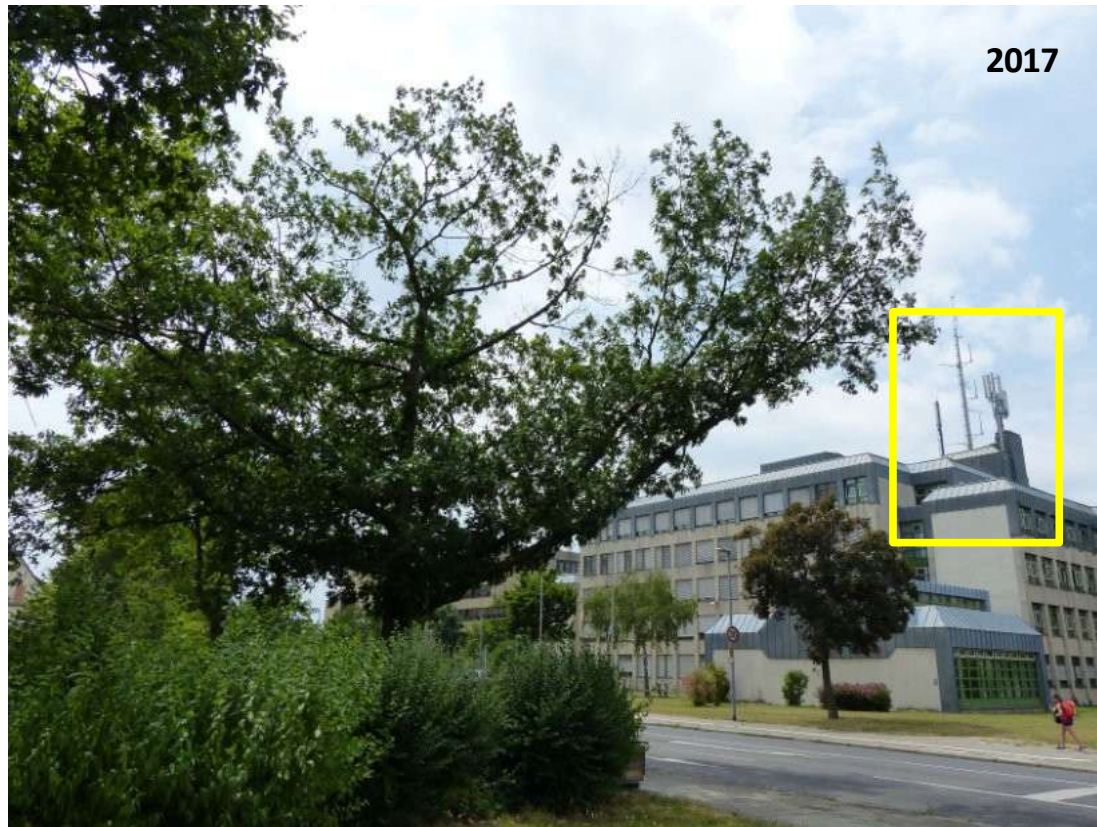
23 JUN 2017 Eichendorff High School (northwest corner), intersection of Schildstraße and Starkenfeldstraße. Red oak tree (view from the northeast), transmitters on the police headquarters. The red oak tree is strikingly wide. The top half has only sparse foliage. Additional examples of the area around the police headquarters can be found on pages 205 and 213.

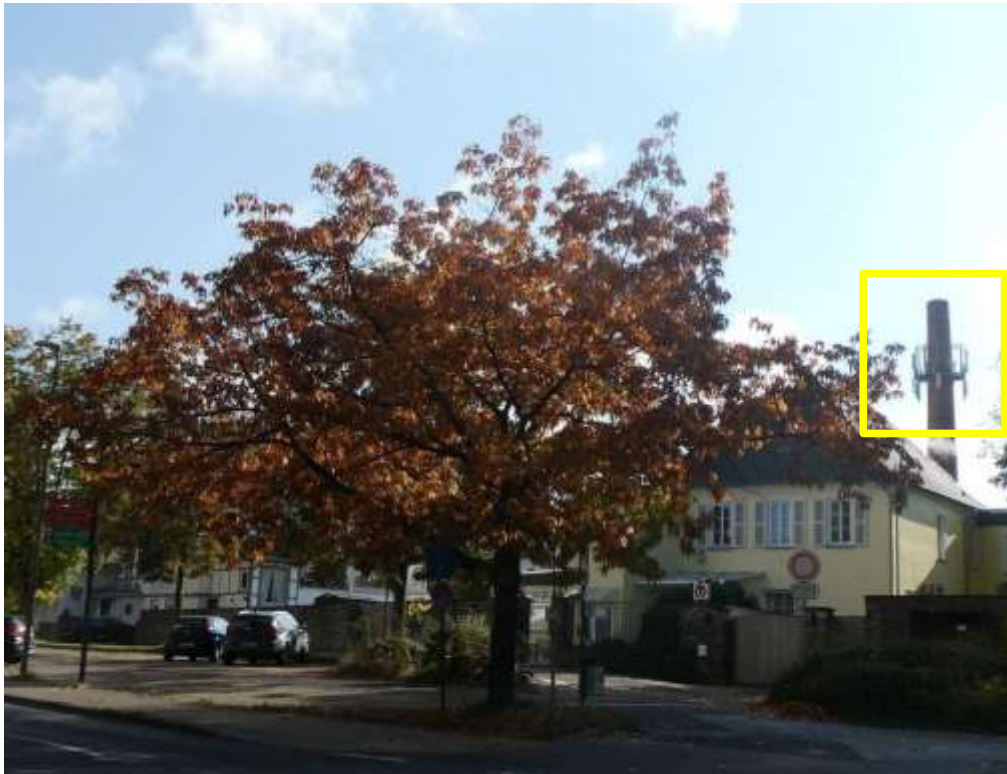
07 OCT 2023 Am Feuerreich. Red oak tree (view from the northwest). Mobile phone base station site certificate from October 19, 2021: installation height 30.5–33 m (100–108 ft), 21 sector antennas (3 x 0°, 50°, 3 x 110°, 3 x 120°, 210°, 6 x 240°, 330°, 2 x 350°)

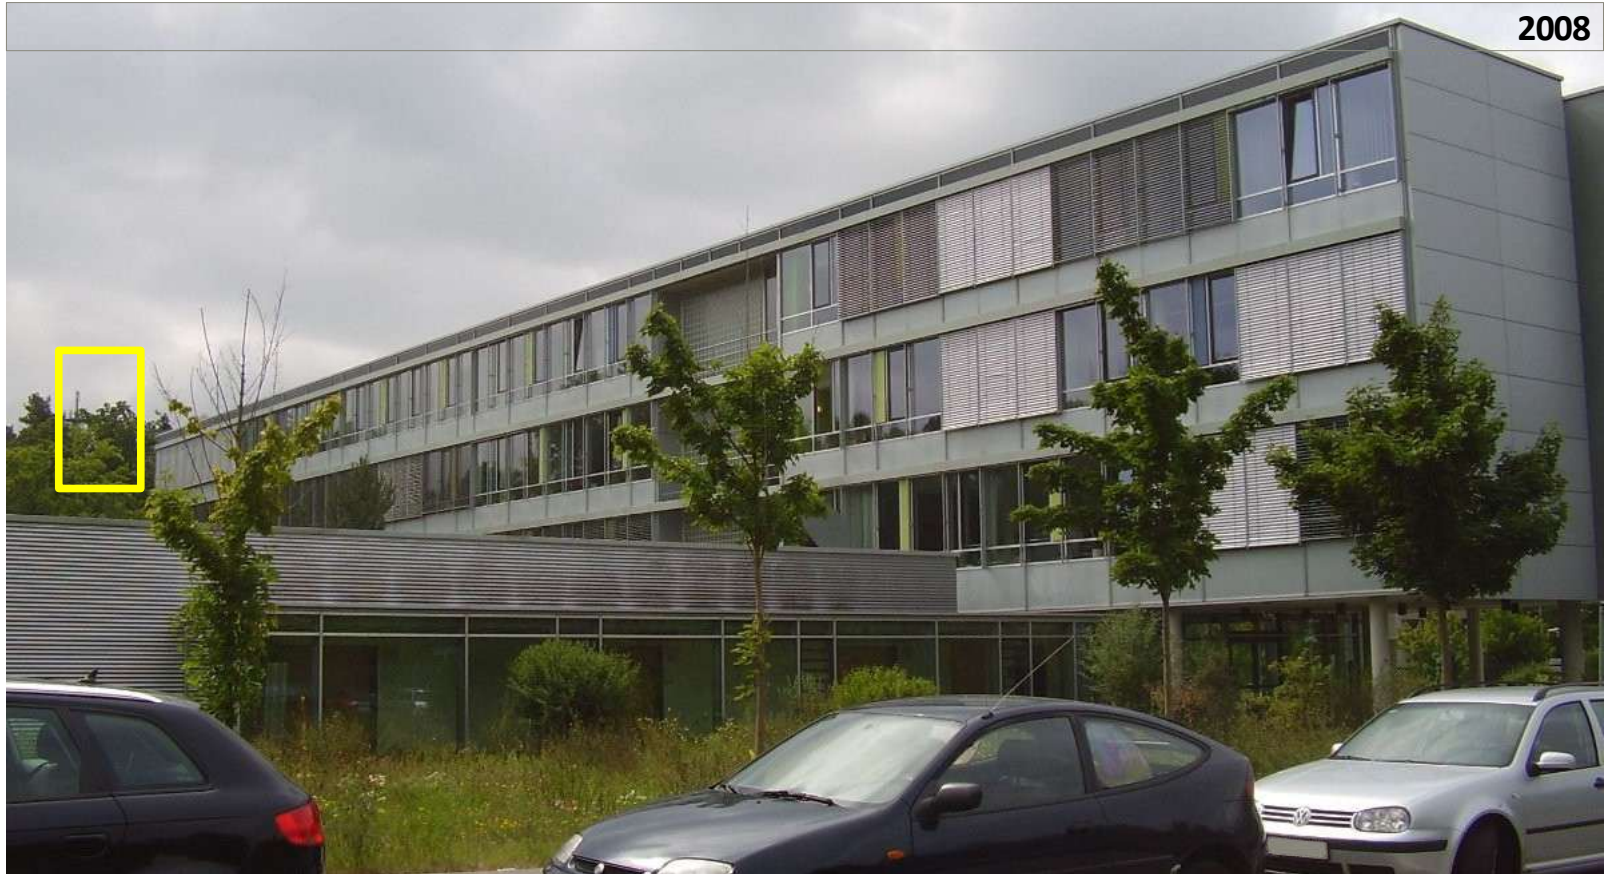
20 JUN 2008 Gutenbergstraße. Four maple trees. Even though the conditions in this meadow are largely the same, the maple trees have developed very differently. From maple tree No. 1 on the left, there is a direct line of sight to the base station, which is 290 m (951 ft) away. However, maple tree No. 4, on the right, has a blocked view due to a building at an angle.

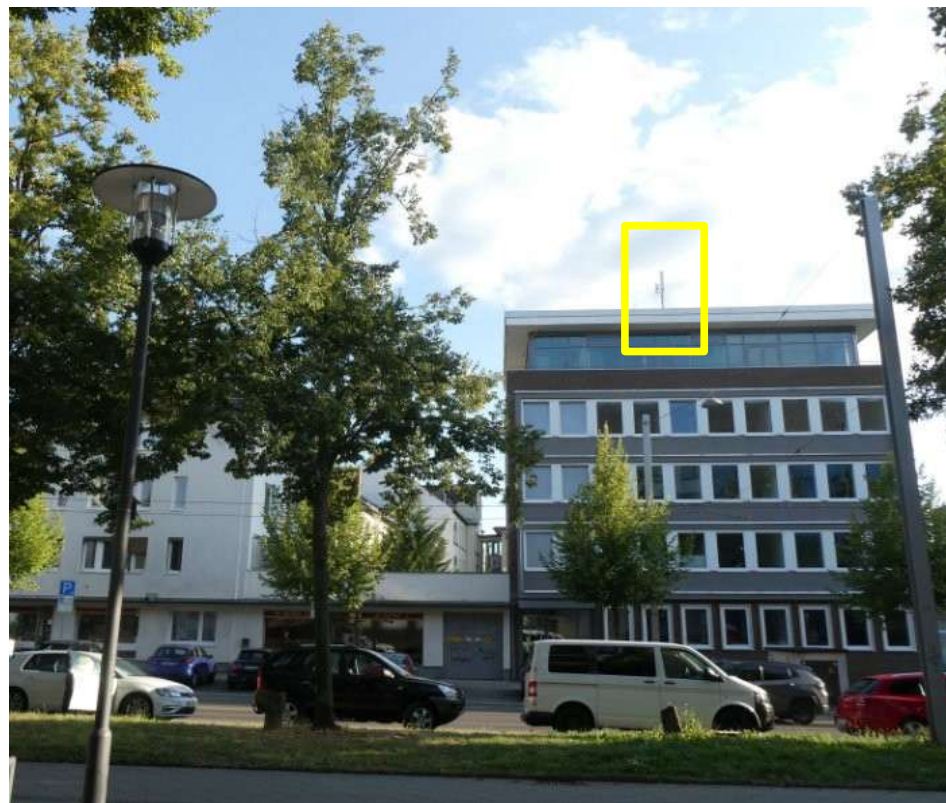
26 AUG 2024 The most severely damaged linden tree had to be cut down. For years, it had stood in the main beam of two 0° sector antennas, and, starting in 2021, five more, which were 70 m (230 ft) away. **Measurement: 96,000 $\mu\text{W}/\text{m}^2$**

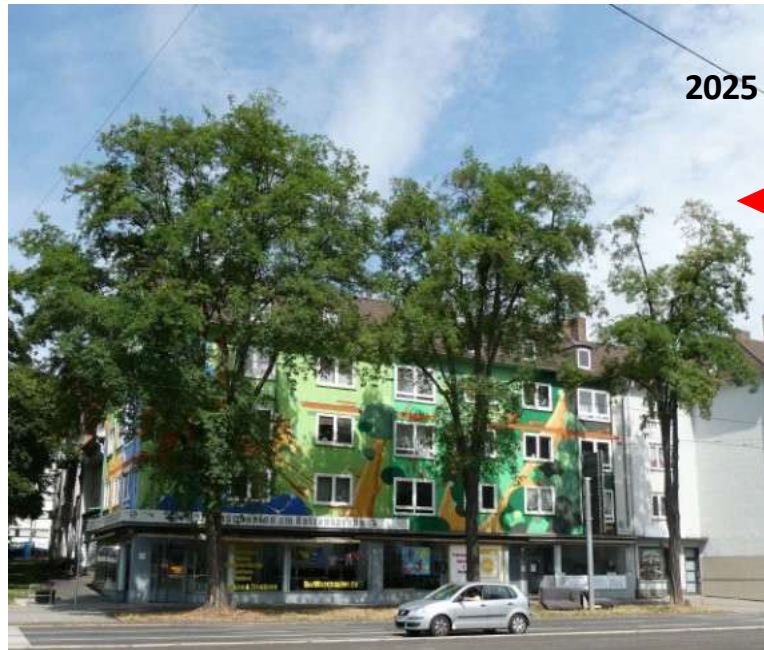
20 JUL 2025 Intersection of Weserstraße and Kurt-Wolters-Straße. The three southernmost locust trees are on the western side (view from the east). The RF radiation is attenuated by the two trees on the right. **Of the two, the southernmost locust tree looks the best.**

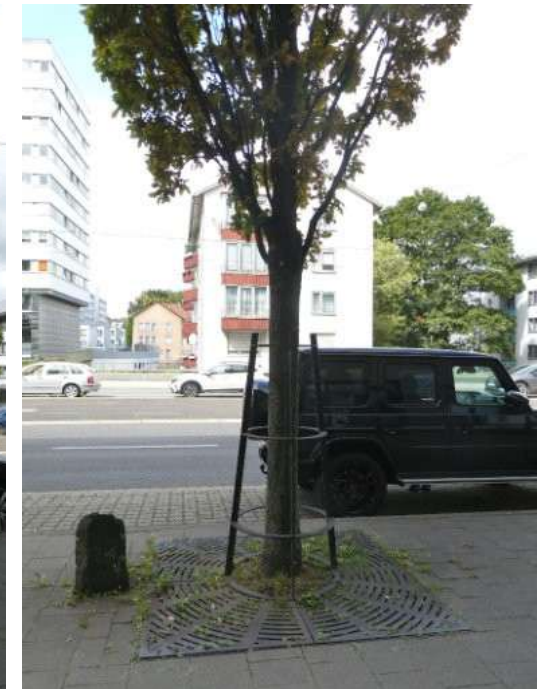
21 AUG 2025 Pyramidal oak tree **No. 5** (**view from the southeast**), **no line of sight** due to an apartment building to the west. The five-story tax office building to the east is exposed to RF radiation that is reflected off of it.
Measurement: **2,630 $\mu\text{W}/\text{m}^2$**

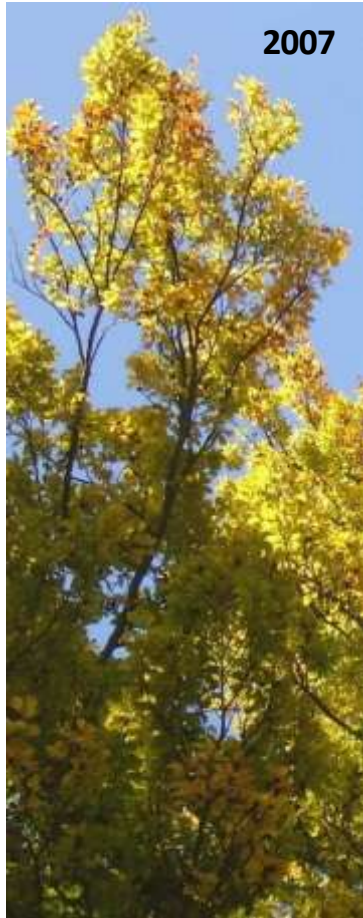
On September 12, 2007, the premature yellowing of a beech tree was noticed at Buger Spitze. Part of the crown is shown in the above picture.

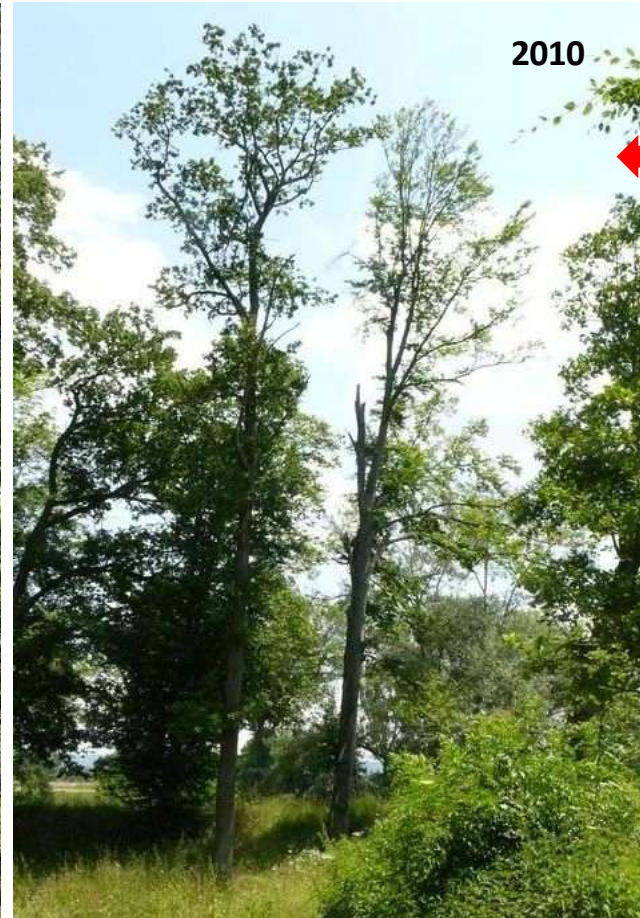
01 JUL 2010 Compared to 2007, the damage has increased significantly. The beech tree and other trees were cut down later.

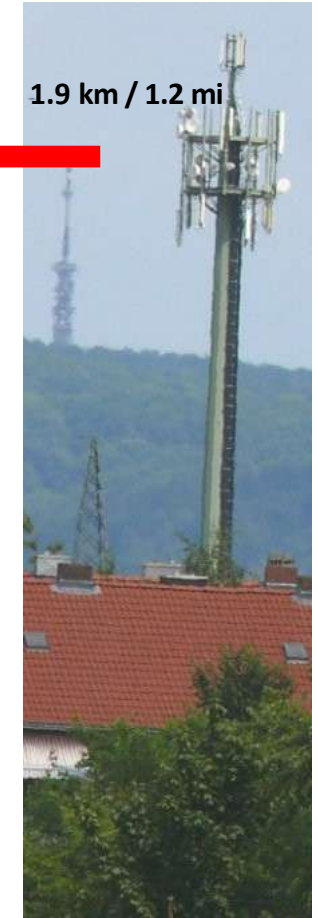
Mobile phone base station at Gutenbergstr. 20:
Height: 38.6–47 m
Sector antennas: 22
Distance: 1.9 km (1.2 mi)
The Geisberg radio tower is in the background.

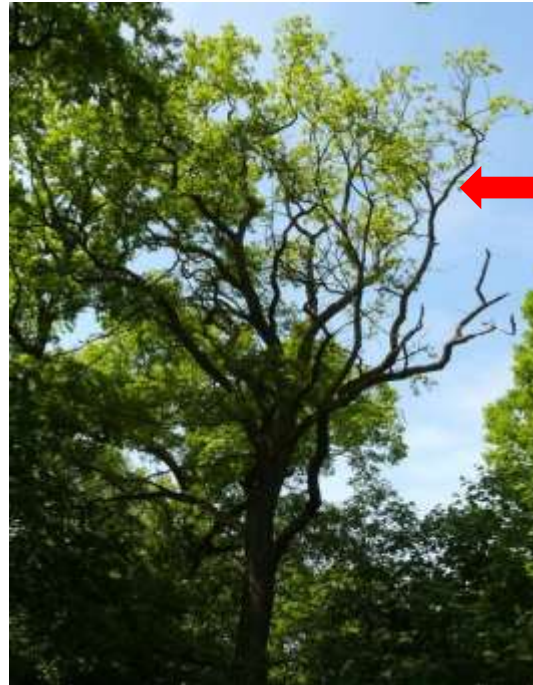
06 MAY 2011
Oak tree, near Regnitz River (view from the south), at the postal sports club. All oak trees showed significant damage.

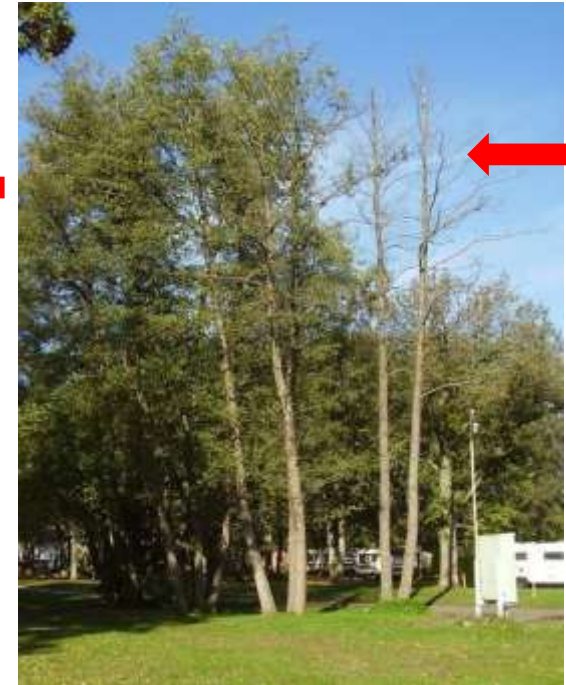
20 OCT 2009
The campground is located on the Regnitz River at the southern end of Bamberg-Bug. Group of alder trees (view from the south). The dead alders on the eastern side were cut down. Then, the alders on the eastern side of the group died.

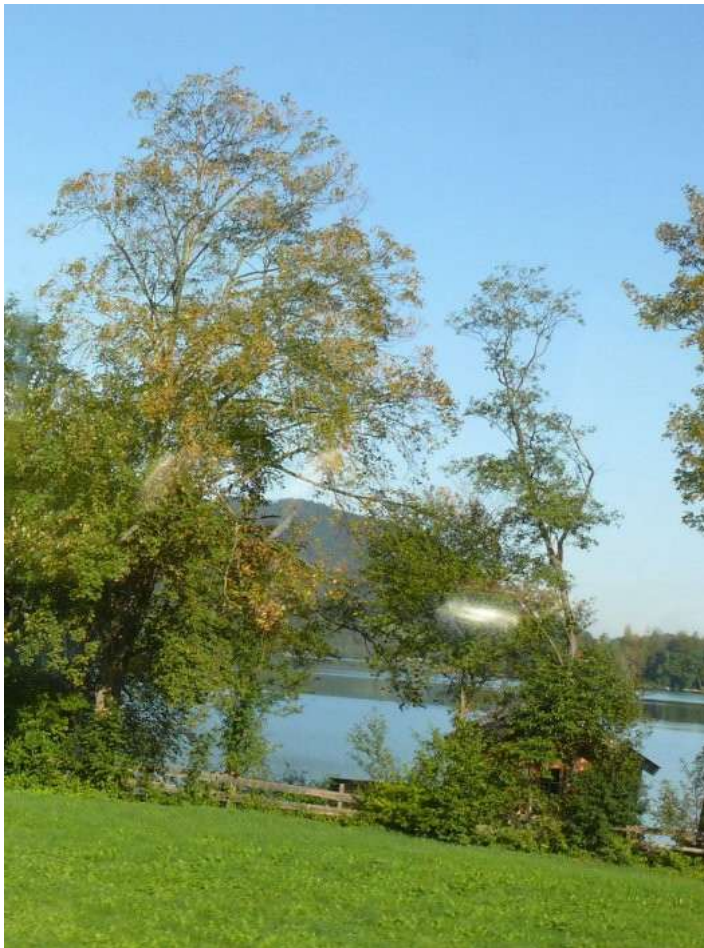
16 SEP 2011 Lake Schliersee, southern bank, damaged riparian woodlands. There is a line of sight to the transmission tower on Huberspitz Mountain (ca. 3.5 km / 2.2 mi) and to the transmitters above Lake Schliersee (ca. 3 km / 1.9 mi).

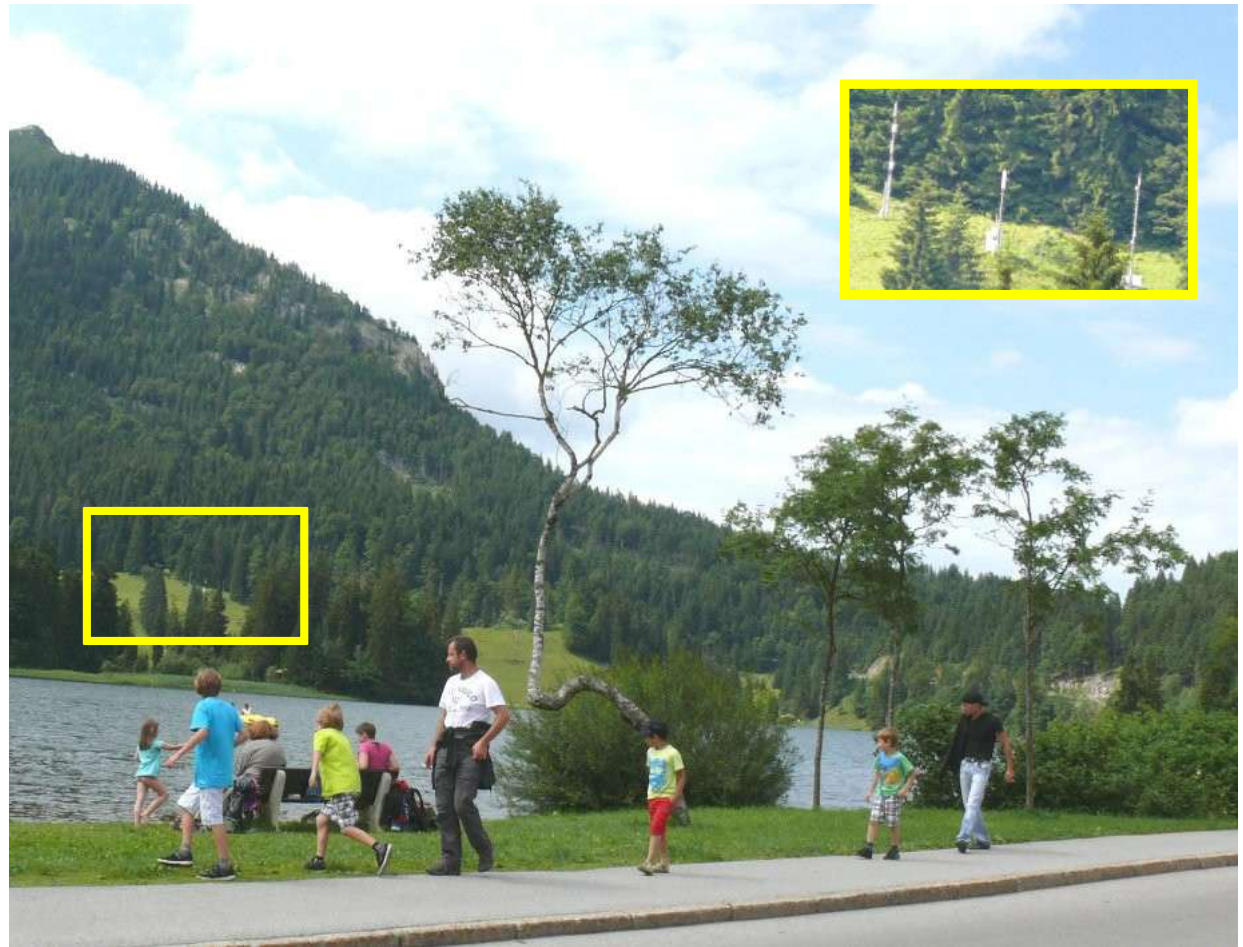
07 JUL 2012 Lake Spitzingsee, southeast bank (view from the south-southeast). Various tree species showed severe damage. The distance to the base stations (yellow) is about 1 km (0.9 mi).
Measurement: **200 $\mu\text{W}/\text{m}^2$**

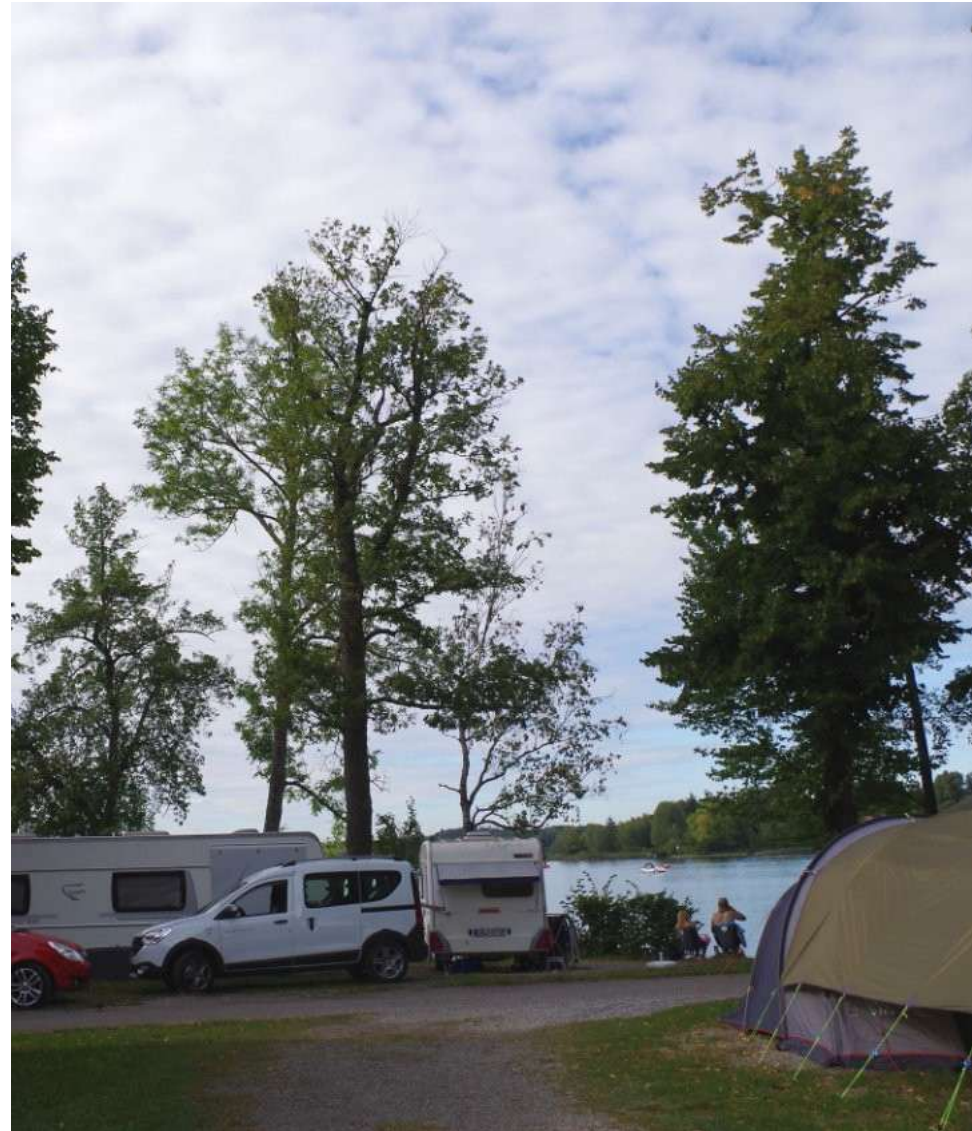
There are many damaged deciduous trees at the campground. Several have already had to be cut back.
The Seehausen base station is 1.5 km (0.9 mi) away.

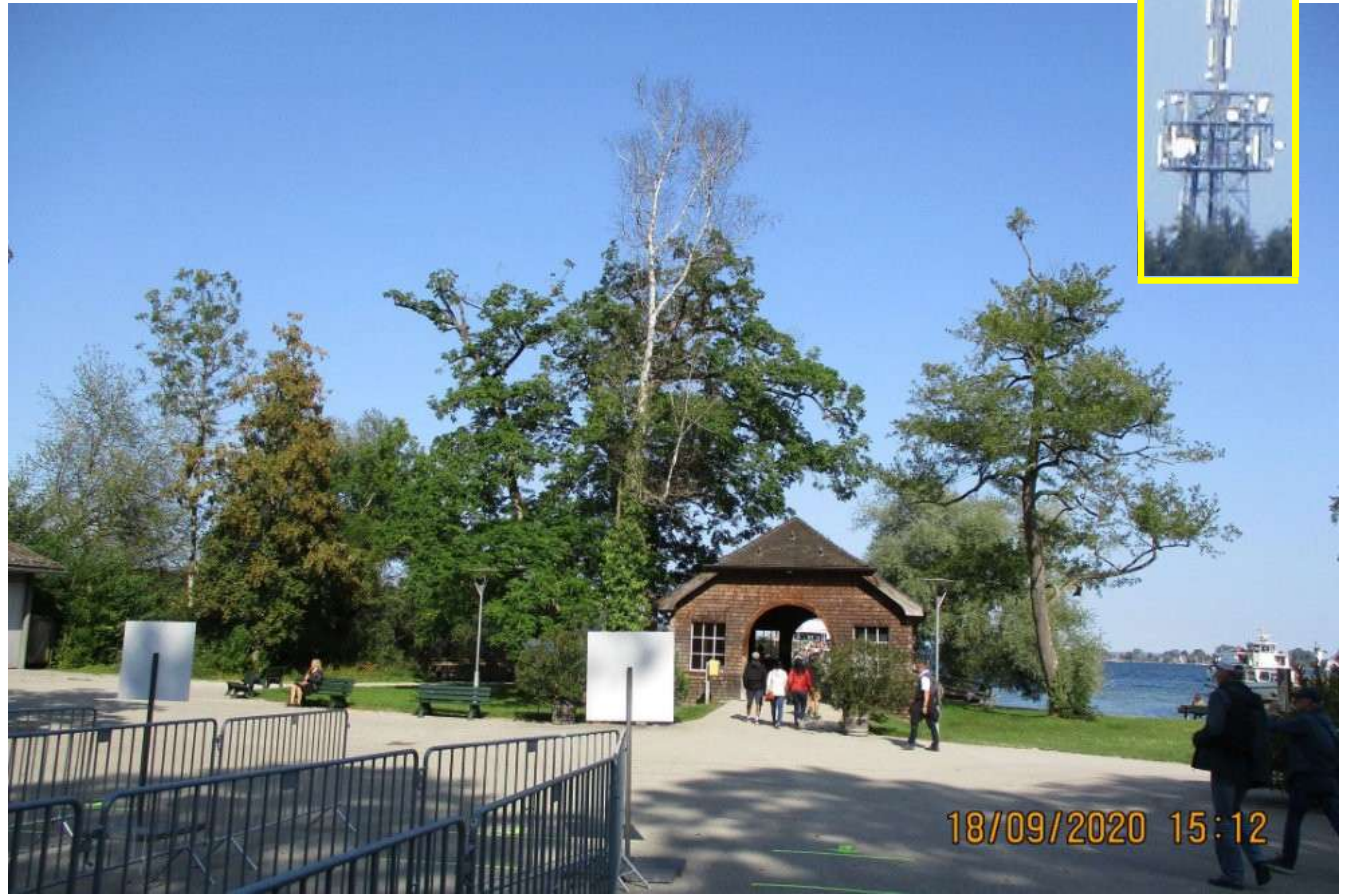
18 SEP 2020 Herreninsel (Men's Island), marina. All of the trees on the lakeshore have damaged crowns. The distance to the mobile phone base station in Gstadt is ca. 3.3 km (2 mi).

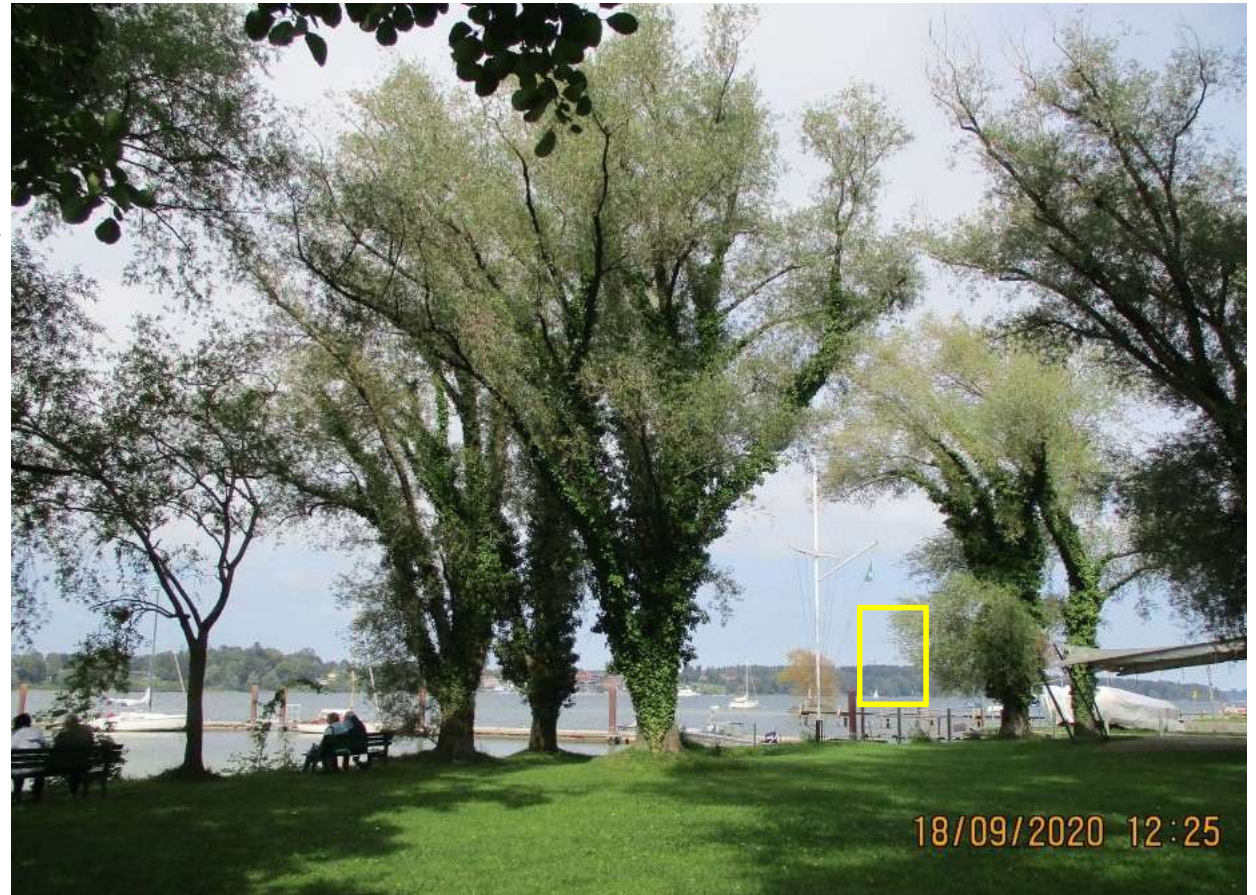
18 SEP 2020 Fraueninsel (Women's Island), western shoreline (view from the south),
direct line of sight to the mobile phone base station above Gstadt (ca. 2 km / 1.2 mi).
Measurement at the northern tip of Women's Island: **100 $\mu\text{W}/\text{m}^2$**
Willow trees lost their leaves prematurely, even young willows. Some trees had to be
pruned or cut back.

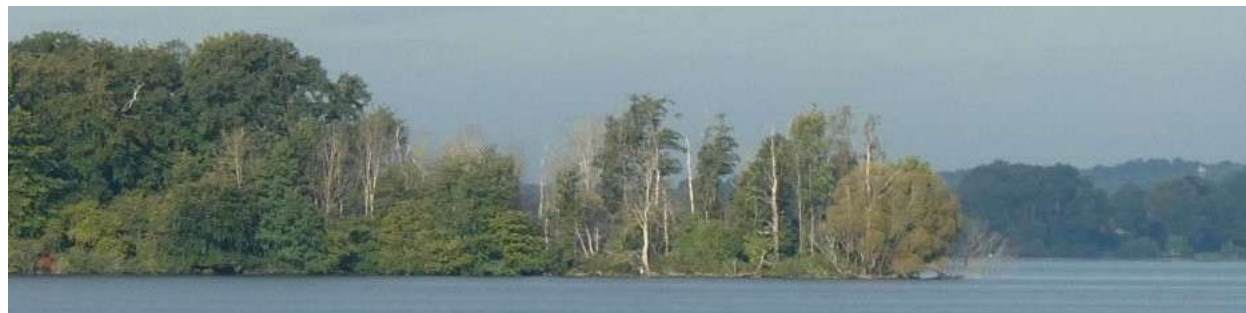
11 SEP 2025 Langenwarder Island (view from the east, Diekseepromenade). Five 280° antennas from the Malente base station expose the island from the east (1.3 km / 0.8 mi).

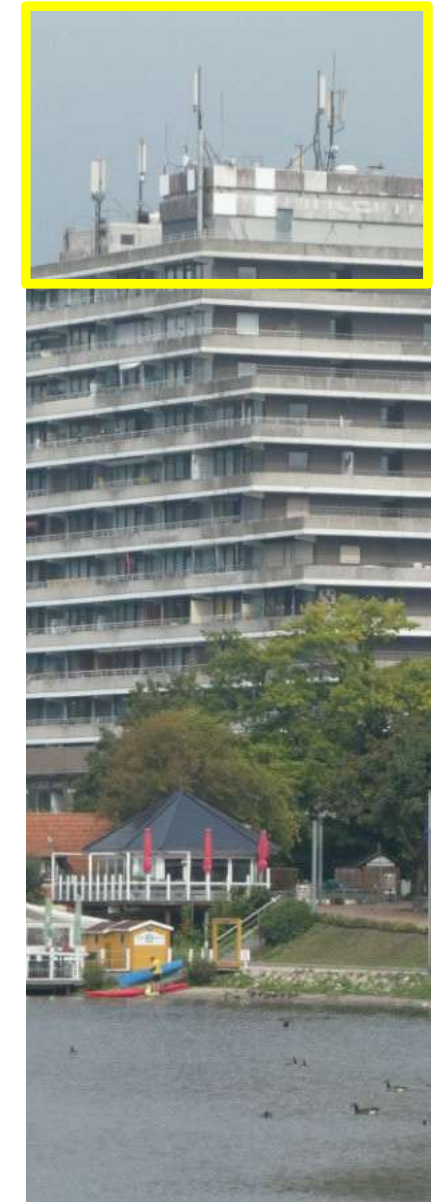
Malente base station at Diekseepromenade 2, height 47–49.6 m (154 – 162 ft), 36 antennas
