Tree Damage Caused by Radiofrequency Radiation

Key Observations from 2005 to 2025 in Germany

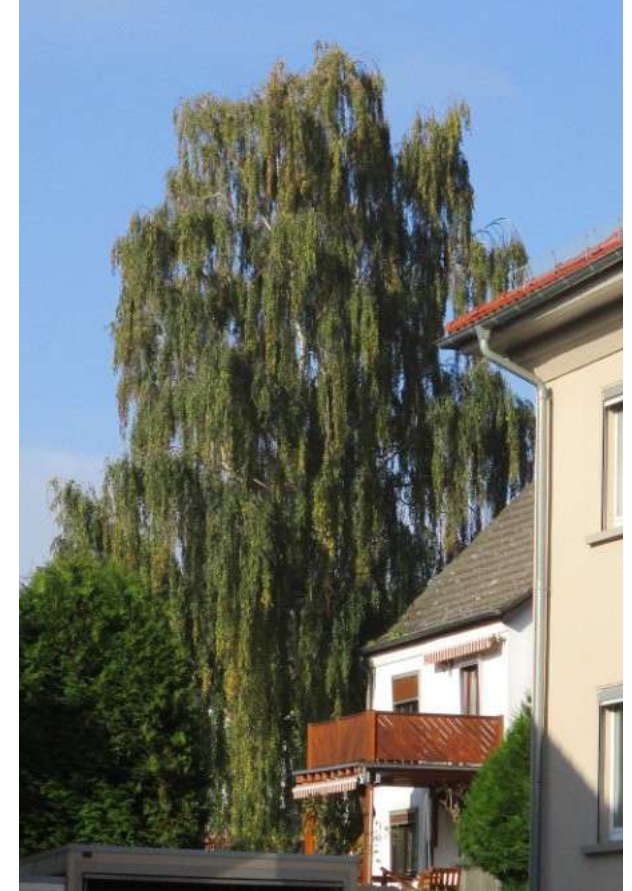
25 OCT 2021 Ihringshäuser Straße.
Birch tree

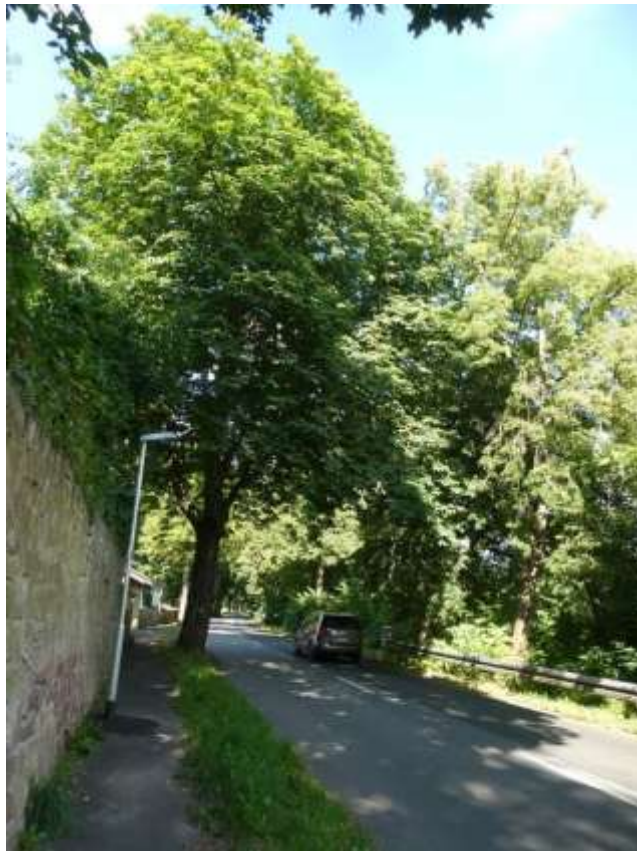
14 JUL 2024 Kassel, Fuldataalstraße. Chestnut tree, radio shadow due to other trees

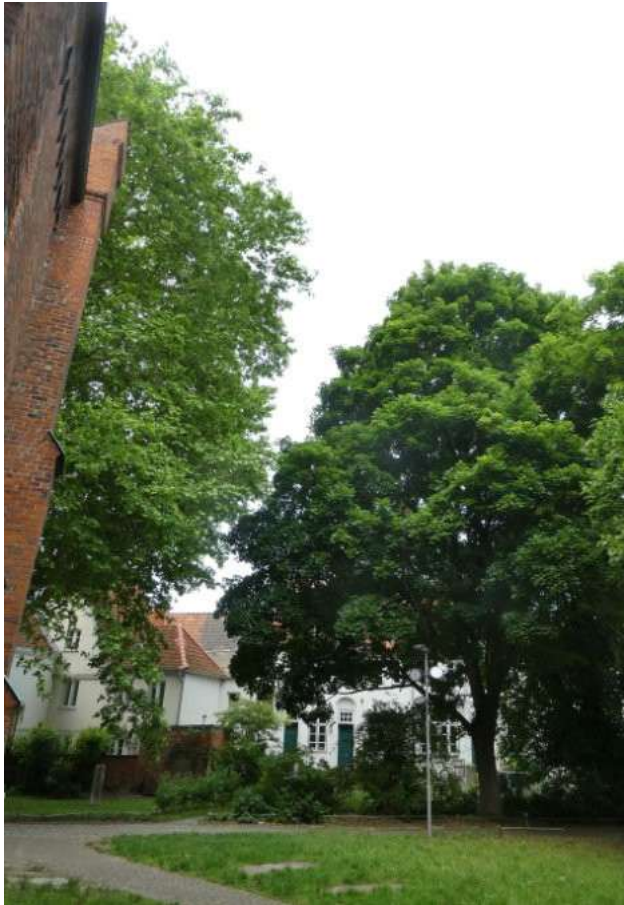
04 JUN 2025 St. Aegidien Church, northwest side. Plane and Norway maple trees, radio shadow due to building.
Measurement: **40 $\mu\text{W}/\text{m}^2$**

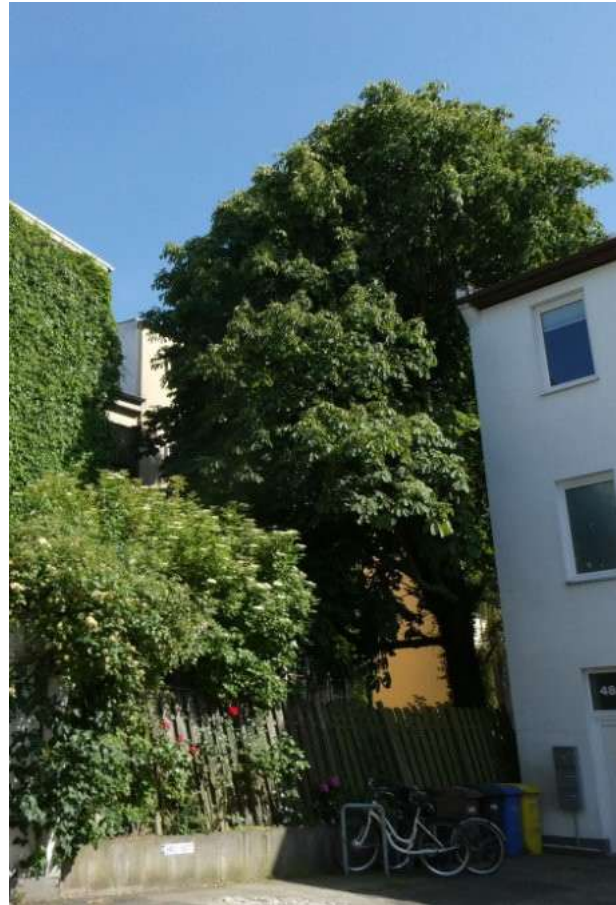
20 JUN 2025 Augustenstraße. Chestnut tree and wild vine, radio shadow due to building.
Measurement: **60 $\mu\text{W}/\text{m}^2$**

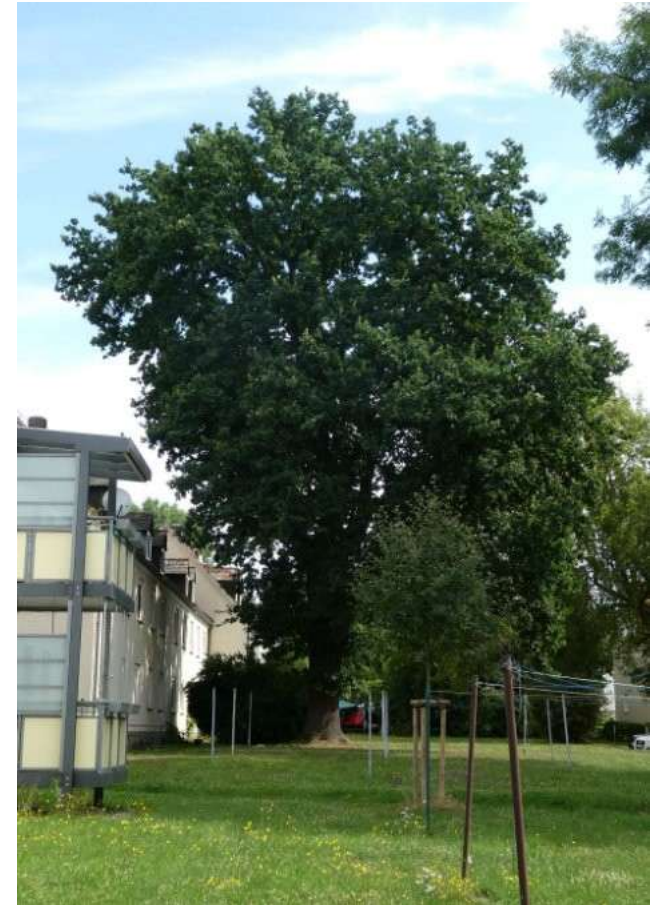
20 JUL 2025 Courtyard between Arnimstraße and Brentanostraße. Oak tree.
Measurement: **40 $\mu\text{W}/\text{m}^2$**

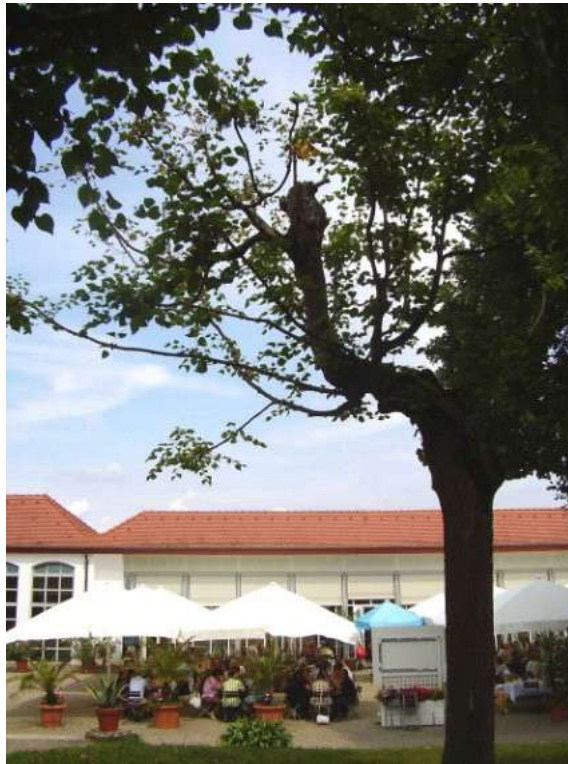
18 AUG 2008 North end of the avenue of linden trees (view from the southwest). This linden tree is exposed to the RF radiation from the base station at the sports field, which is 210 m away (see map on p. 263).

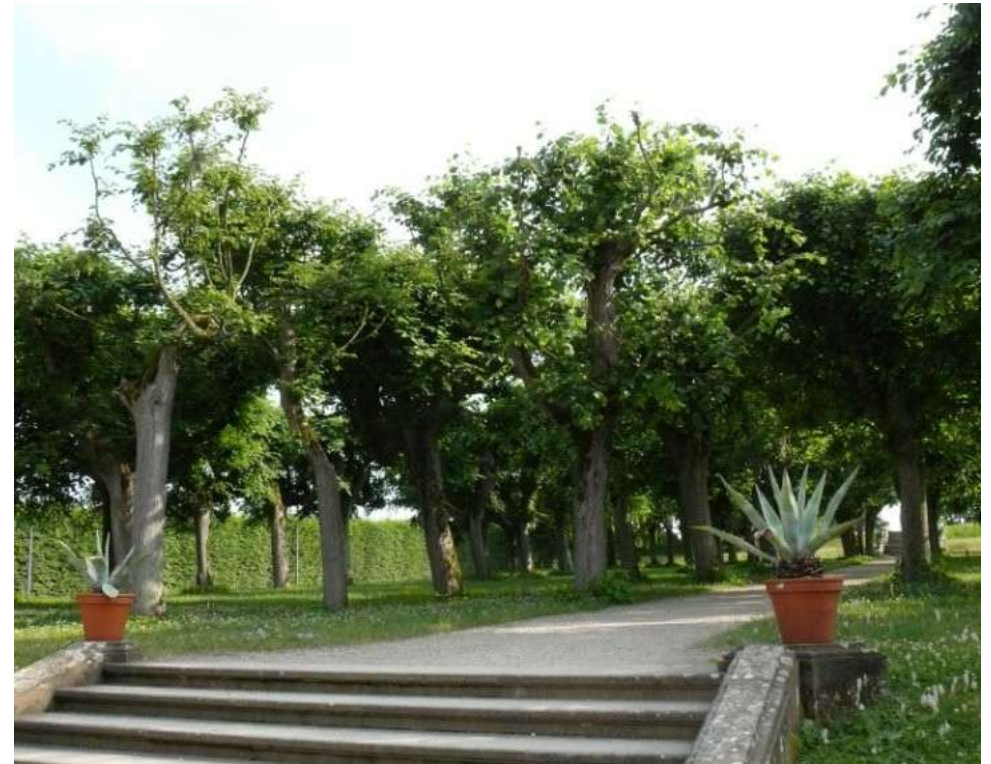
01 JUL 2010 North side of the avenue of linden trees (view from the north-northwest). The northern linden trees are damaged. The northern linden trees attenuate the RF radiation from the base station. The rear linden trees have denser foliage. This path was closed in October 2023.

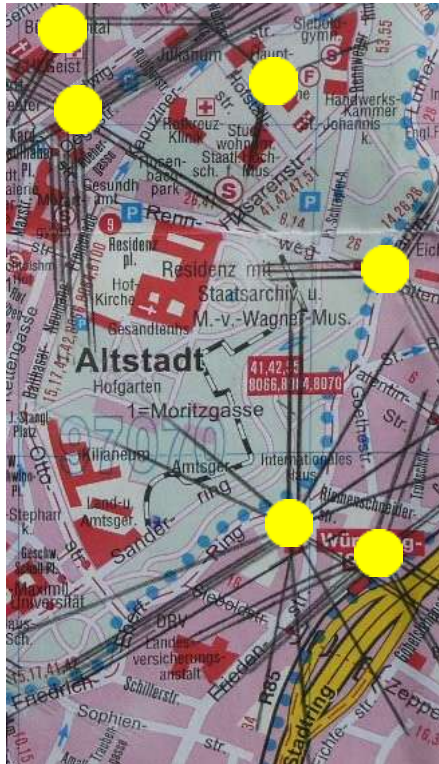
Section of the Cityplan, Falk. Added items: location of base stations (yellow) with the main beam directions of the sector antennas

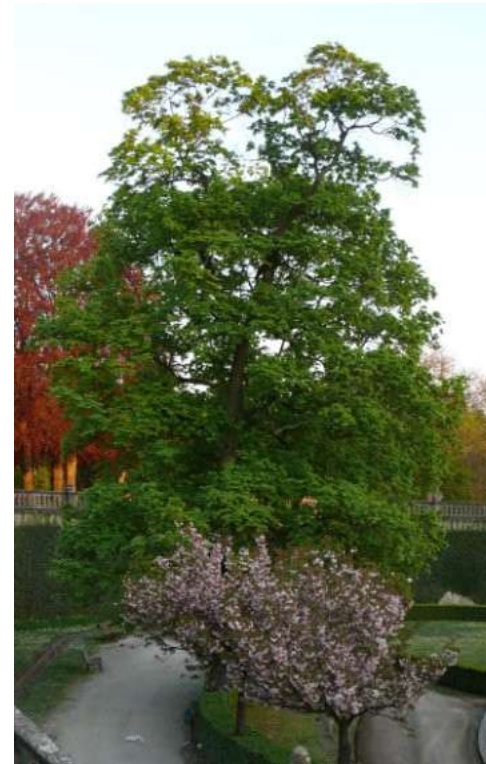
18 APR 2011 Maple tree with damaged top (view from the north)

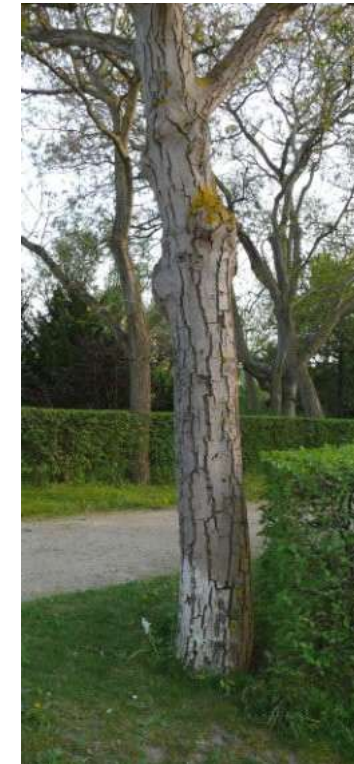
29 APR 2010 The walnut trees showed cracks in their trunks.

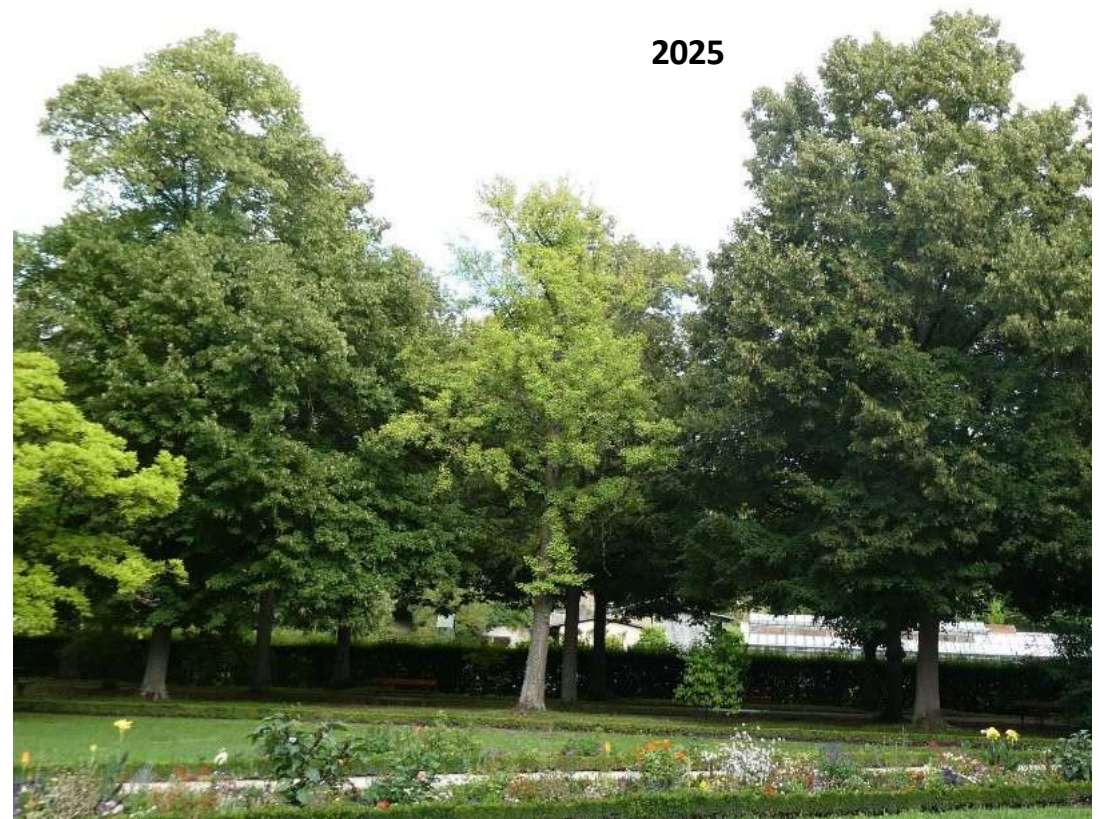
04 AUG 2025 Court garden, linden avenue (view from the west). This is the section with the linden tree that was severely damaged in 2013. It has not grown at all in the last 12 years.

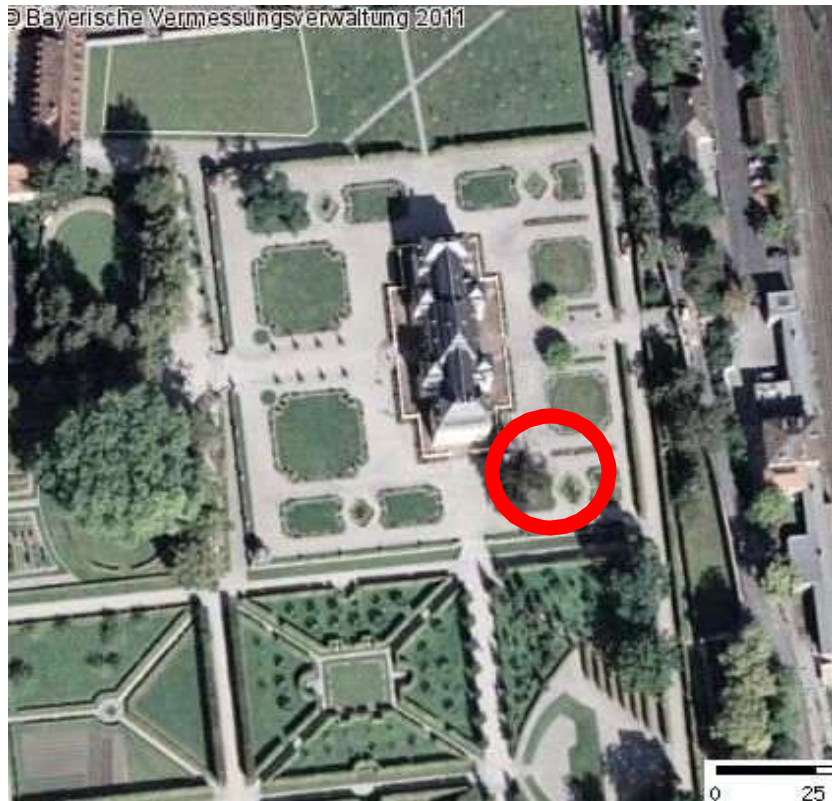
Aerial photographs, Bavarian State Office for Survey and Geoinformation, 2008 (accessed on Bayernviewer in 2011).

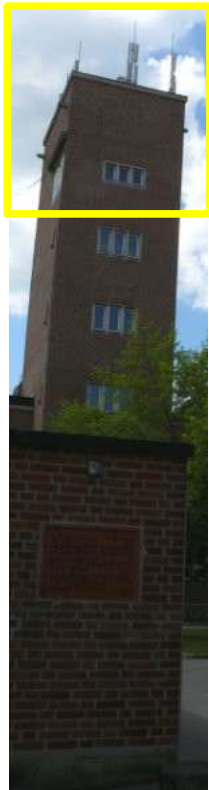
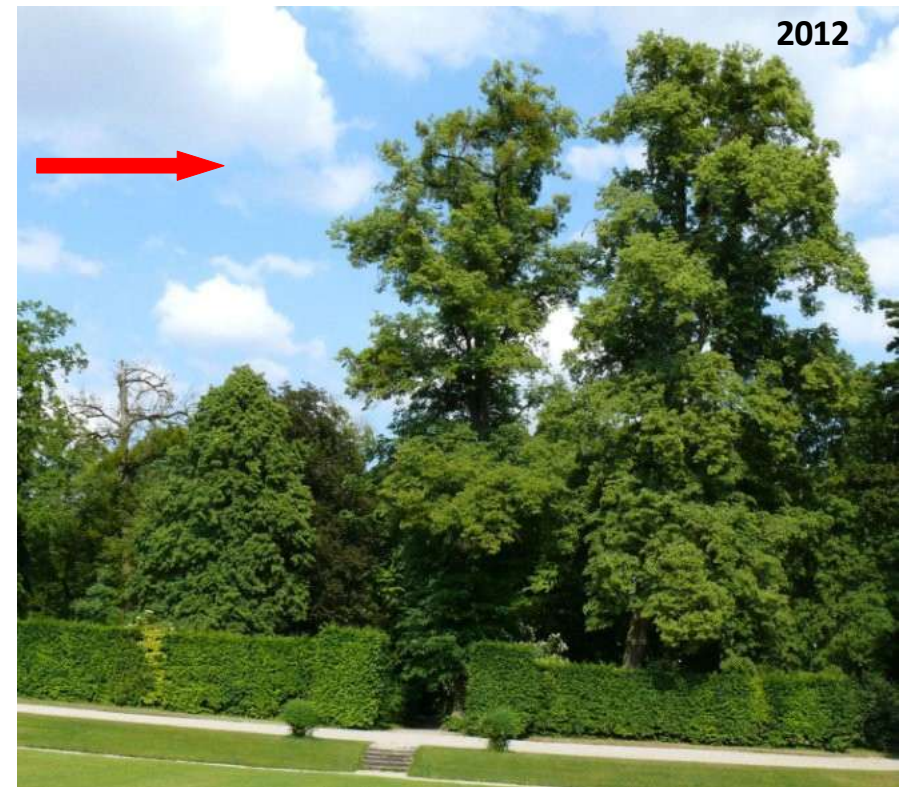
Mobile phone base station at the Bureau of Standards

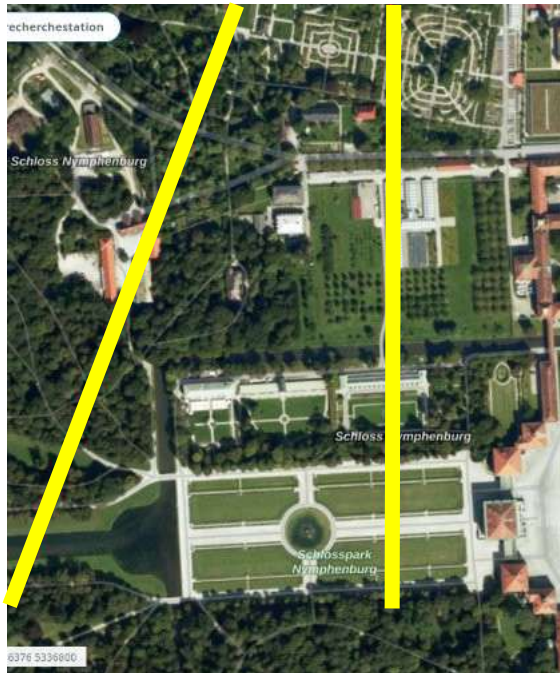
Bavarian State Office for Surveying (LDBV), 2024. Added items: main beam directions of five 180° and nine 200° antennas.

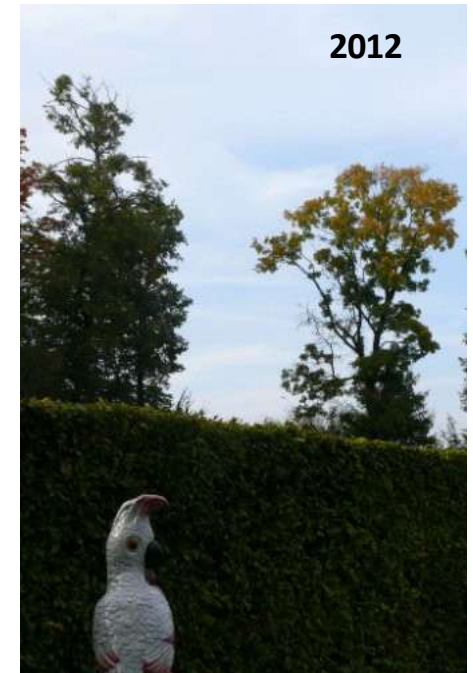
11 OCT 2012 Crown damage near the museum (view from the southeast), which is 730 m (2,395 ft) away from the base station.

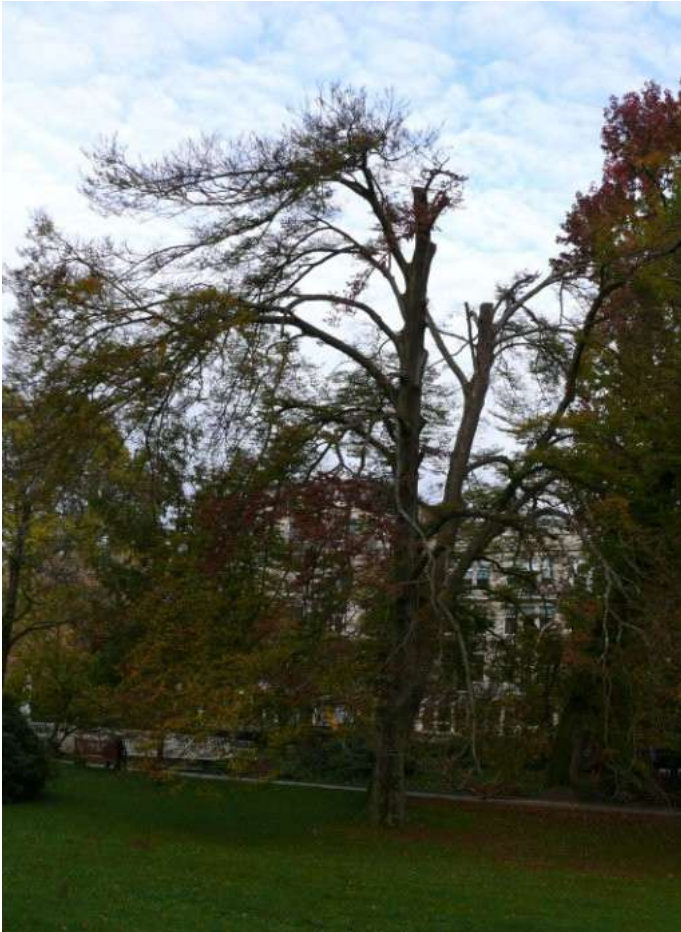
31 OCT 2014 The two cutleaf beech trees have already had to be cut back.

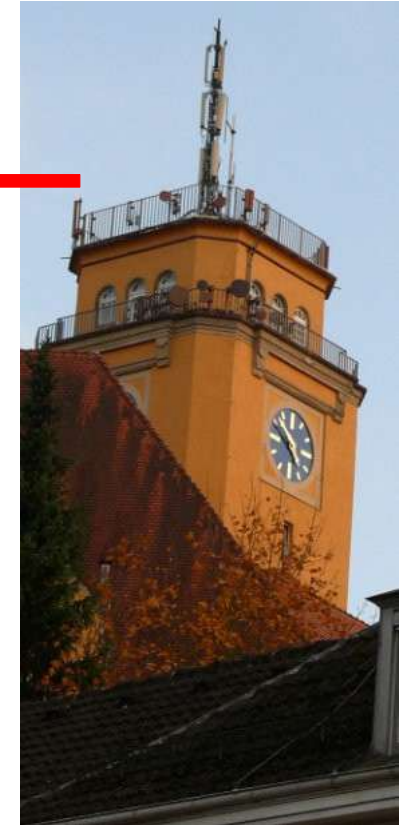
01 NOV 2014 Mobile phone base station at the Markgraf Ludwig High School. **Four 260° antennas** reach the trees along the Lichtenthaler Allee.

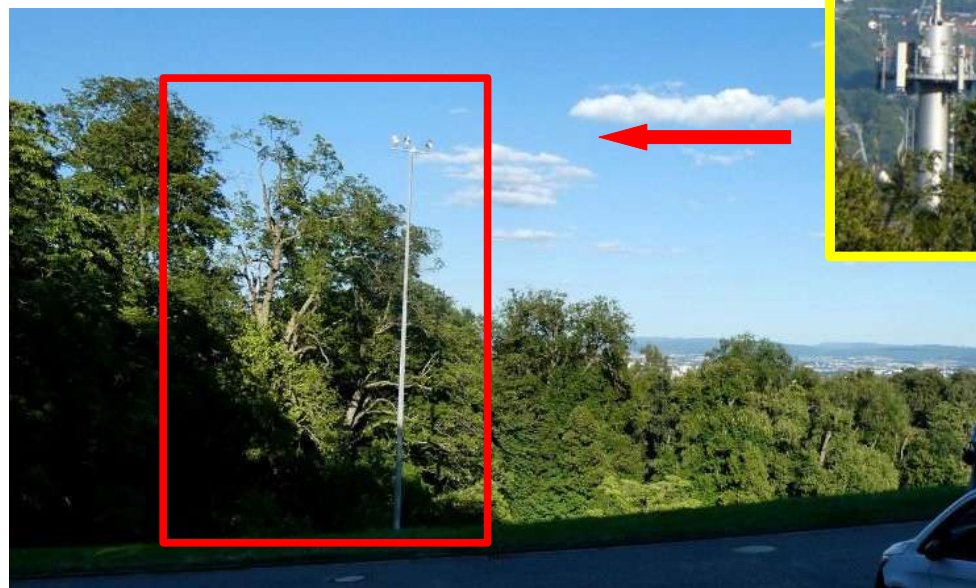
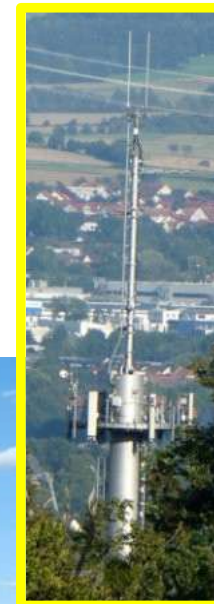
31 AUG 2016 Wilhelmshöhe Palace with a park on the north side (**view from the southeast**). In August 2016, damage to one side of the group of sycamore maple trees was noticed. Documentation of base station locations with the main beam directions of sector antennas suggested that radiofrequency electromagnetic fields from the Hessischer Rundfunk (hr) radio tower were the cause.

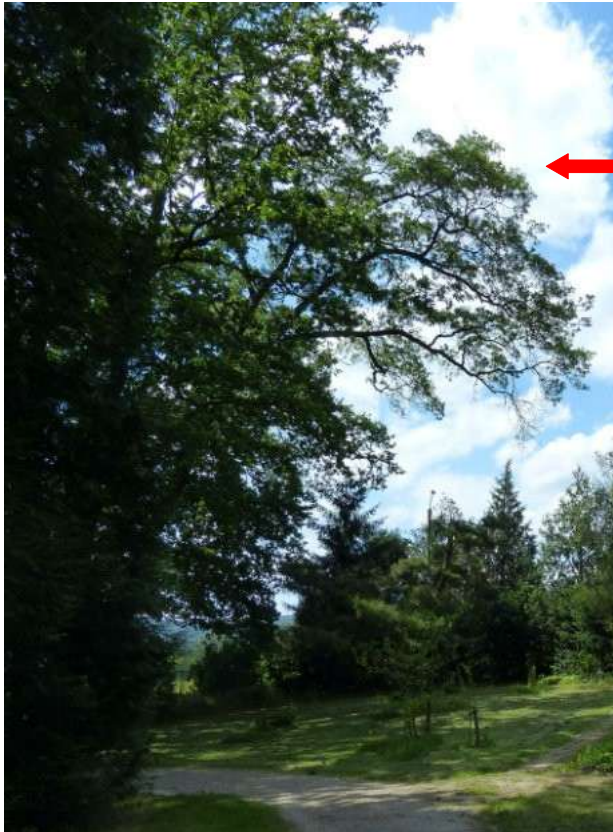
12 JUN 2017 Scarlet oak tree (view from the south), top cut back or tree cut down.

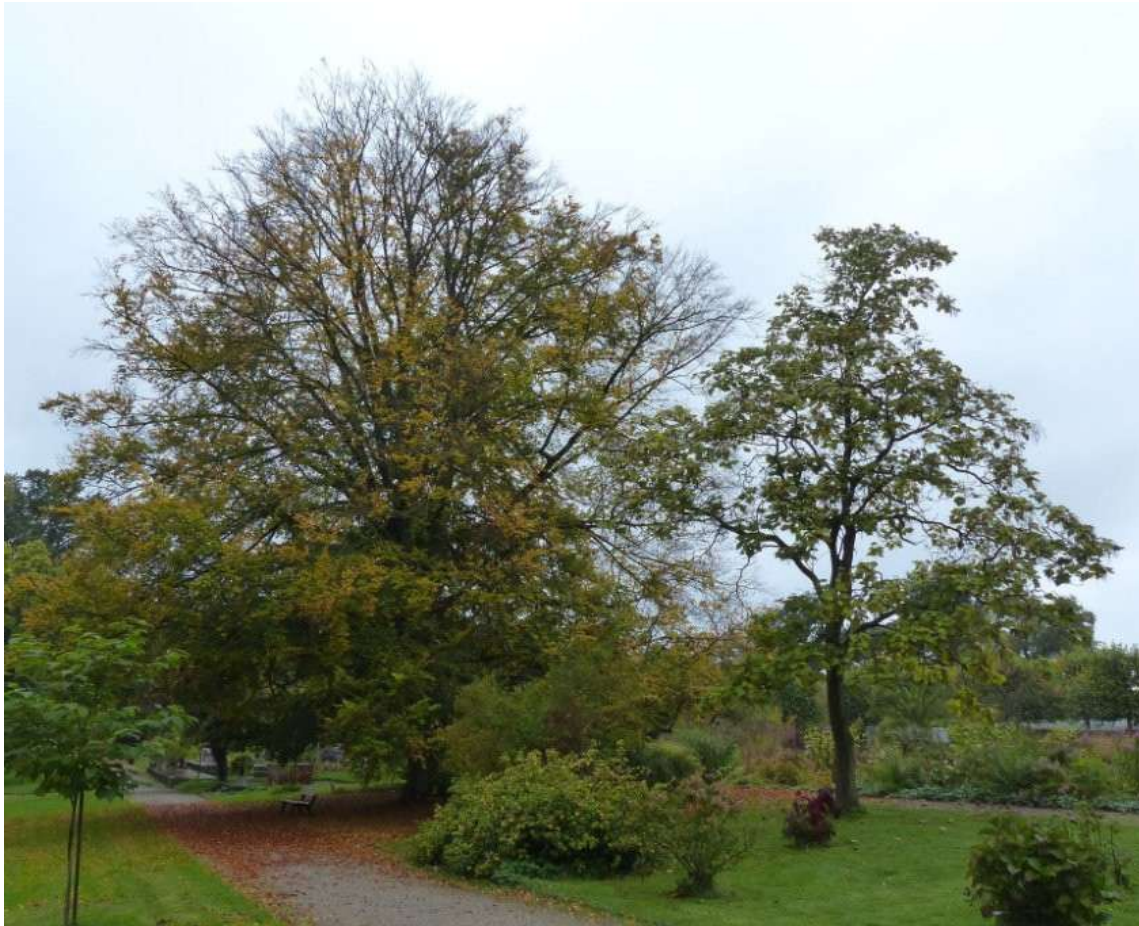
02 OCT 2017 Beech and trumpet trees (view from the southeast), line of sight to the base station. Even before the hot and dry periods, crown damage and premature leaf drop were noticeable. Measurement northeast of the two trees: **13,580 $\mu\text{W}/\text{m}^2$**

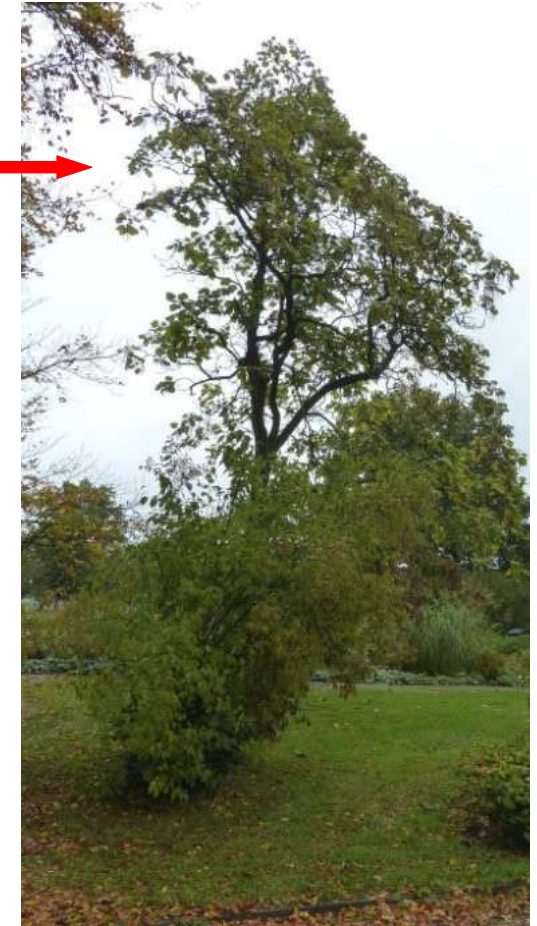
02 OCT 2017 Trumpet tree (view from the southwest) with a distinct difference in growth on each side.

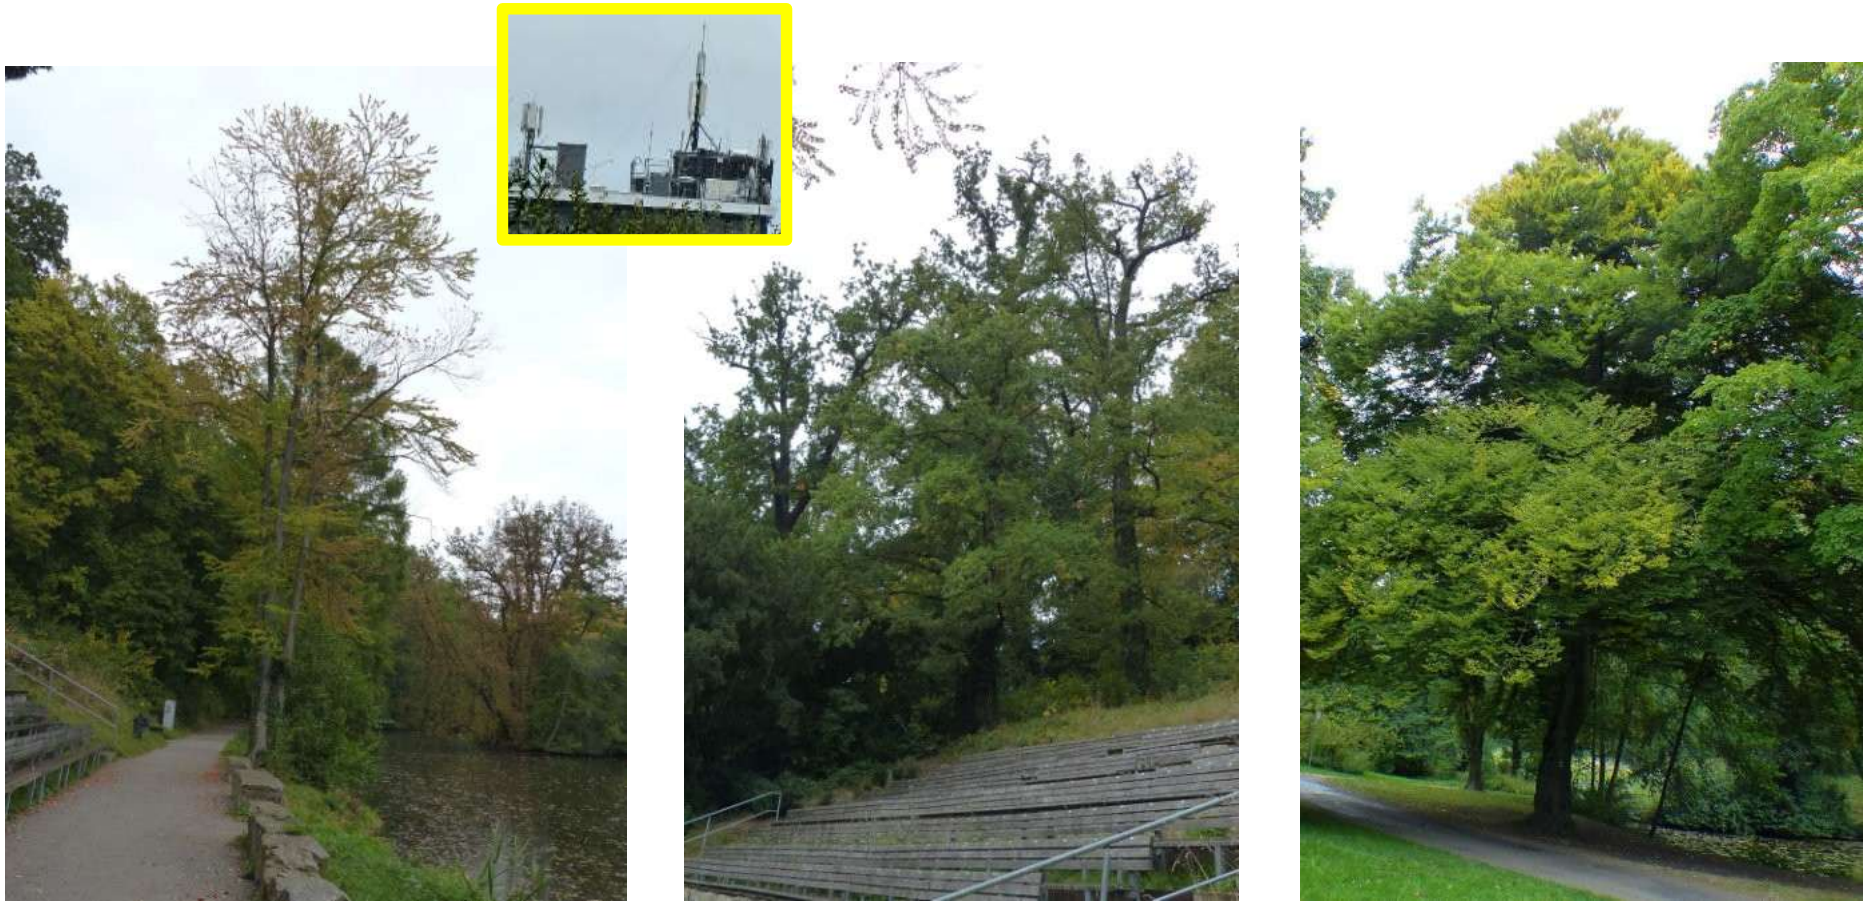
26 SEP 2019 At the lake. Katsura tree. Extensive damage was also found in the lower part of the park and near the lake. This area is exposed to RF radiation from the base station on Frankfurter Straße.

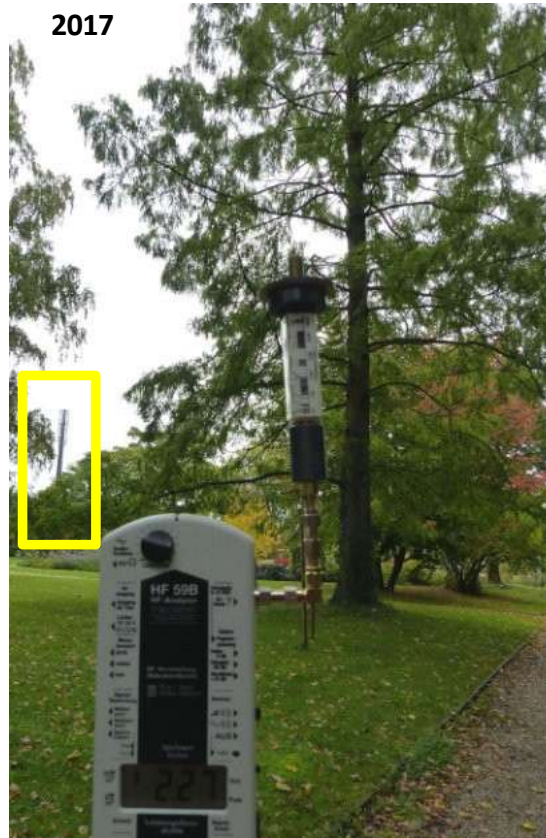
02 OCT 2017 Dawn redwood (view from the southwest).
Measurement: **2,270 $\mu\text{W}/\text{m}^2$**

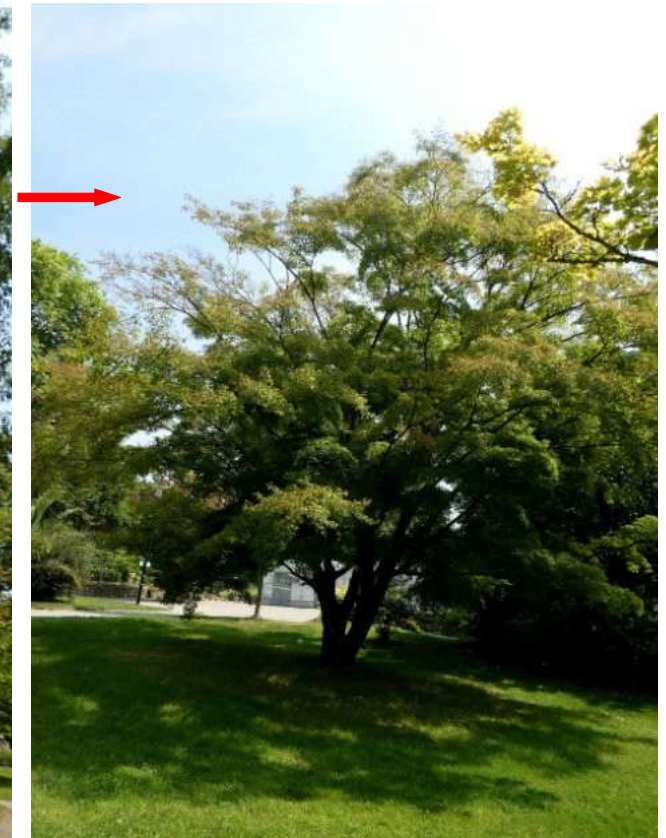
21 JUL 2024 Japanese maple tree (view from the southwest), difference between left and right side as well as between top and bottom. This type of damage pattern suggests RF radiation exposure as a cause.

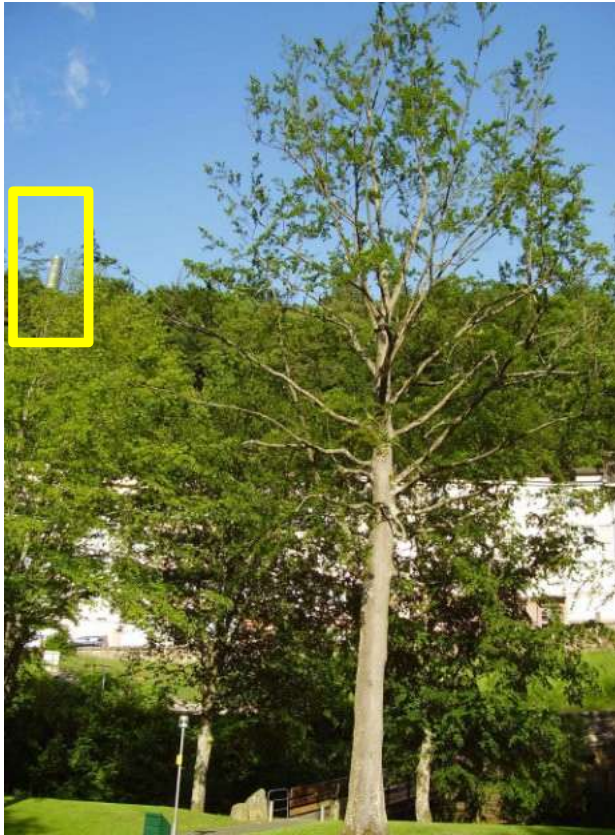
11 JUN 2007 Spa gardens. Beech trees with sparse crowns stood next to the Große Enz Stream. A chimney with antennas on the east side of the municipality is visible in the background (view from the west).

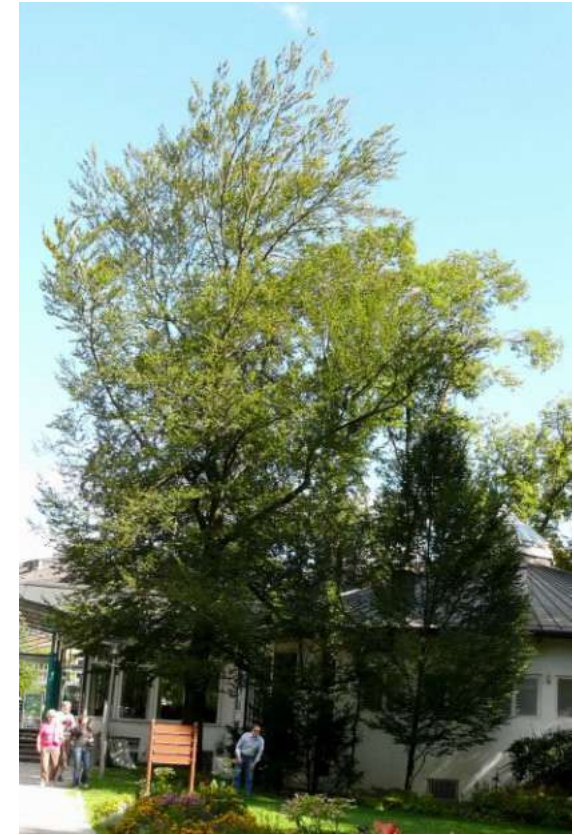
09 SEP 2011 Spa gardens. Beech tree with sparse crown (view from the north). The damage steadily increased. By 2022, the beech tree had died. RF radiation reaches the spa gardens from multiple directions, including from the mountains.

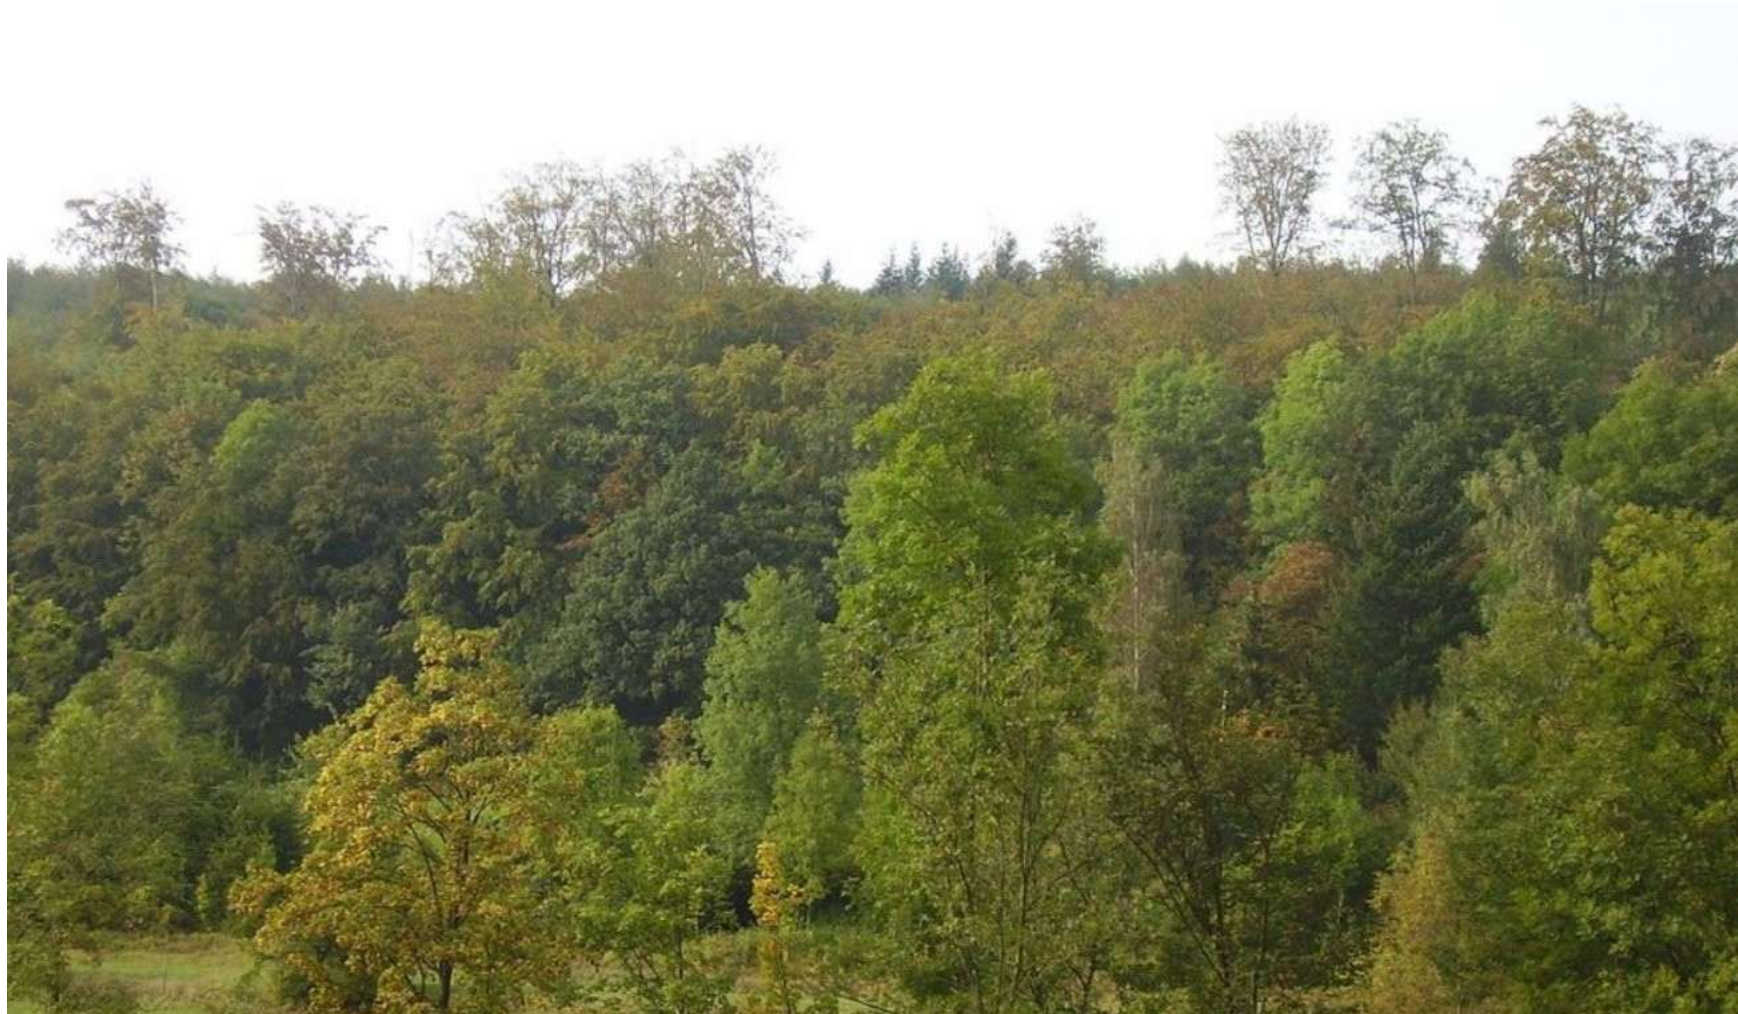
15 SEP 2009 This is the view from Zeegendorf on the southern slope of Geisberg Mountain. The beech trees at higher elevations were clearly damaged. The trees were exposed to RF radiation from radio and microwave radio transmitters, as well as mobile phone base station antennas, on Geisberg Mountain (585 m / 1,919 ft above sea level) and television and microwave radio transmitters, as well as mobile phone base station antennas, at the Bamberg Tower near Kälberberg (558 m / 1,831 ft above sea level, 3.7 km / 2.3 miles away). The Geisberg Mountain and Forest are located in the southernmost part of the Albrauf Fauna Flora Habitat Reserve (FFH No. 6032-371) between Dörnwasserlos and Zeegendorf.

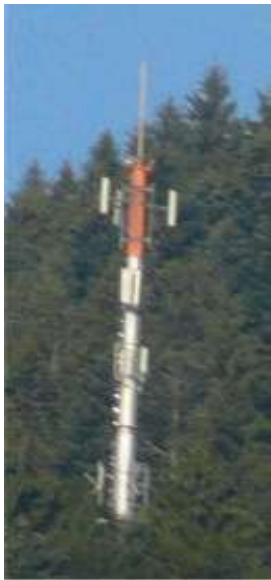
16 SEP 2011
Ringberg base station

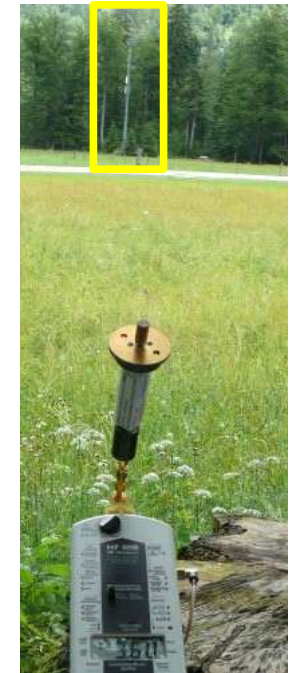
15 SEP 2011 Group of beech and linden trees on a meadow (view from the south). The base station is 200 m (656 ft) away. There was extensive damage to other trees. Given the favorable location, locals found the damage to be inexplicable.

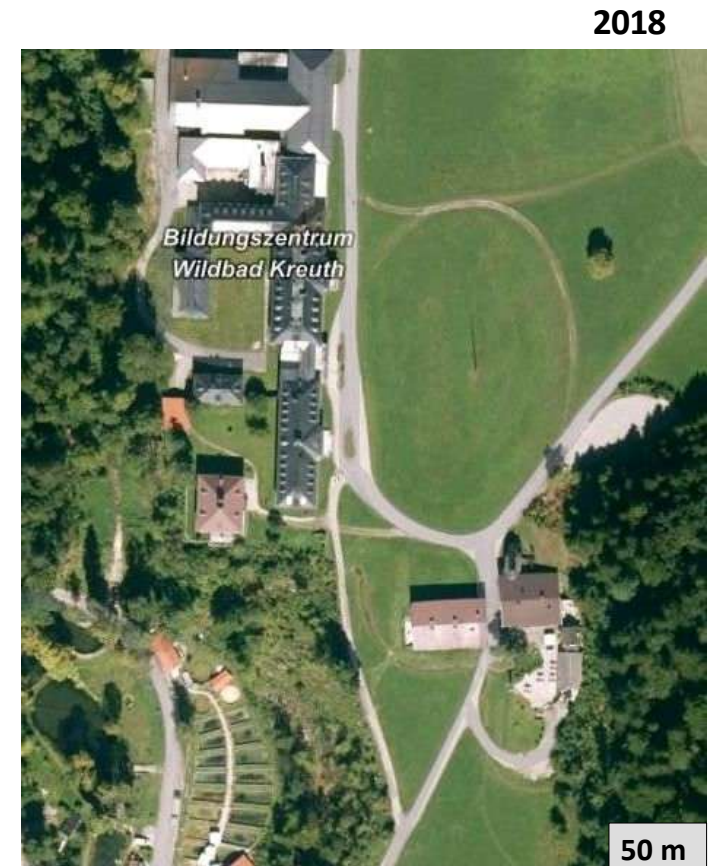
Bavarian State Office for Surveying (LDBV), 2018. A comparison of aerial photographs from 2009 and 2018 shows that many trees had to be removed south of the education center.

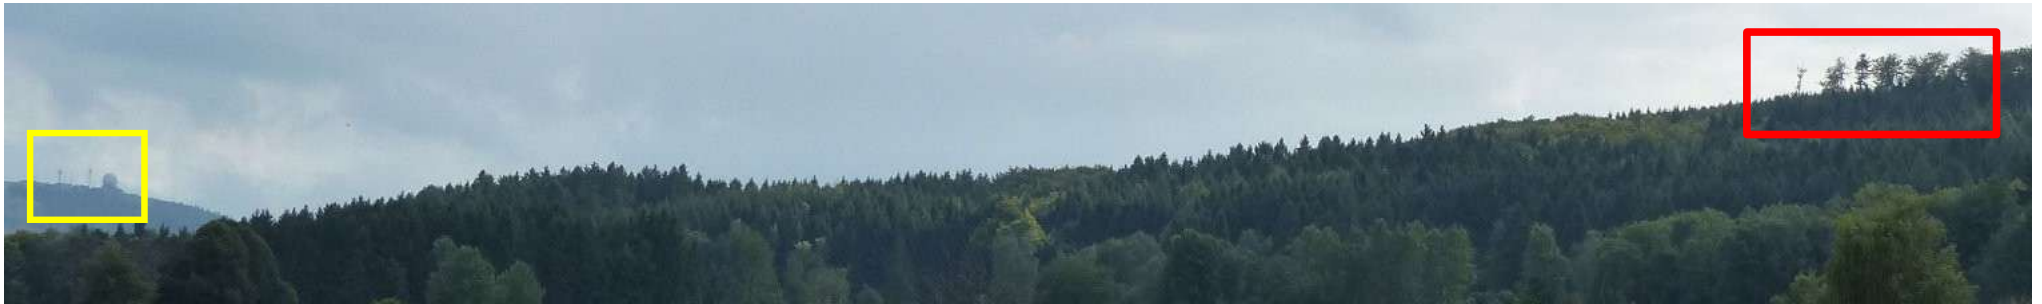
07 SEP 2017 View from the Scheppenbach Valley on Wasserkuppe Mountain (950 m / 3,120 ft) and Bubenbarder Stein Mountain (759 m / 2,490 ft) with tree damage visible from a distance (view from the northeast).

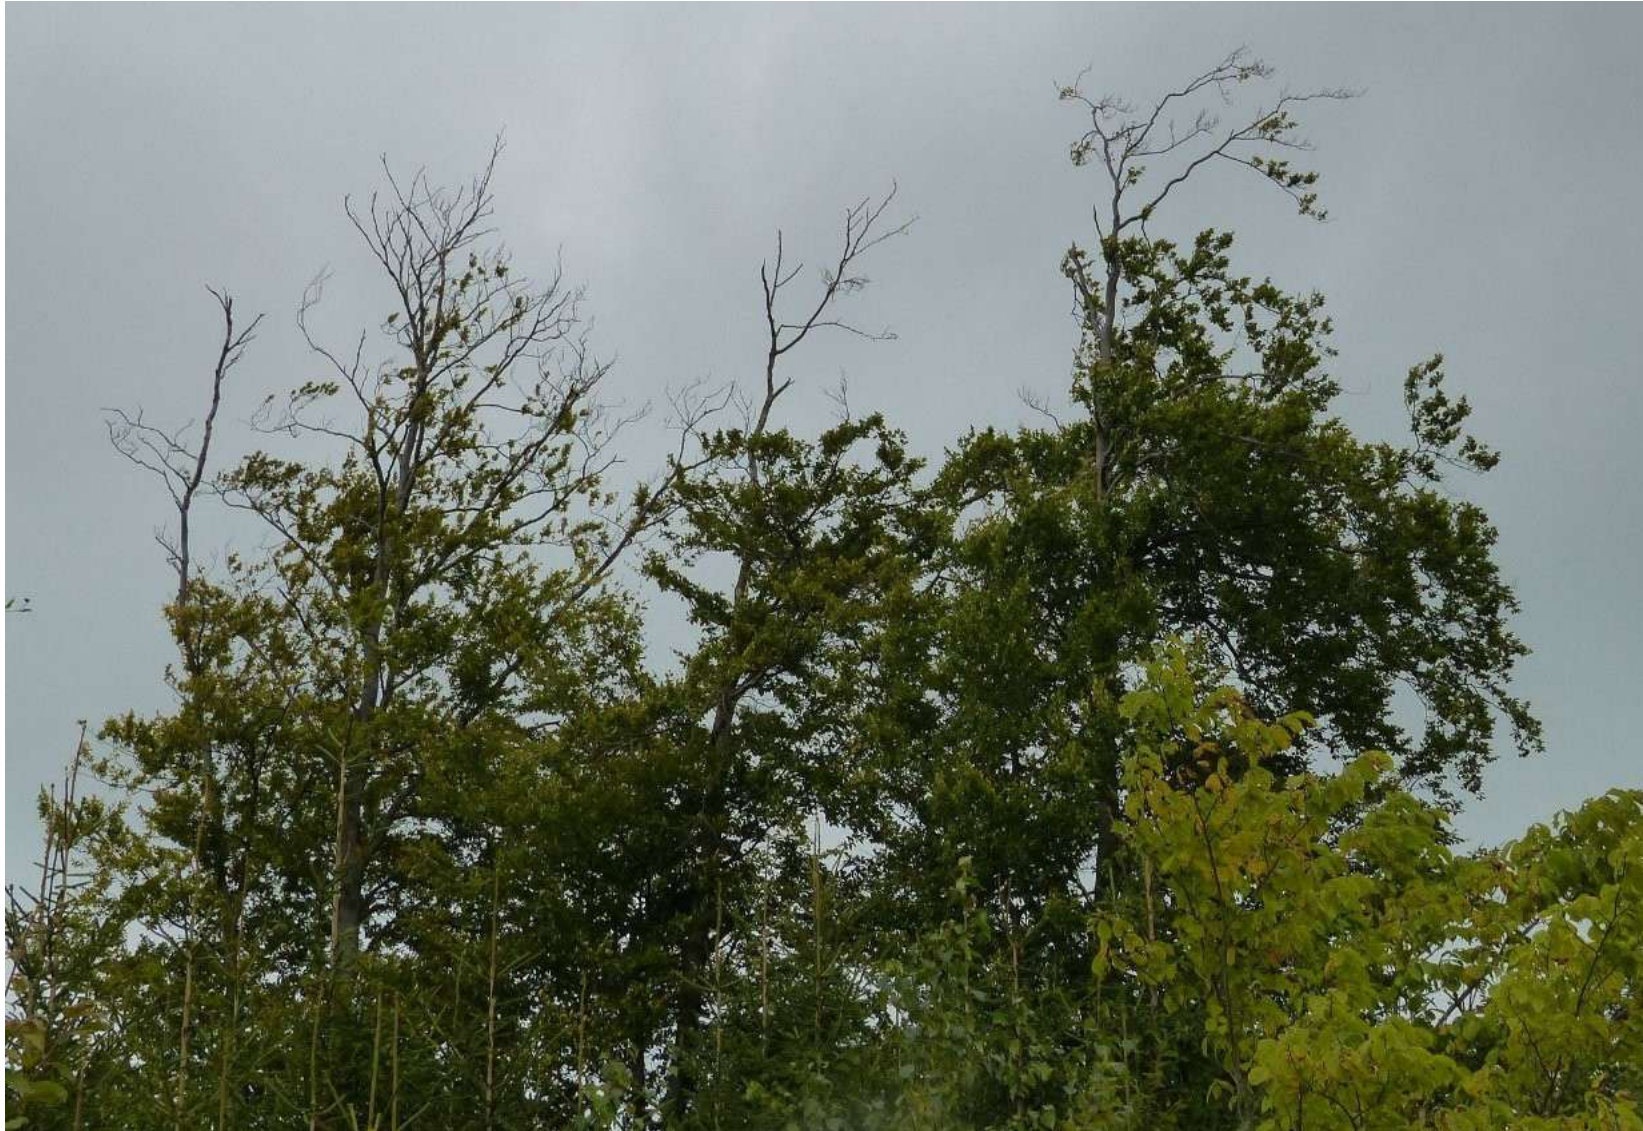
07 SEP 2017 Bubenbarder Stein Mountain. Beach trees. In 2014, foresters announced that nearly all of the beech trees in the Rhön region had abnormal foliage. Wasserkuppe Mountain is home to mobile phone base stations, microwave radio, and BOS digital radio. In May 2006, the analog television transmitter on Heidelstein Mountain was replaced with a digital TV transmitter (DVB-T). In November 2017, the transmitter was converted to DVB-T2.

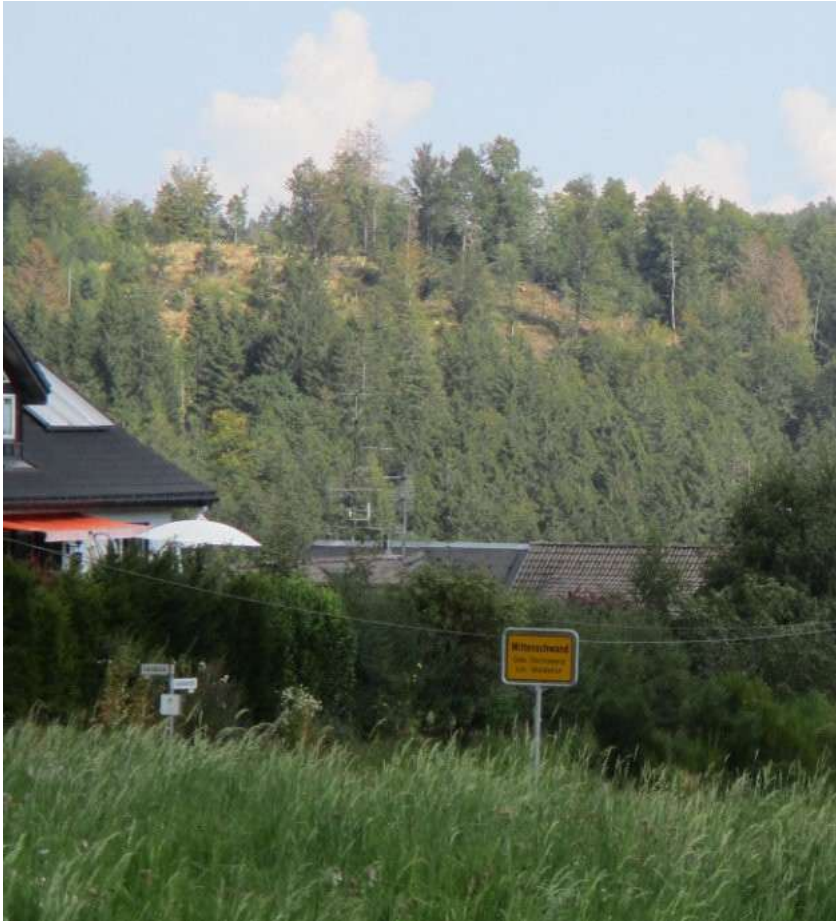
05 SEP 2021 Wittenschwand. The western slope is exposed to RF radiation from three antennas belonging to a mobile phone base station located about 1.5 km (0.9 mi) south of Wittenschwand. A clearing has developed in this forest area.
