Tree Damage Caused by Radiofrequency Radiation

Key Observations from 2005 to 2025 in Germany

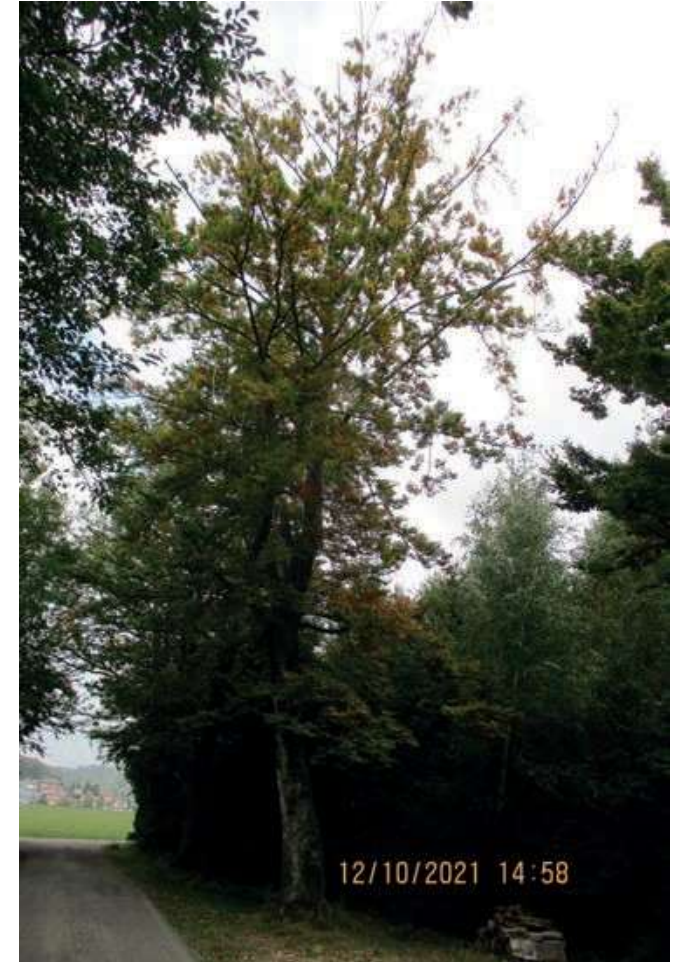
12 OCT 2021 Forest's edge. Beech tree located south of the oak tree. There is significant damage to its crown.

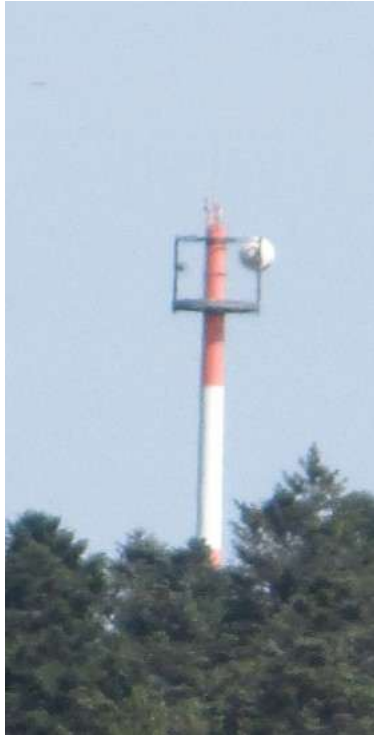
ca. 900 m / 2,950 ft

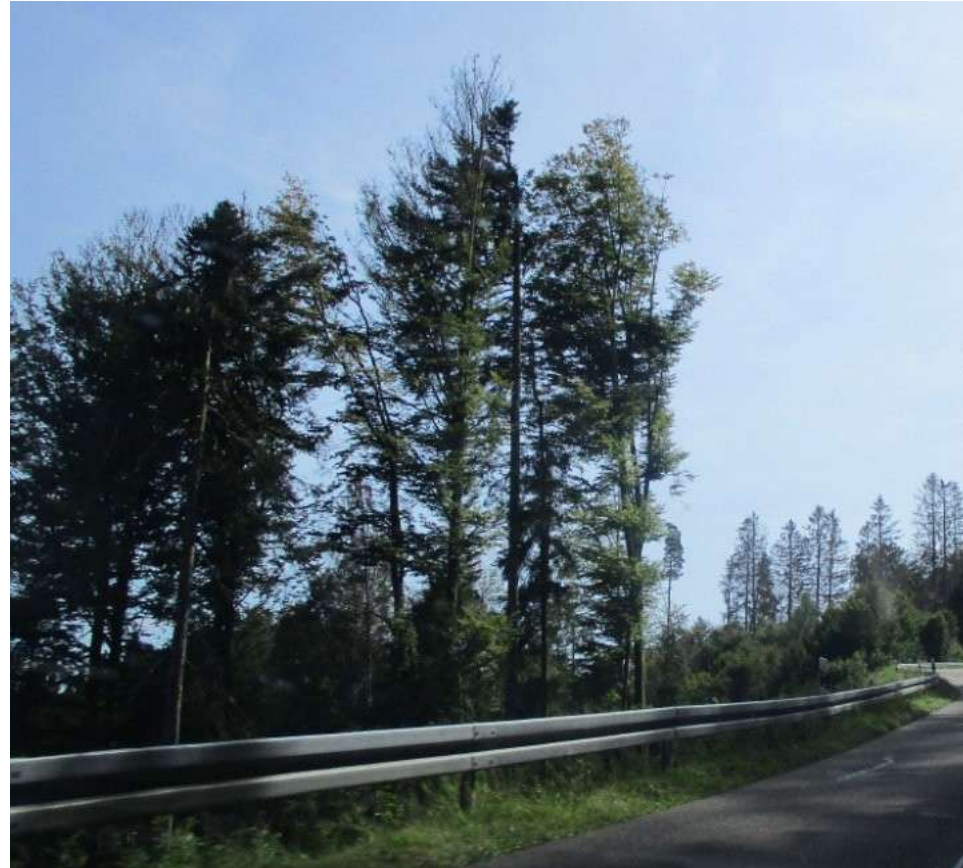
TETRA base station for BOS digital radio. Site certificate No. 27010505 from September 8, 2009: installation height 50.5 m (165 ft)

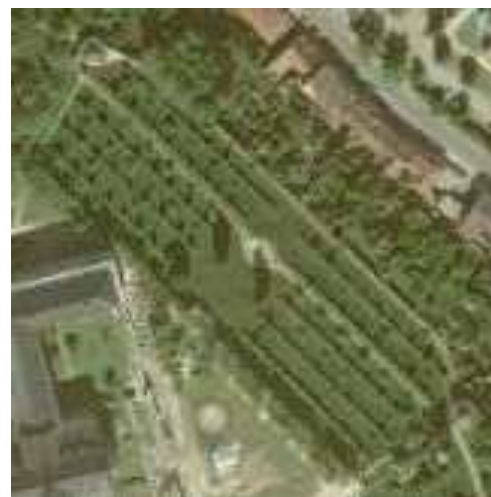
Bayernatlas, State Office for Survey and Geoinformation, 2011

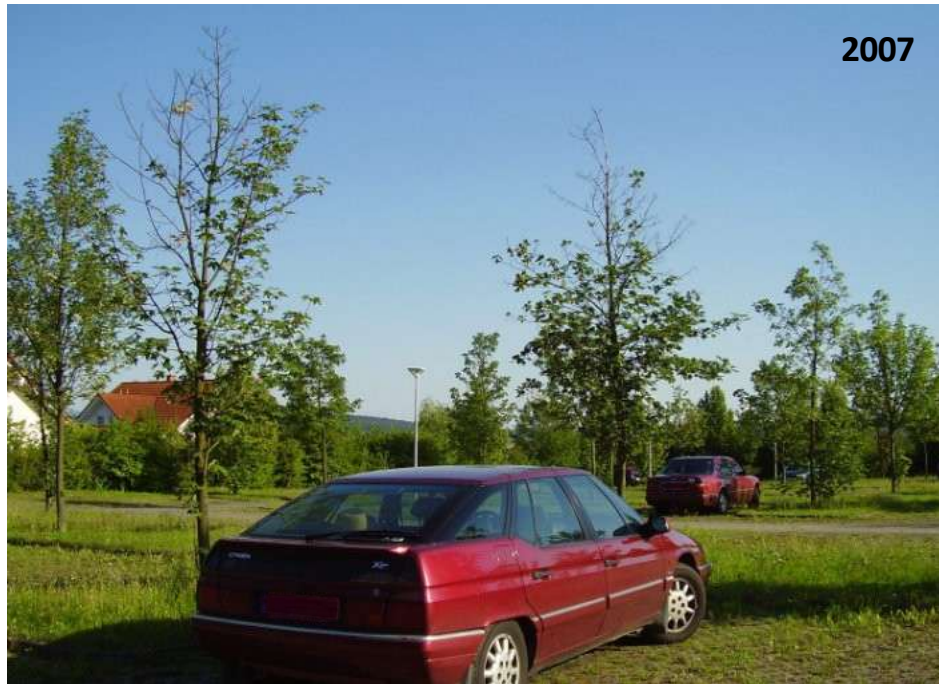
15 JUL 2007 Hünfeld, parking lot at the east side of the hospital (view from the **north**). The young trees in the parking lot, including the maple trees, were damaged to varying degrees. There was a mobile phone base station on the hospital building to the right of the parking lot, which is not shown in this photo.

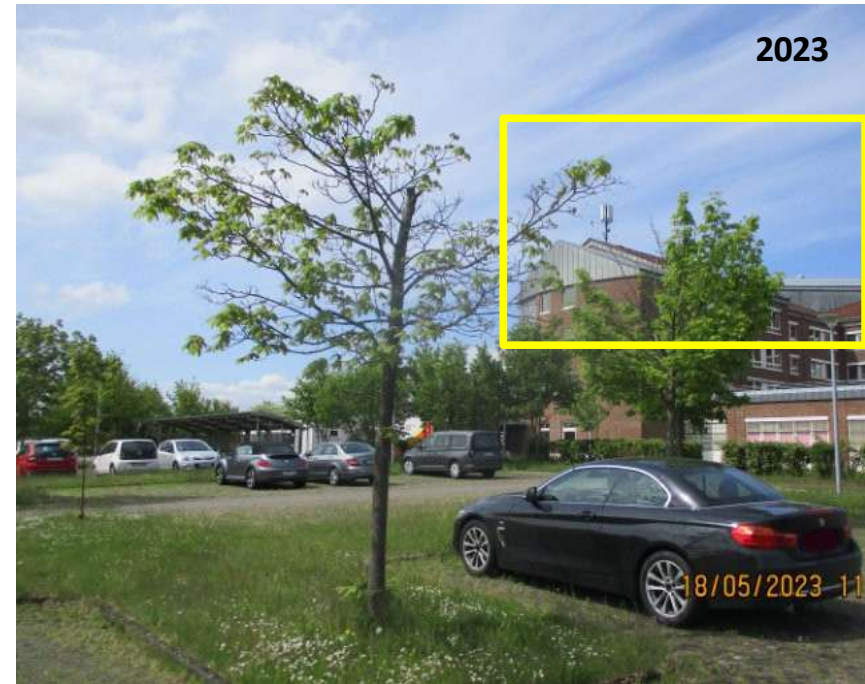
18 MAY 2023 Hünfeld, parking lot at the east side of the hospital (view from the **northeast**).
Mobile phone base station No. 230668.
Many of the trees had not developed properly.

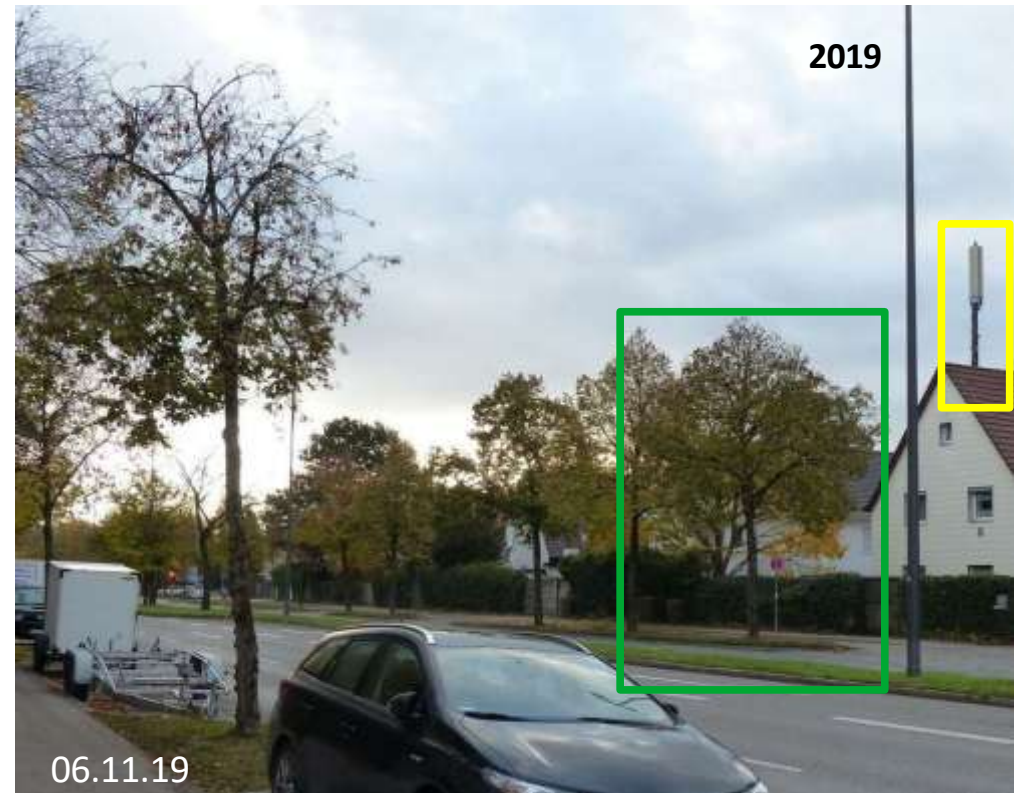
Munich, Von-Kahr-Straße. Linden tree (view from the west) with mobile phone base station No. 530853 at Von-Kahr-Str. 61. The linden tree on the left has not grown in 11 years. The linden tree on the right (green) is located under the main beams. It has been growing horizontally. In 2024, the tree on the left was cut down.

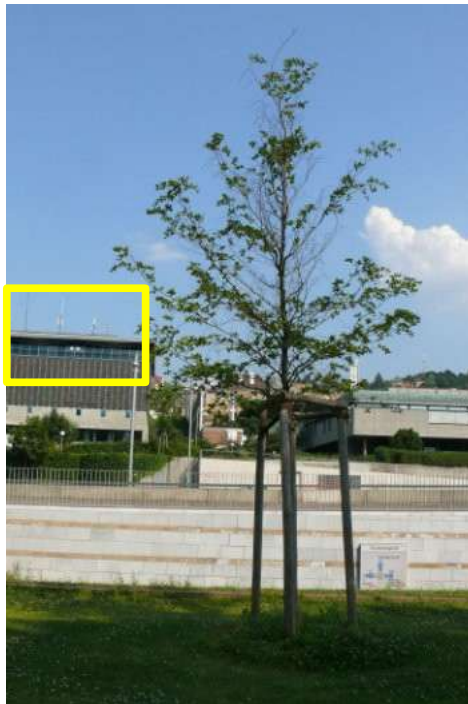
03 JUL 2010 View from the Upper Palace Garden to the state library and the transmitters on the courthouse, damaged beech tree.
Measurement on July 8, 2021:
28,300 $\mu\text{W}/\text{m}^2$

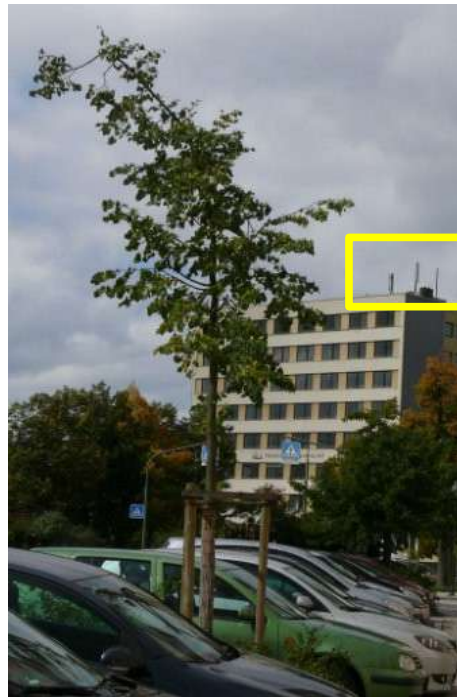
16 SEP 2010 Bahnhofplatz. Linden tree. Dr. Kurz and a biologist from the **State Office of Environmental Protection** were shown the tree damage near the train station.

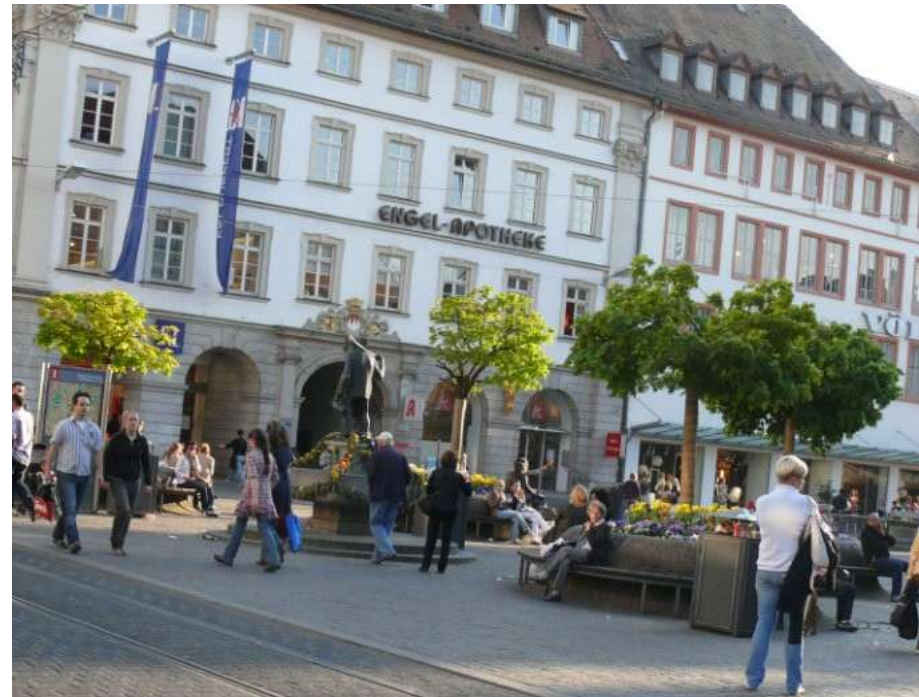
18 APR 2011 Market square. Globe Norway maple trees with crown damage. The trunks were protected. The market square is exposed to RF radiation from the mobile phone base station on Schönbornstraße, which is also reflected off the buildings. The trees have since been removed.

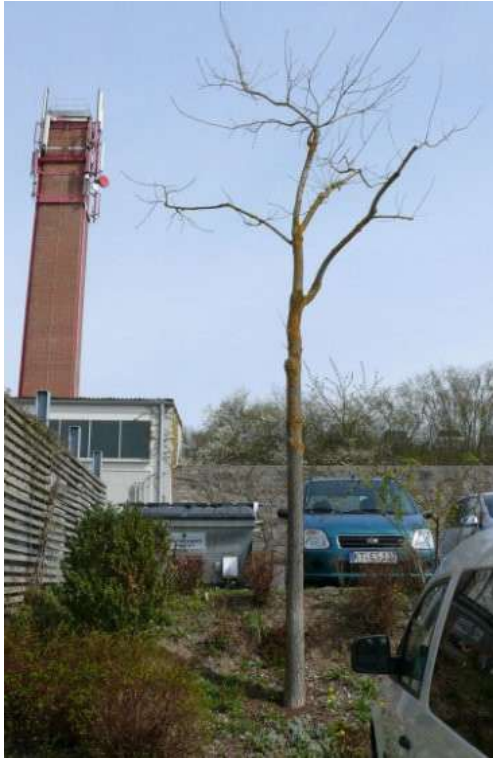
Veitshöchheim, Bavarian State Institute for Viticulture and Horticulture, April 2011

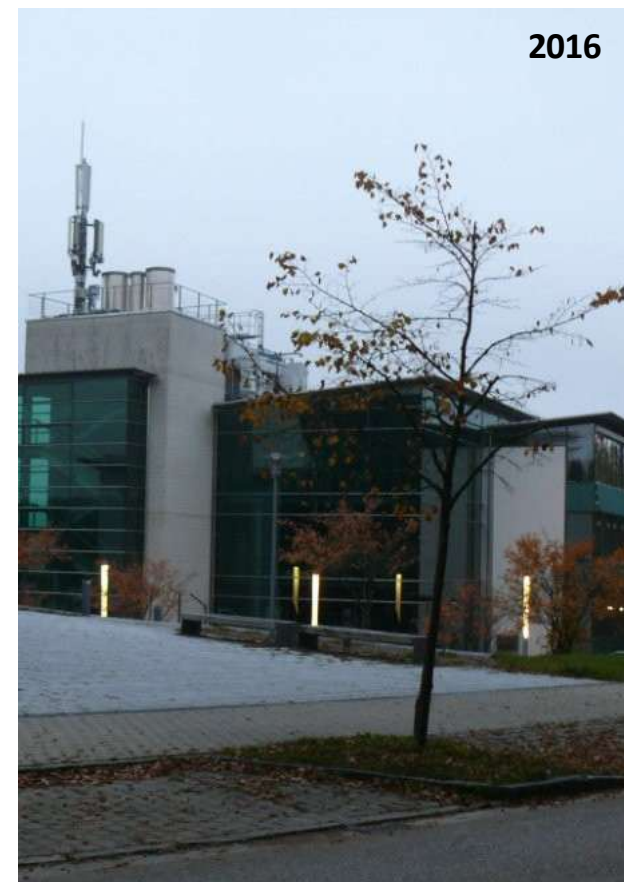
20 JUN 2012 Lange Point 10.
Linden tree (view from the west).
Measurement: **6,840 $\mu\text{W}/\text{m}^2$**

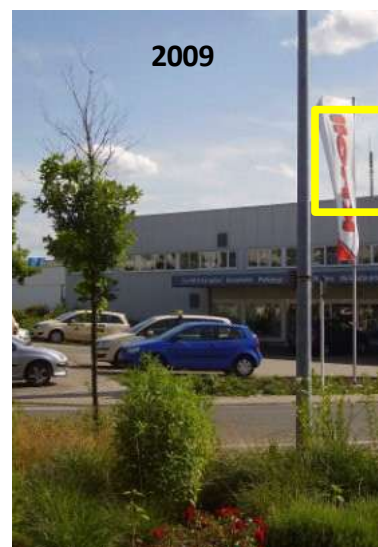
10 JUN 2009 Oak tree.
The top half of the tree was dead.

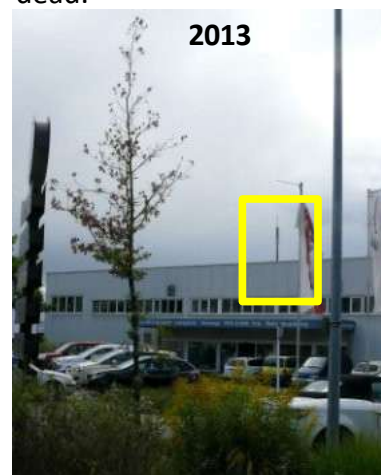
17 SEP 2013 The replanted oak tree did not thrive either. RF radiation exposure should be considered as a possible cause.

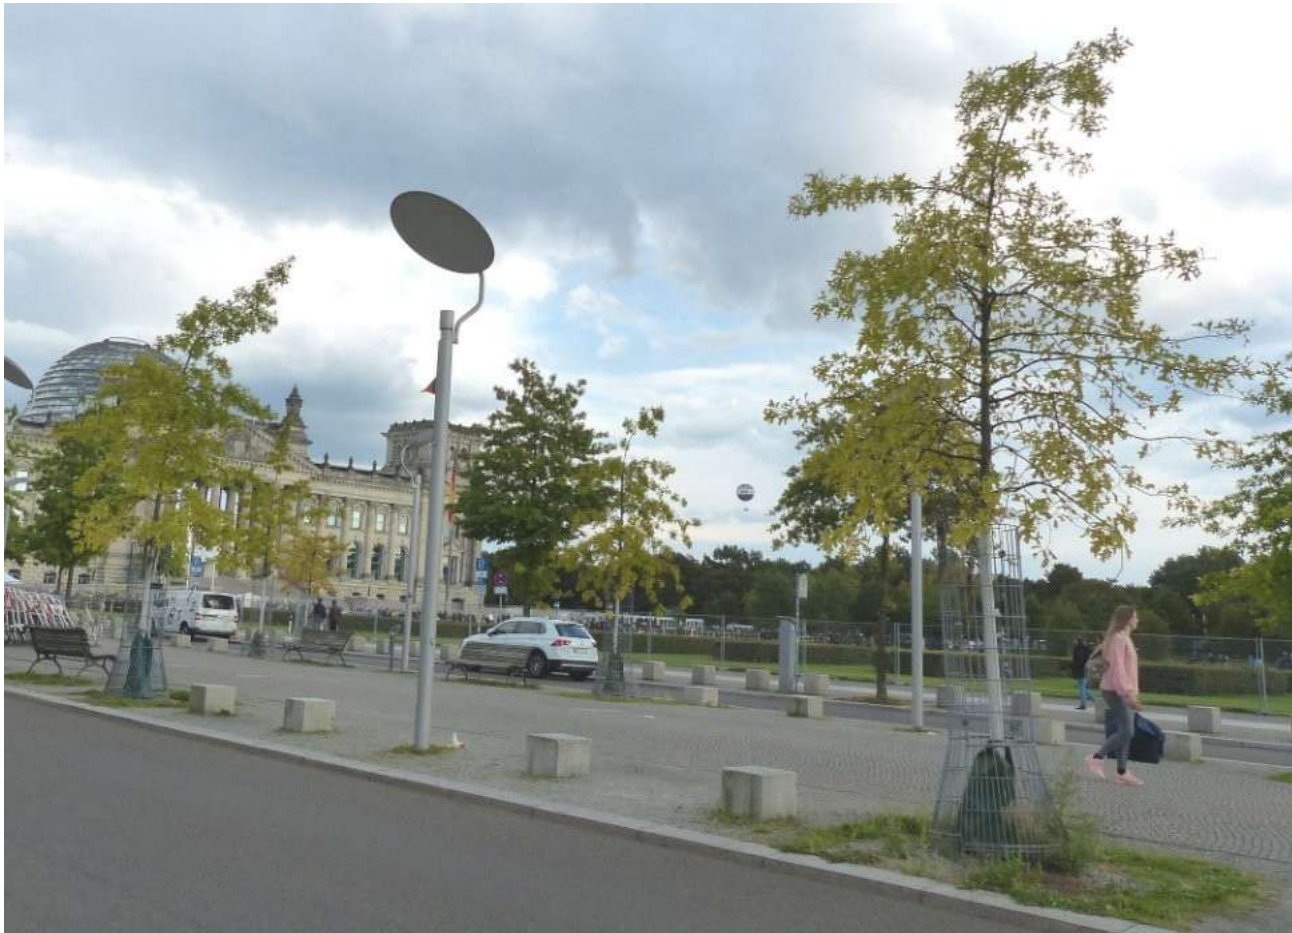
16 SEP 2017 View from Paul-Löbe-Allee (view from the northwest) across Platz der Republik to the German Bundestag in the Reichstag building. Pin oak trees.

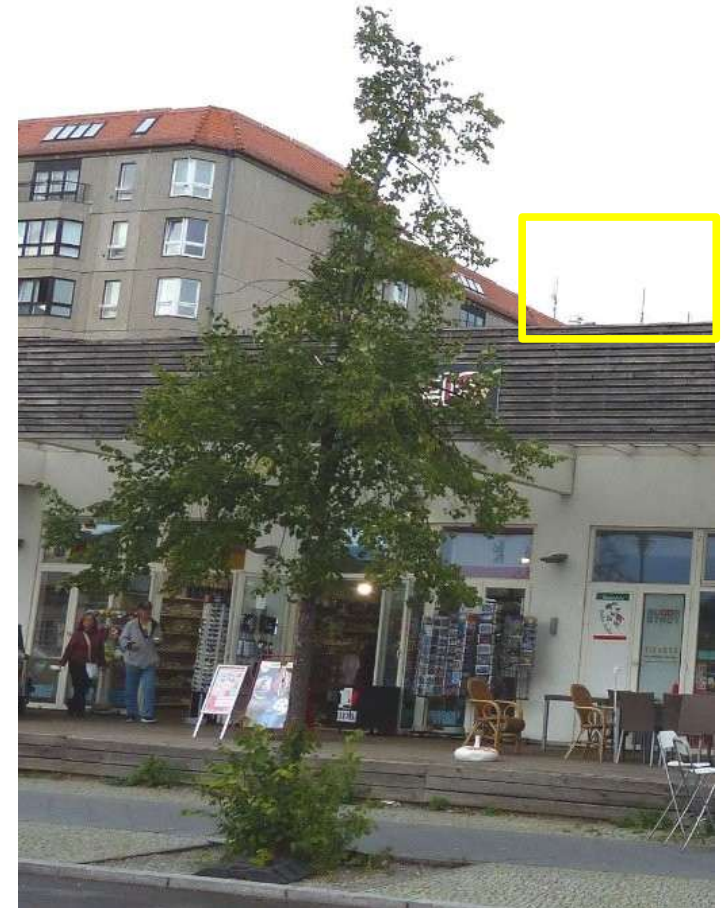
15 SEP 2017 Cora-Berliner-Straße.

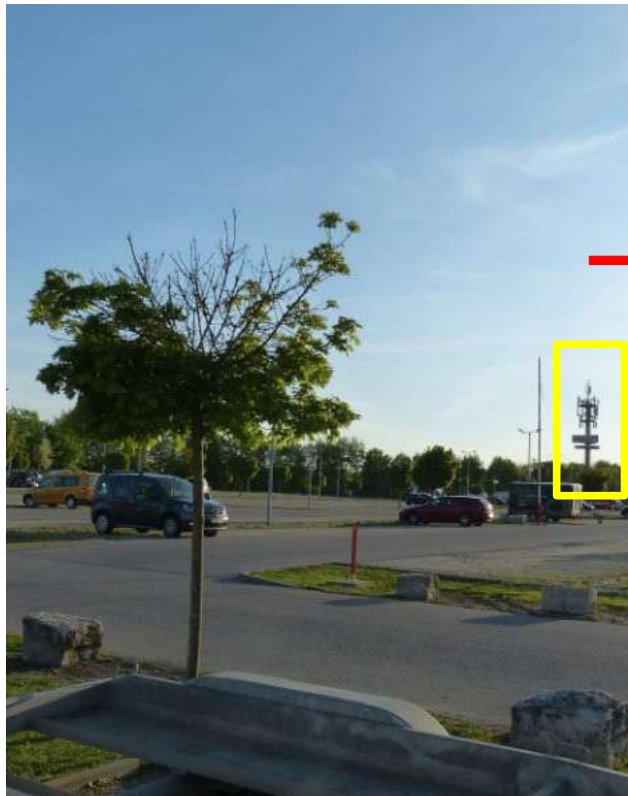
24 APR 2018 Parking lot, Augsburg Exhibition Center.
Maple tree (view from the east).
Many trees in the parking lot are damaged.

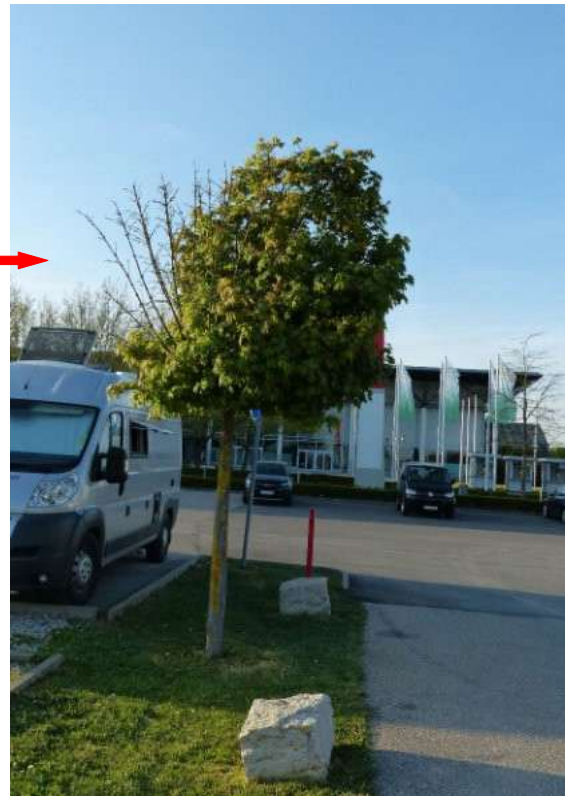
24 APR 2018 Parking lot, Augsburg Exhibition Center.
Maple tree (view from the south)

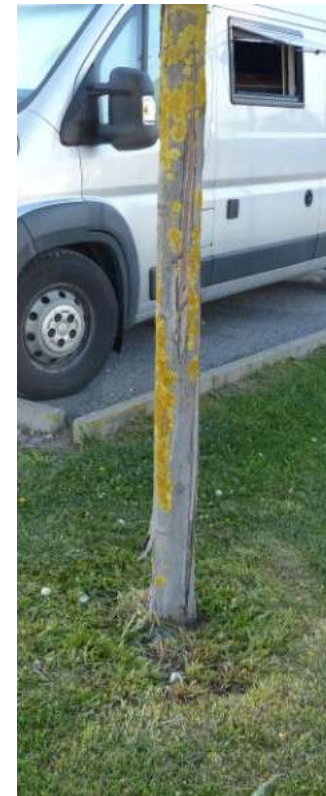
24 APR 2018 Cracks along the trunk and lichens

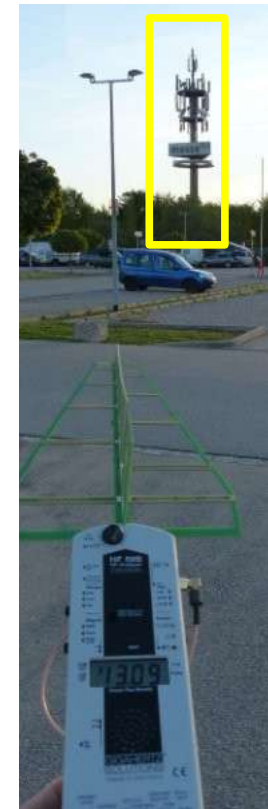
24 APR 2018
Measurements between **1,000** and **13,090 $\mu\text{W}/\text{m}^2$** confirmed the uneven distribution of the radiofrequency field.

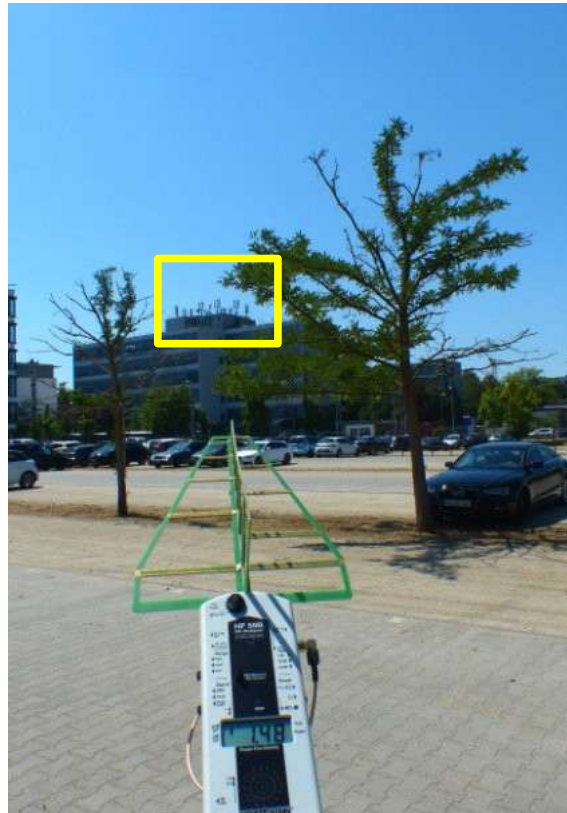
24 JUL 2019 Parking lot at the Boehringer company. Damaged locust trees.
Measurement: **1,480 $\mu\text{W}/\text{m}^2$**
Mobile phone base station No. 400379,
site certificate from June 28, 2019:
installation height 27.5 m (90 ft), 33 sector
antennas

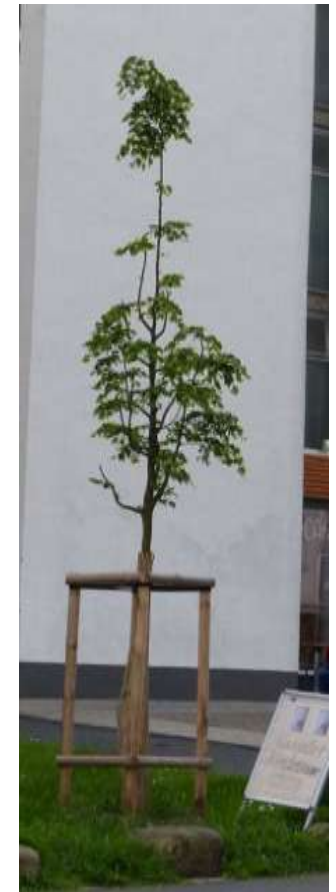
Section of the EMF database of the German Federal Network Agency (BNetzA) with locations of mobile phone base stations. Several mobile phone base stations (marked in red) emit RF radiation in different directions along Wilhelmshöher Allee. This results in an **uneven distribution of radiofrequency fields**. In summer 2016, severe damage to linden trees was observed, with significant variation noted among the trees.

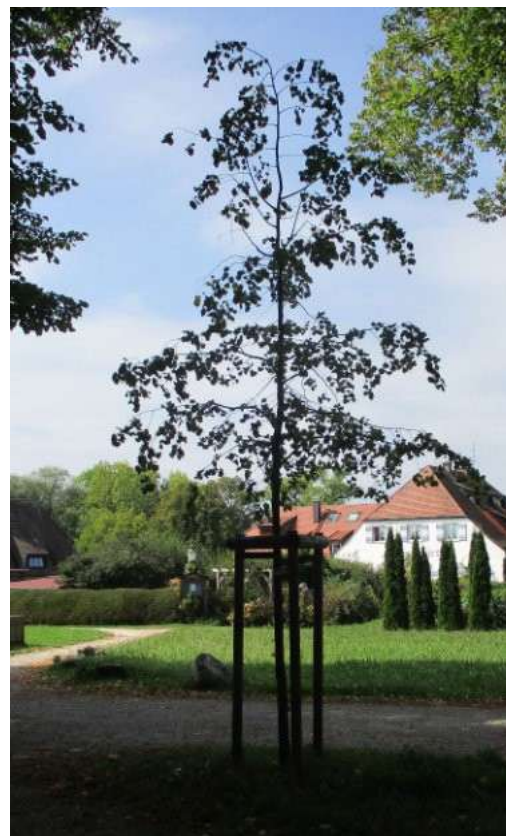
18 SEP 2020 Natural Monument of Lindenhain. This linden tree on the north side of the linden grove has signs of disturbed development. There is a line of sight to the transmitter near Gstadt, which is 2 km (1.2 mi) away.

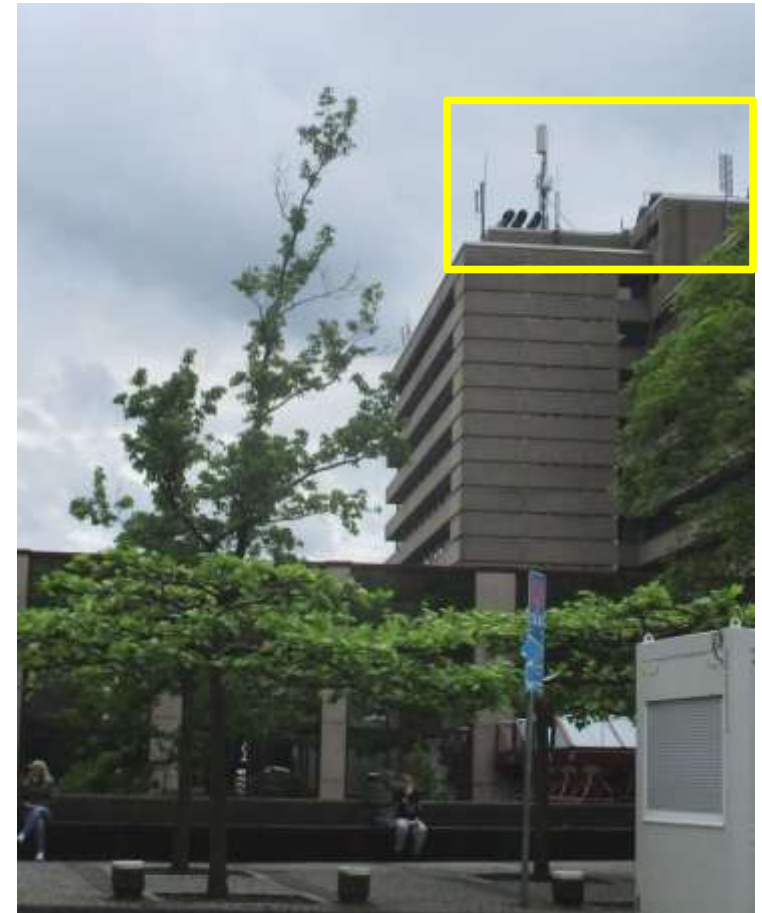
24 MAY 2022 Hospital with mobile phone base station. Sweet gum tree. The trees around the hospital have sustained extensive damage, typically beginning on the side facing the transmitters.

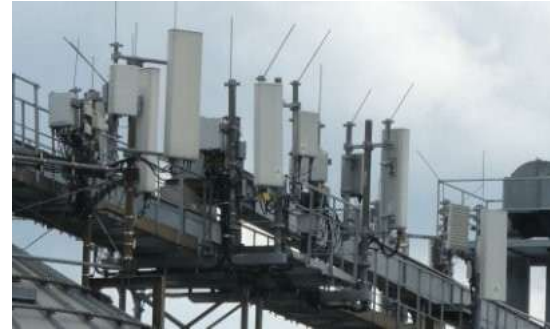
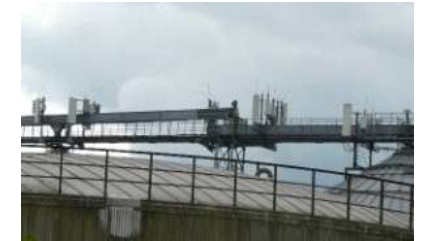
Section of the city map, Falk. Added items: location of mobile phone base stations (yellow) with the main beam directions of the known antennas and the location of trees (green).

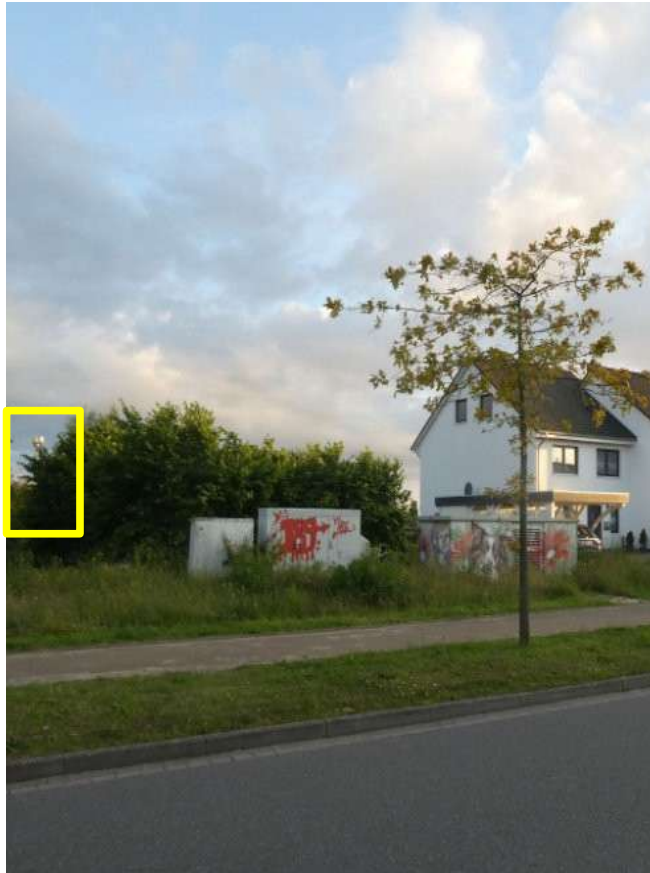
18 JUN 2025 Kantenweg. Pin oak tree (view from the north). Line of sight to the base station, No. 66011002, on Doberaner Landstraße, which is 380 m (1,247 ft) away.
Measurement: 23,500 $\mu\text{W}/\text{m}^2$

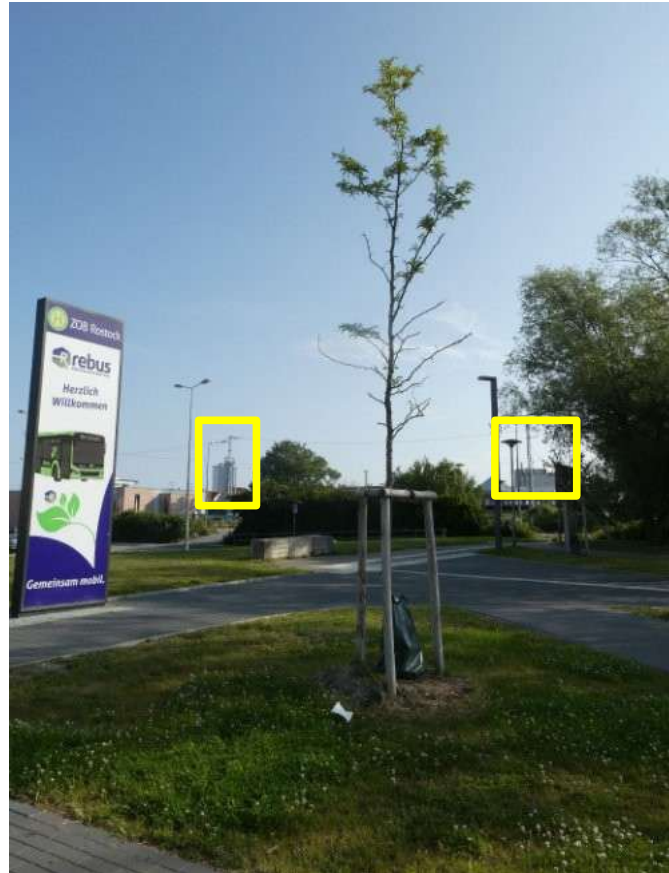
21 JUN 2025 ZOB, southwest side of the main train station. Honey locust tree (view from the south). In addition, base station radiation from the south affects the young trees. There was significant damage throughout the area, affecting both young and older trees.

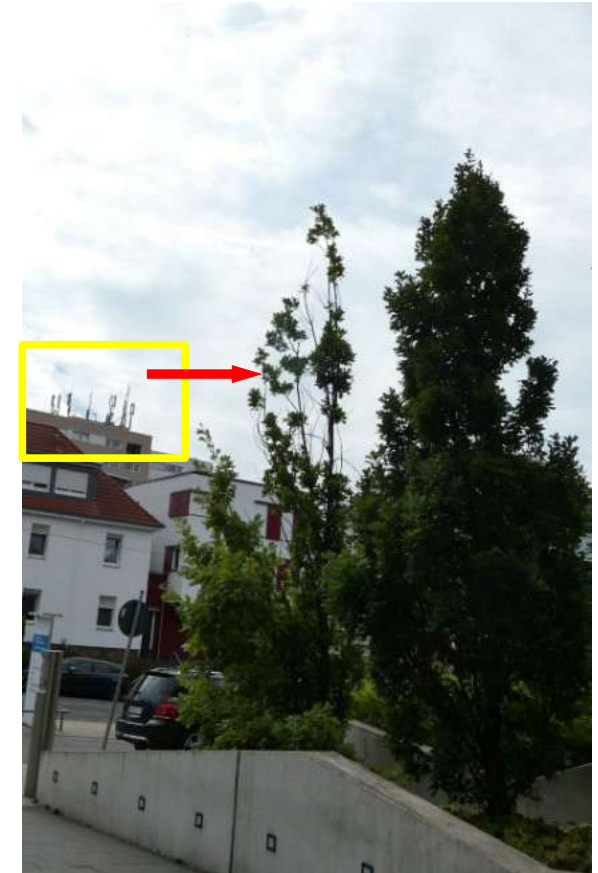
20 JUL 2025 Kassel, hospital entrance. Pyramidal oak trees (view from the west). The mobile phone base station at Mönchebergstr. 50 has 33 sector antennas.
Measurement: 6,400 $\mu\text{W}/\text{m}^2$

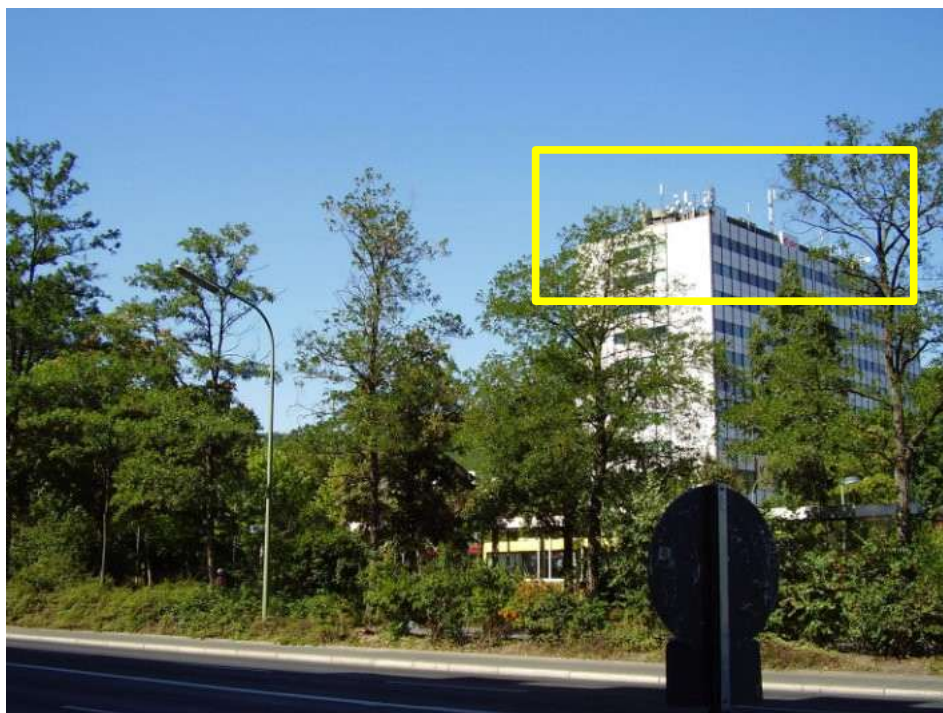
26 AUG 2006 Würzburg, Röntgenring, near train station. A row of locust trees on a grass strip between road and sidewalk (**view from the south**). The locust trees all had sparse foliage. They had to be cut down in subsequent years.

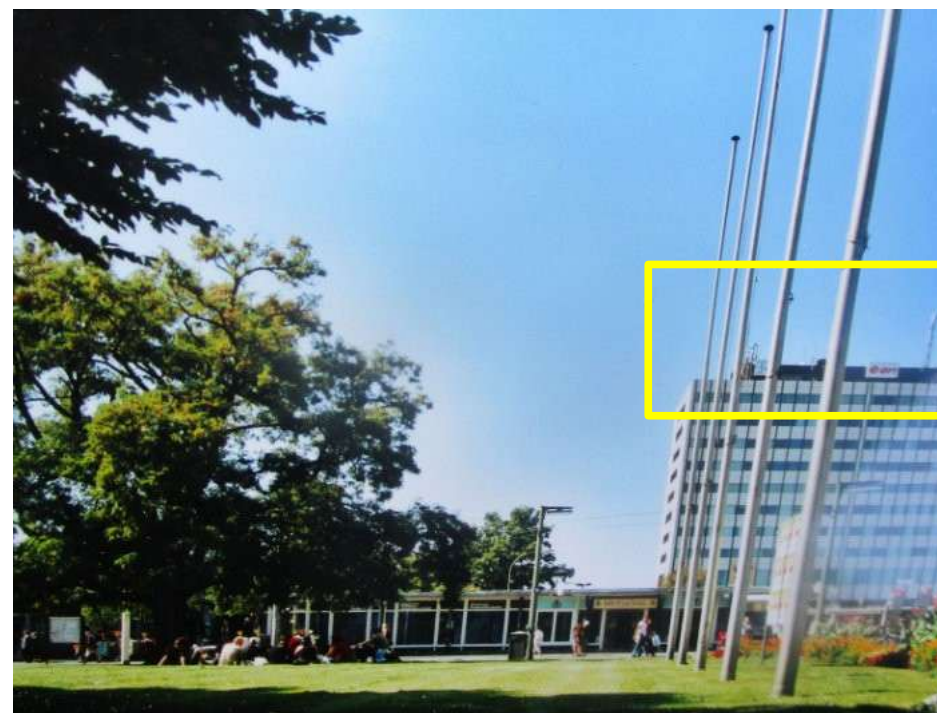
26 AUG 2006 Würzburg, Bahnhofplatz. Locust tree on a meadow (**view from the east**). Not only along the road did locust trees show crown damage, but also in the meadow in front of the train station building. Side lobes struck the locust tree from above. The tree was cut down in 2017/2018.

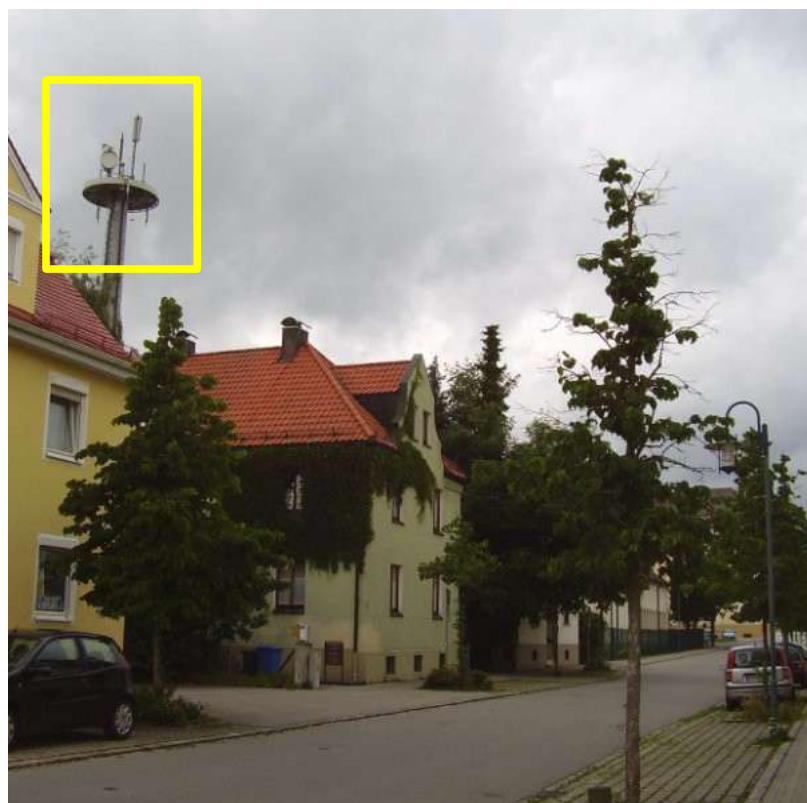
13 JUN 2008 Plattling, Reiterstraße. Tree hazel avenue (view from the south). There is a line of sight from the tree hazel on the right to the base station. This tree shows clear crown damage. The tree hazel on the left is located in the radio shadow of the yellow house.

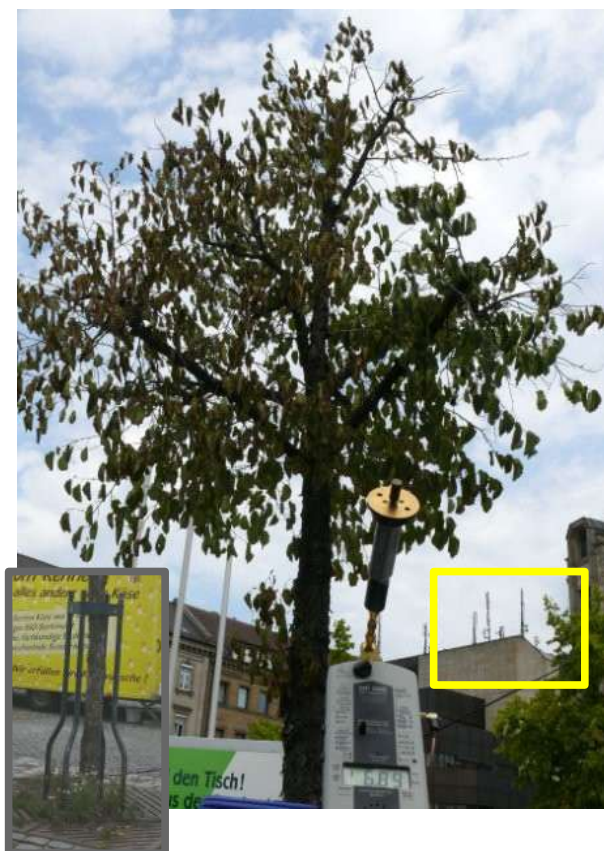
02 AUG 2012 Fürth, Bahnhofplatz. Tree hazel. The location was carefully protected. Measurement: **6,890 $\mu\text{W}/\text{m}^2$**

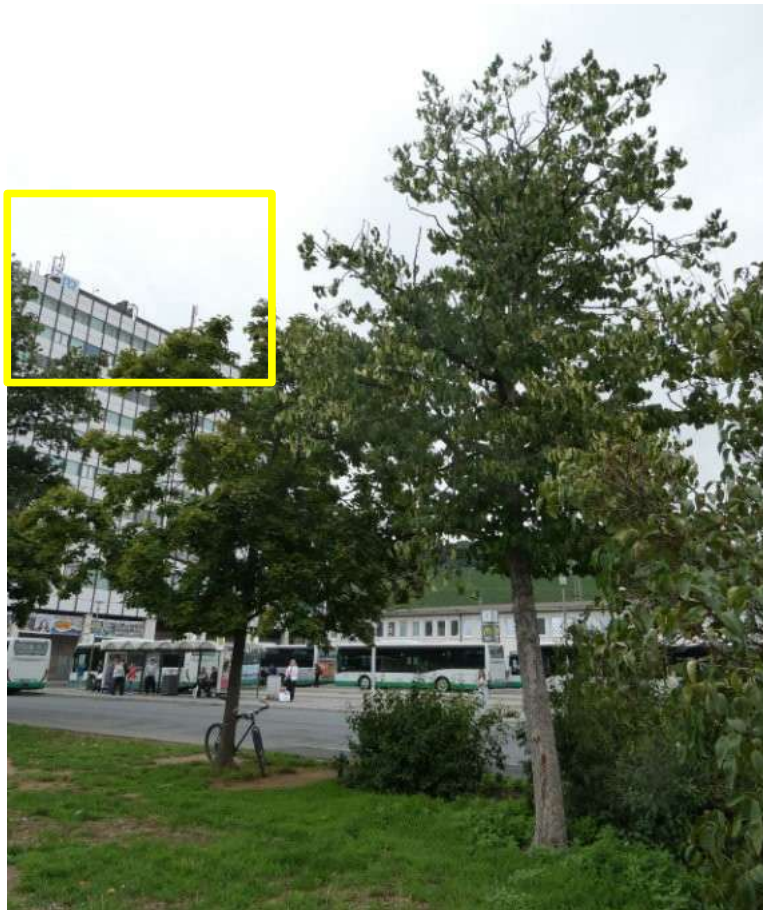
04 AUG 2025 Würzburg, Bahnhofplatz.
 Tree hazel with crown damage in a small grass strip
 (view from the southeast).
 Measurement: **4,200 $\mu\text{W}/\text{m}^2$**

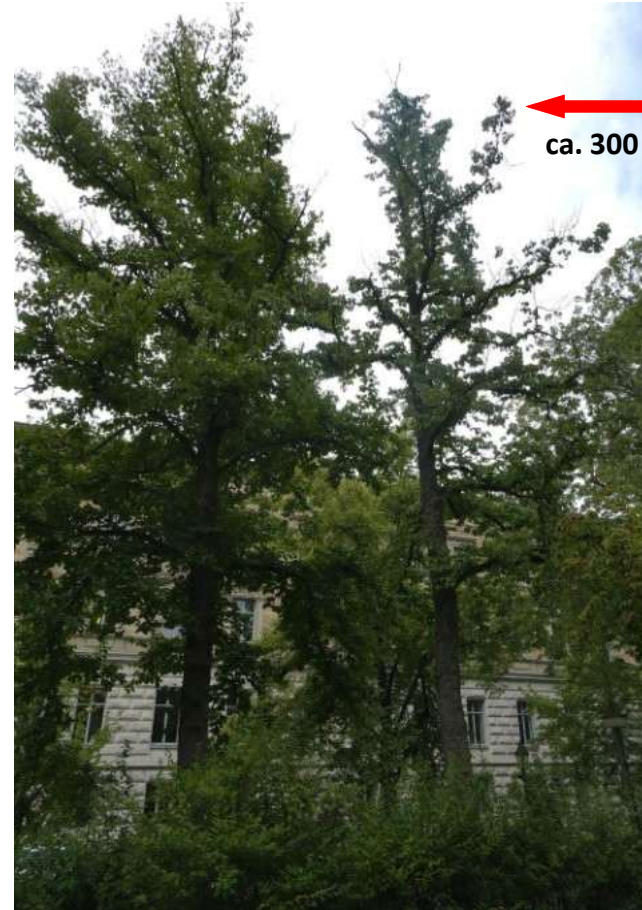
04 AUG 2025 Würzburg, Ringpark, near Justice
 Center. Two tree hazels (view from the south).
 The eastern tree hazel already had to be cut
 back. From the base station at Friedrich-Ebert-
 Ring 14, RF radiation reaches the west and north
 part of the Ringpark. Numerous trees had to be
 cut back, topped, or cut down.

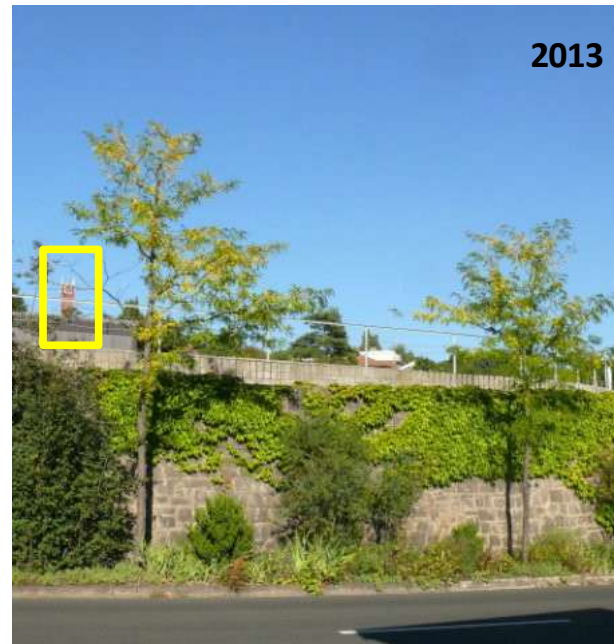
05 SEP 2013 Birkentalstraße. Two honey locust trees (view from the southwest). Line of sight to the base station on An der Steige, premature yellowing. There was extensive damage to trees and shrubs on the LWG premises.
Measurement: **1,810 $\mu\text{W}/\text{m}^2$**

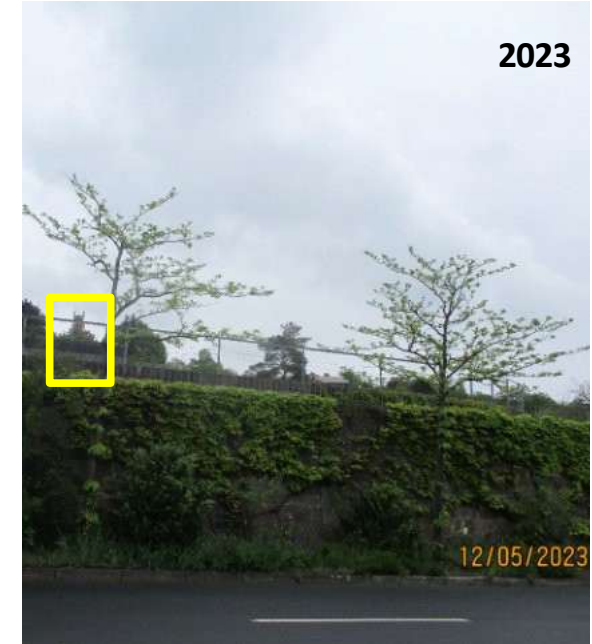
12 MAY 2023 Birkentalstraße. Two honey locust trees (view from the southwest).
They have not grown in ten years.

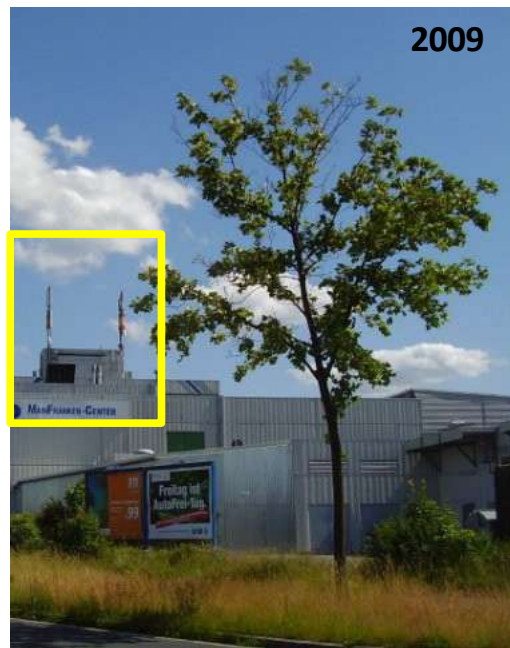
Bamberg, Berliner Ring, 2009–2016

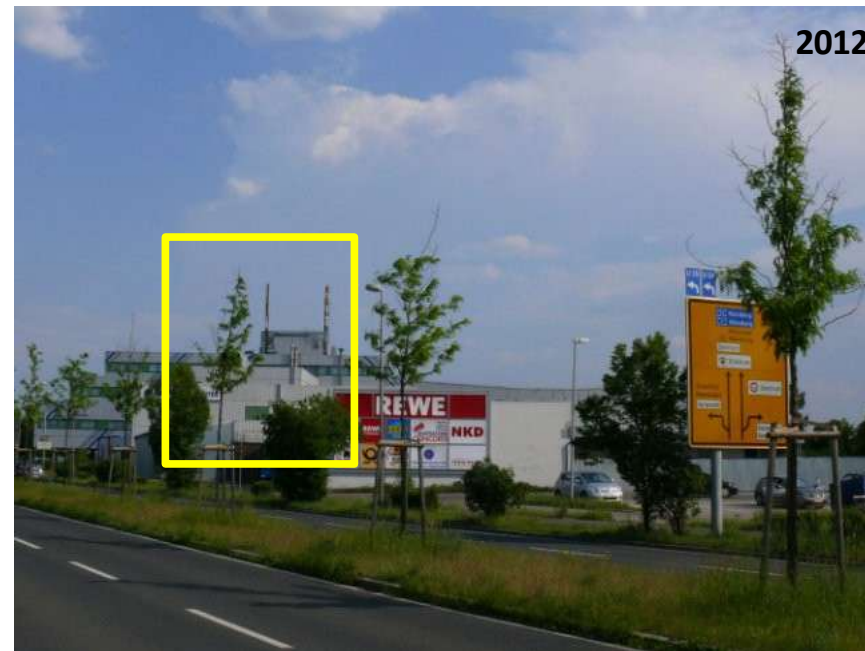
10 JUN 2009 Berliner Ring, MainFranken Center. A maple tree from a row on the median strip (view from the north). All of the maple trees had damaged crowns, so they were cut down.

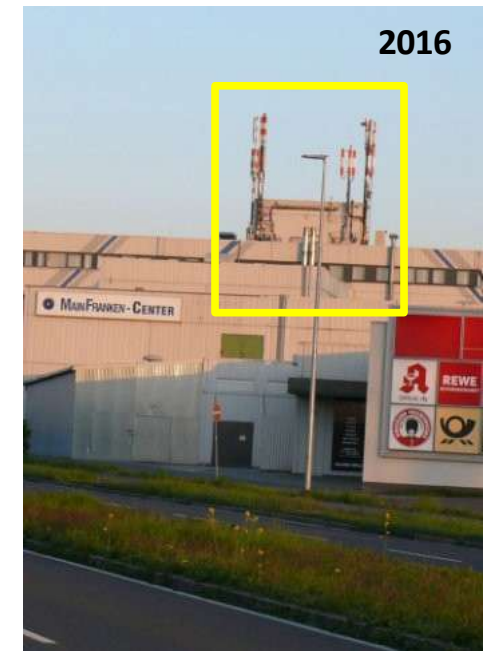
23 MAY 2012 Berliner Ring, MainFranken Center. A row of honey locust trees (view from the northwest). **The row was planted in 2010.** Measurement: **5,460 $\mu\text{W}/\text{m}^2$**
The honey locust trees already showed crown damage in 2012. There was extensive damage to various tree species in the vicinity of the base station.

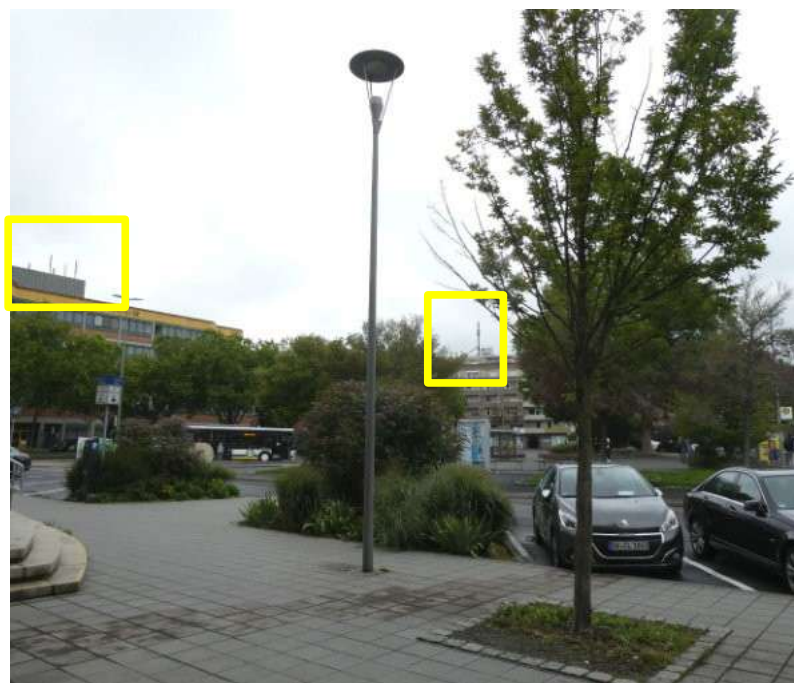
04 AUG 2025 Schweinfurt.
Three damaged hornbeam trees on the north side of the train station (**view from the northwest**). The hornbeam trees that stood farther to the west also showed signs of damage.

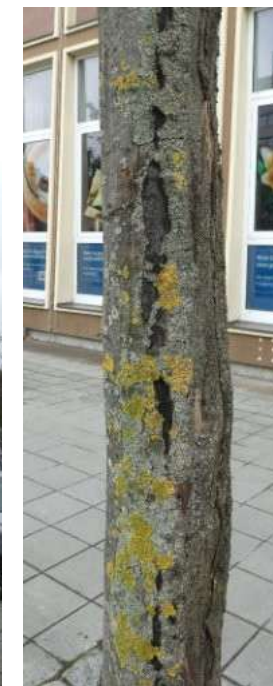
04 AUG 2025 Hornbeam Tree No. 3 (**view from the southeast**). There is a direct line of sight from the hornbeam trees to two mobile phone base station: No. 661216 and No. 660515.
Measurement: 94,800 $\mu\text{W}/\text{m}^2$

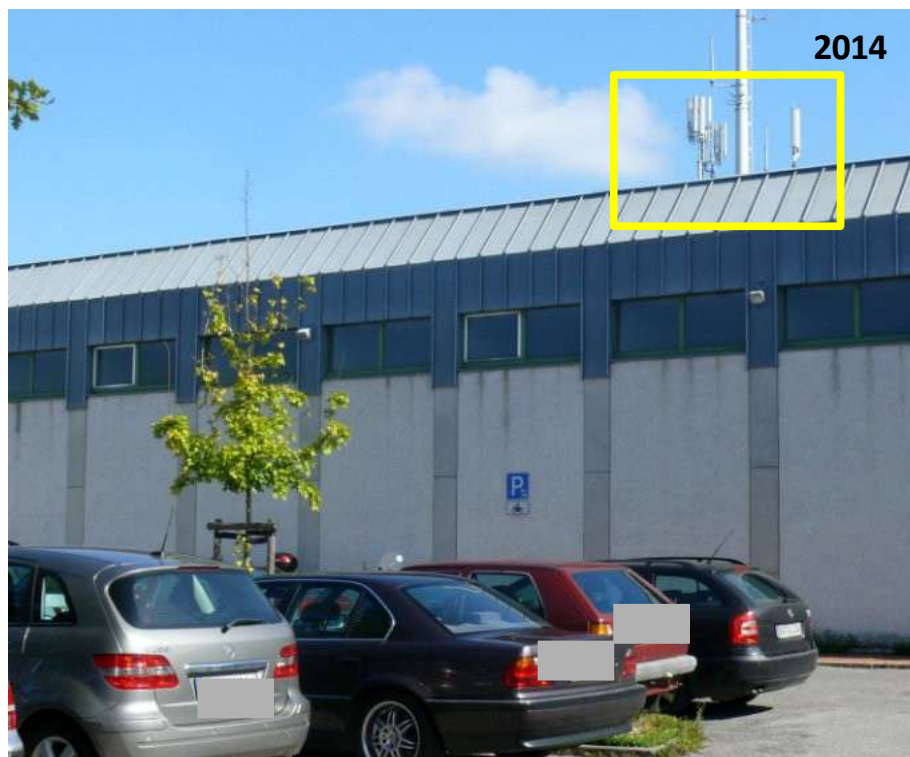
17 SEP 2014 Bamberg, police headquarters, west side of parking lot. Young field maple tree with dead top. Measurement: **4,190 $\mu\text{W}/\text{m}^2$**
