Tree Damage Caused by Radiofrequency Radiation

Key Observations from 2005 to 2025 in Germany

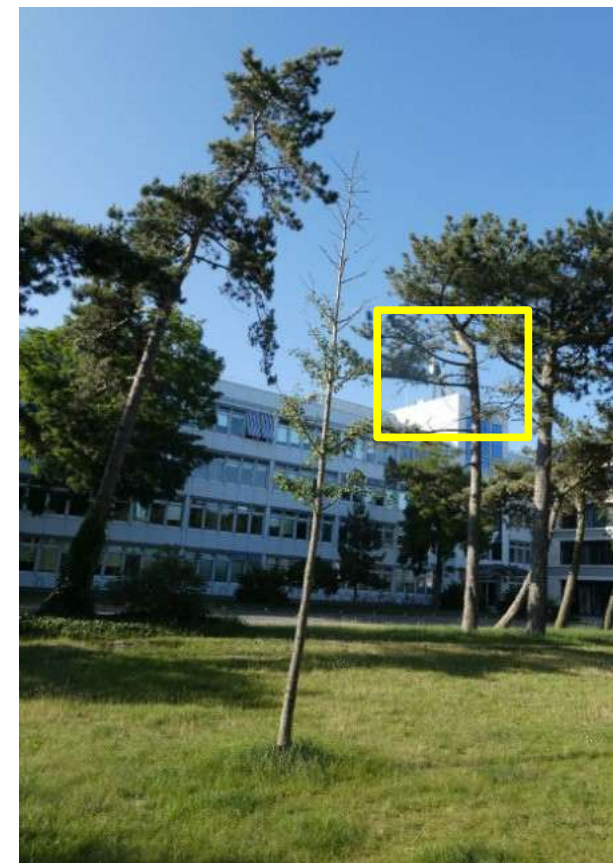
20 JUN 2025 Rostock-Warnemünde, spa gardens, north. Ginkgo (view from the southwest). Mobile phone base station at the Leibniz Institute for Baltic Sea Research (IOW). Site certificate from August 3, 2022: 18 antennas (6 x 0°, 6 x 120°, 6 x 240°). The pine trees show signs of disturbed growth.

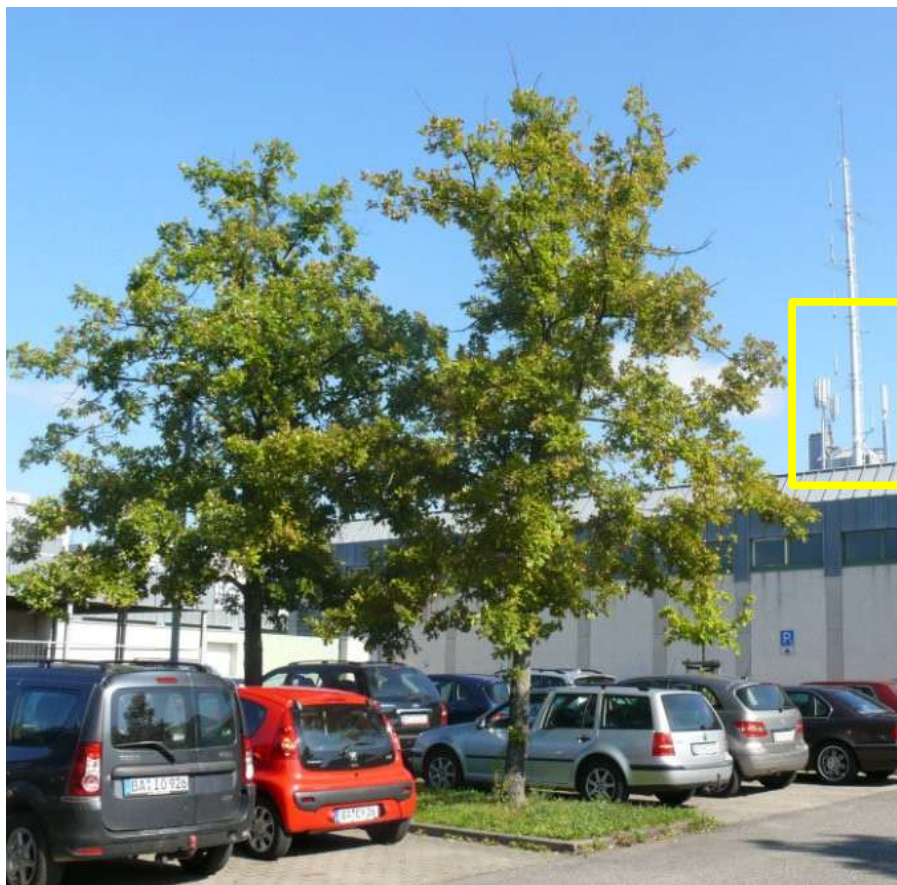
17 SEP 2014 Bamberg, police headquarters, west side of parking lot. Damaged oak trees were visible here as early as 2014 (view from the southwest).

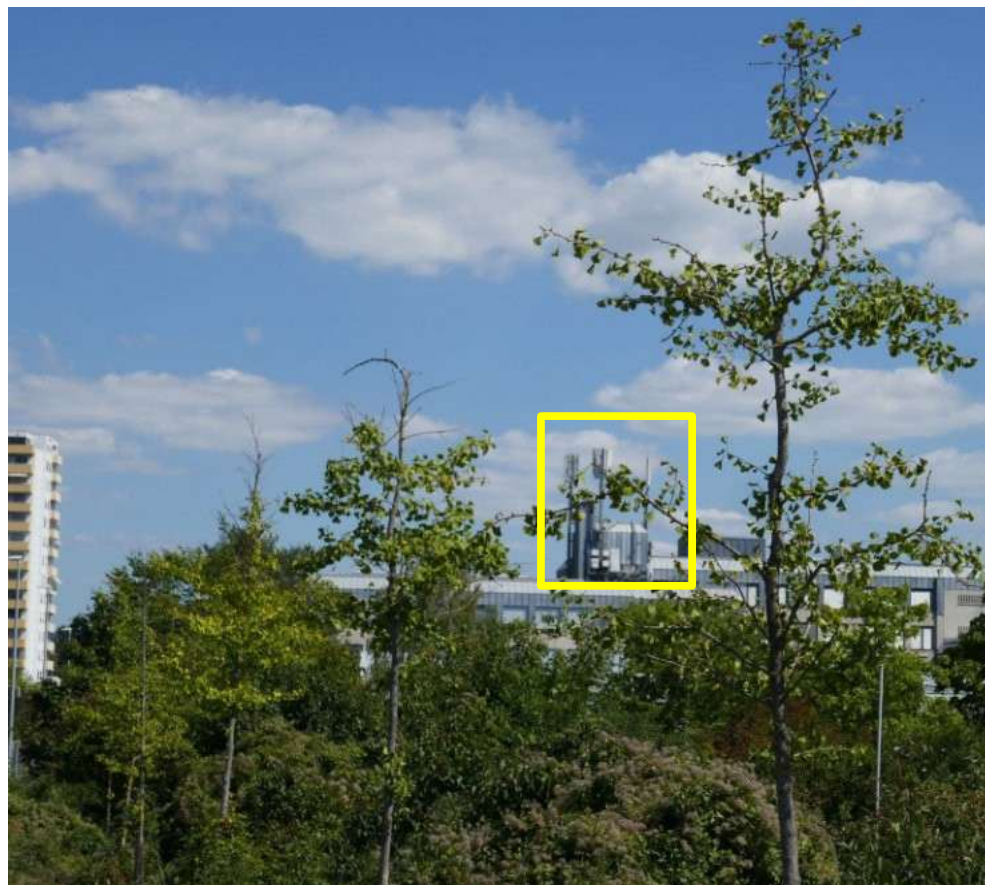
19 AUG 2025 Bamberg, Starkenfeldstraße. A row of ginkgo trees (view from the west). There is a direct line of sight to base station No. 670448, which is located on the roof of the police headquarters building at Schildstraße 81.

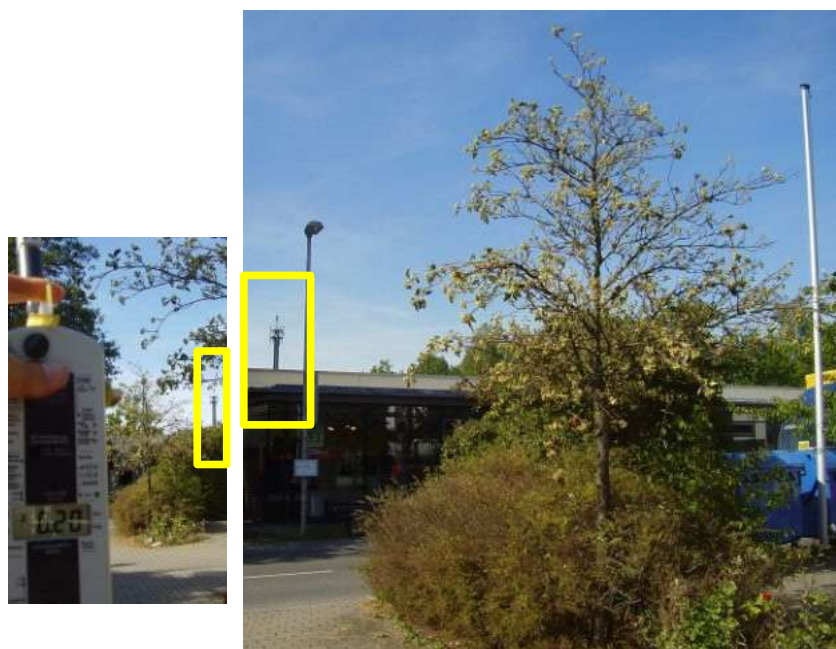
31 AUG 2009 Bamberg, Strullendorfer Straße. Whitebeam tree. This whitebeam tree and others lost their leaves prematurely. The mobile phone base station at Gutenberg-Str. 20 is 320 m (1,050 feet) away. Measurement: **200 $\mu\text{W}/\text{m}^2$** . The base station was surrounded by trees that had sustained extensive damage.

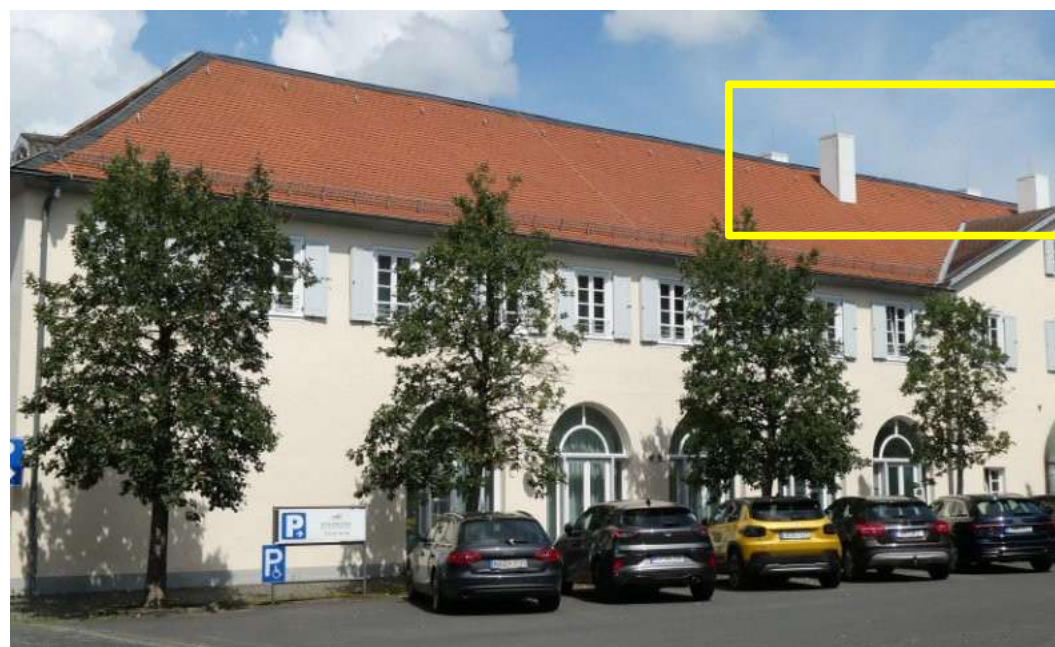
25 JUL 2025 Kassel, Schlosspark 8, Schlosshotel. Four whitebeam trees. Base station No. 66011818, located in the white chimneys, began operating in 2020. The focused RF radiation from the main beams and side lobes, as well as the attenuation caused by leaves, may explain the differences in crown damage. Measurement taken on July 25, 2025 within 30 m (98 ft) of the base station: **145,000 $\mu\text{W}/\text{m}^2$**

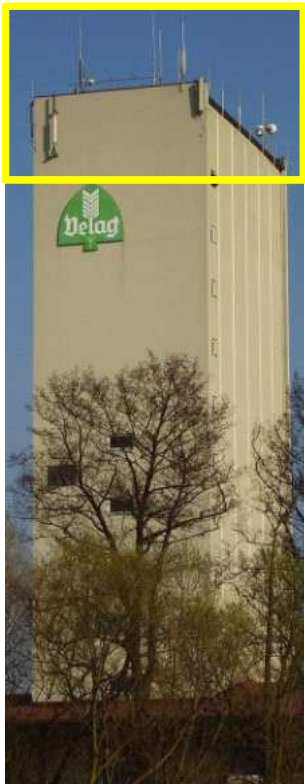
30 APR 2007 Sulzdorf.
Base station
No. 770395

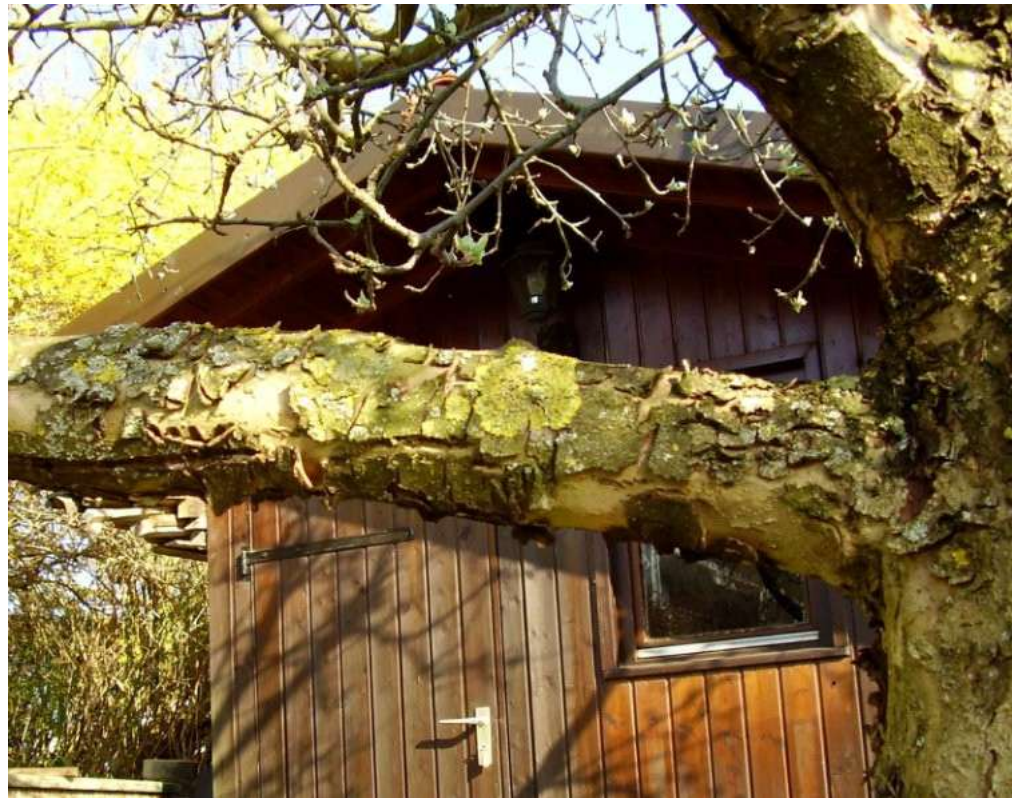
30 APR 2007 Sulzdorf, Im Rohr. The base station is about 450 m (1,476 ft) away. The fruit trees in this garden were covered in cracks and peeling bark. Lichens had spread.

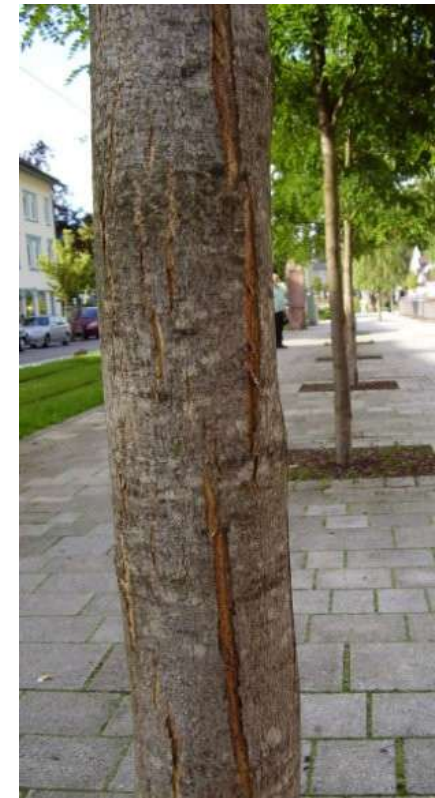
30 JUN 2007 König-Karl-Straße.
Line of sight to the base station
at Palais Thermal.

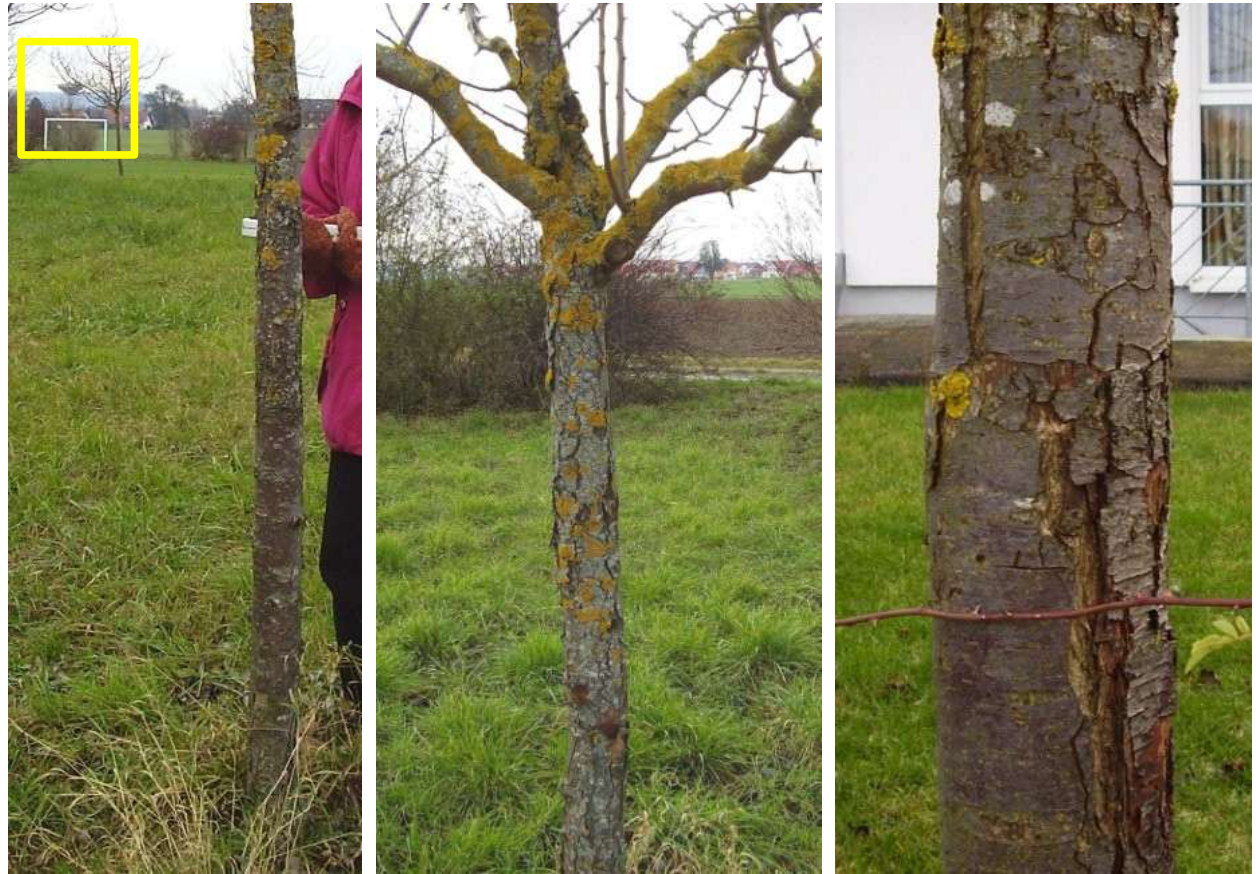
29 NOV 2007 Rosengarten-Westheim. Base station at the water tower in Uttenhofen since 1993

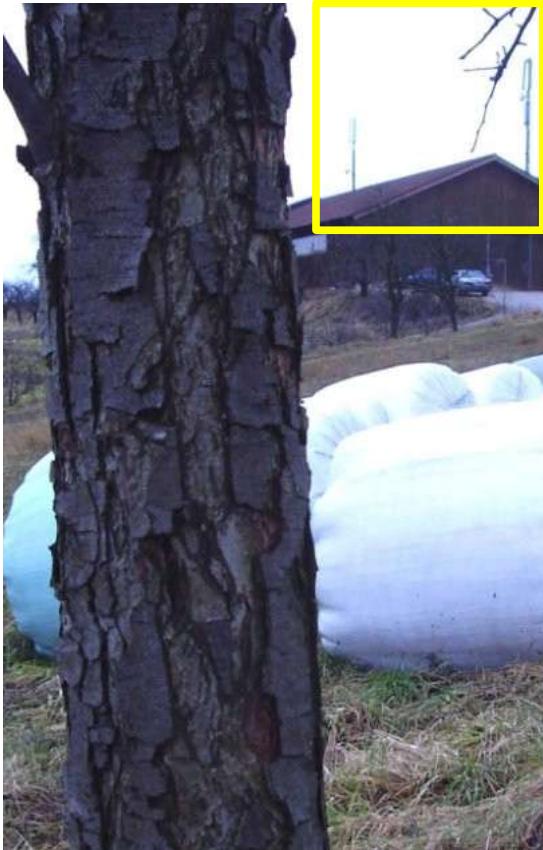
19 JAN 2008 Weilersbach.
Measurement: **4,600 $\mu\text{W}/\text{m}^2$**

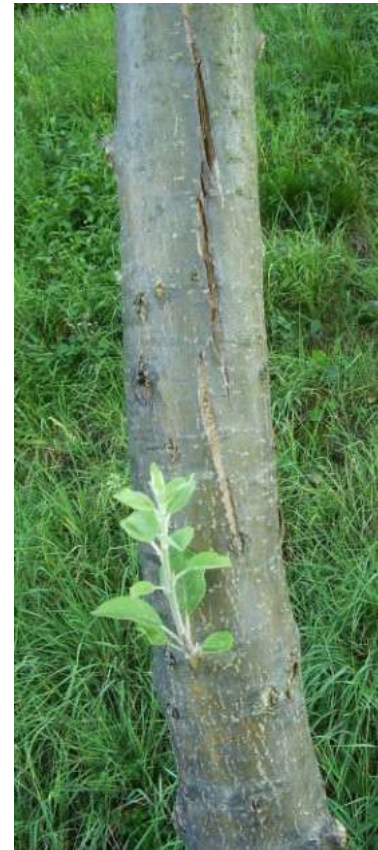
30 AUG 2008 Bamberg, St.
Michael's Monastery,
terraced gardens. Many of
the fruit trees planted in
1998 showed damage to
their trunks.

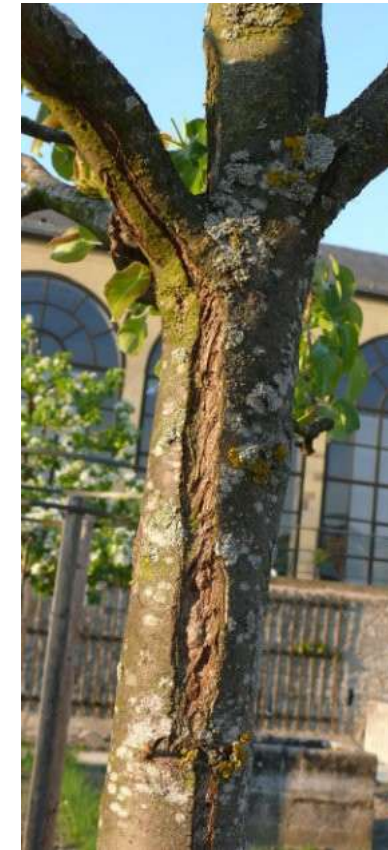
18 APR 2011 Würzburg,
court garden. Fruit tree

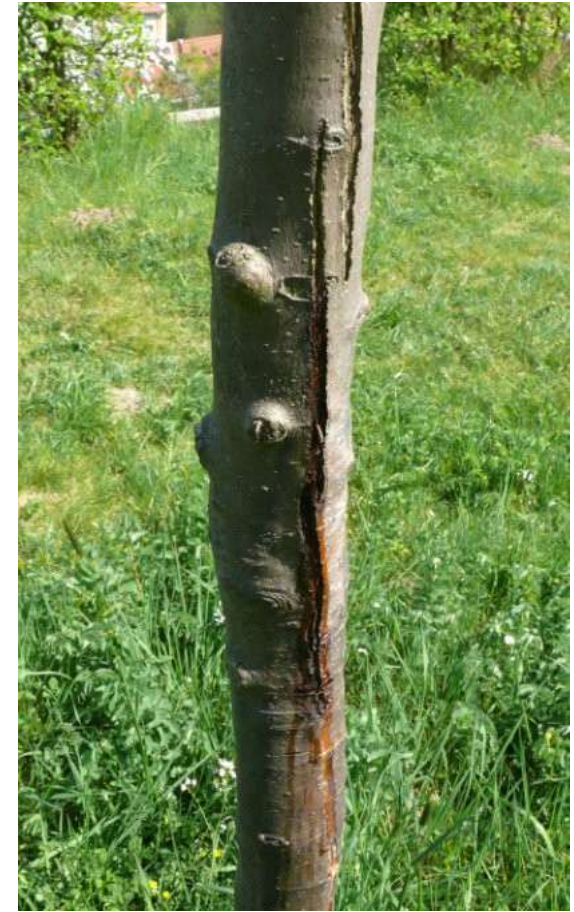
21 APR 2011 Bamberg, St. Michael's
Monastery, terraced gardens.
Fruit tree, planted in 1998 (see p. 170).

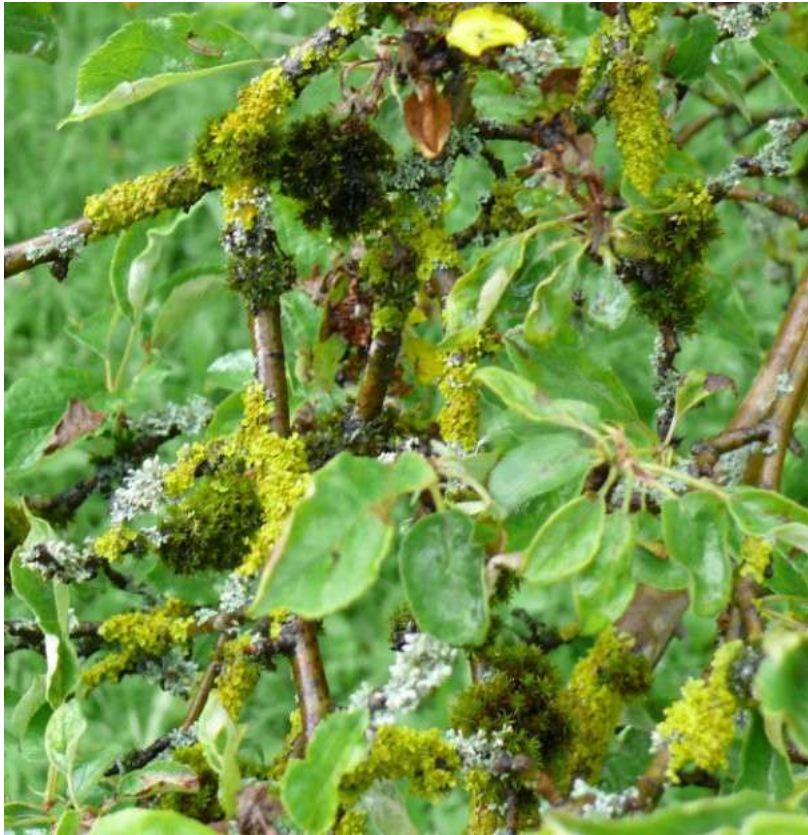
31 MAY 2010 Munich, Prof.-Eichmann-Straße. Apple tree

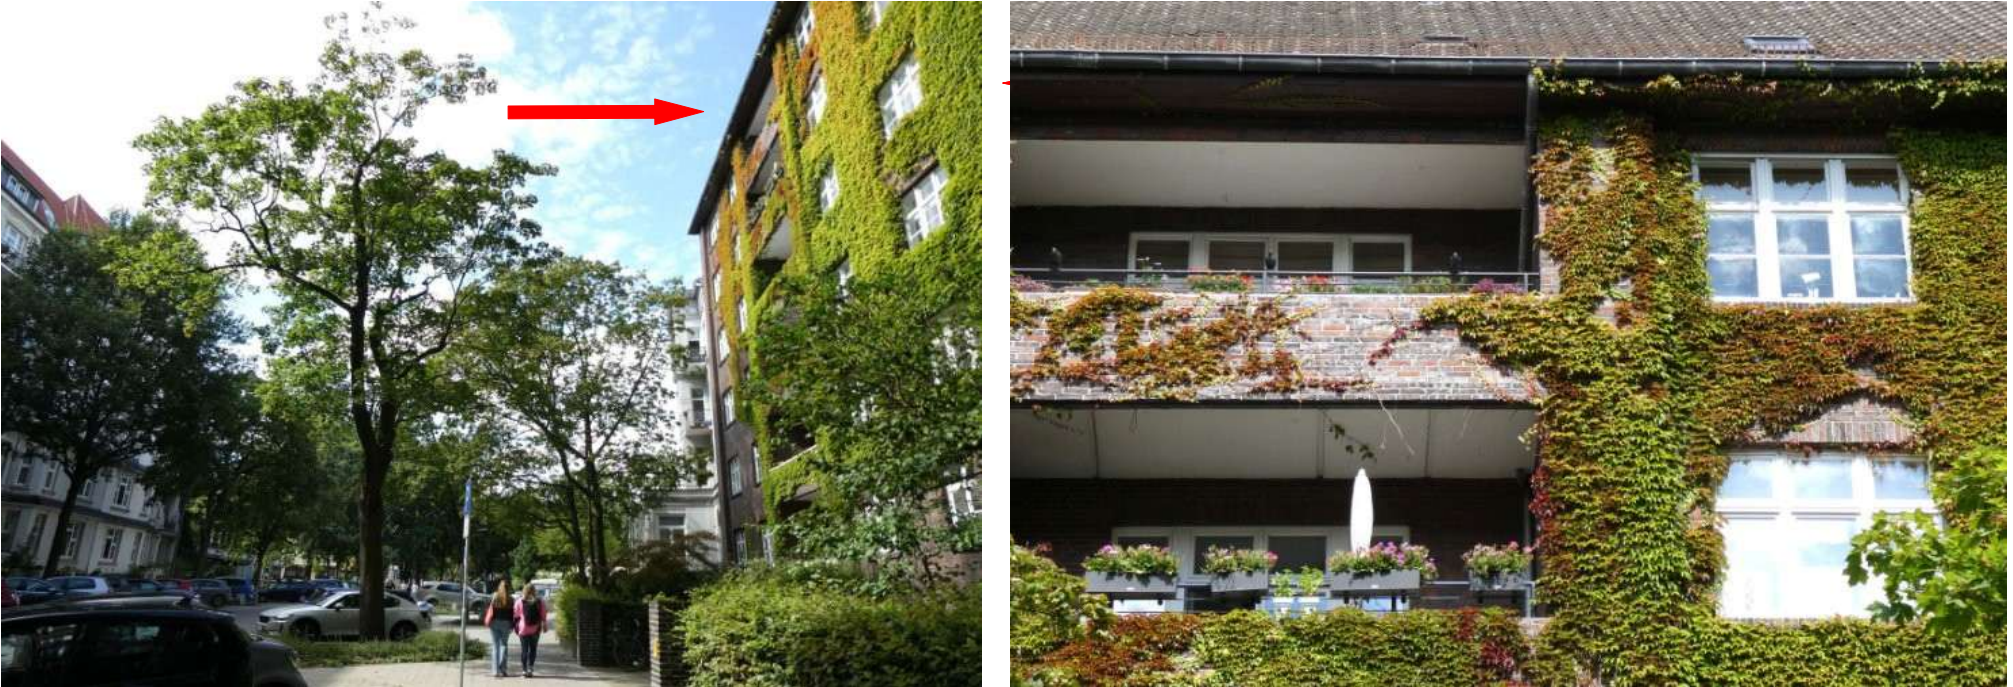
05 AUG 2023 Schlüterstraße. Maple trees with crown damage and the premature reddening of the wild vine on the upper stories (view from the south).
RF radiation from a mobile phone base station on a university building strikes the trees and the wall of the house.
Measurement at the entrance of house No. 6: **6,200 $\mu\text{W}/\text{m}^2$**

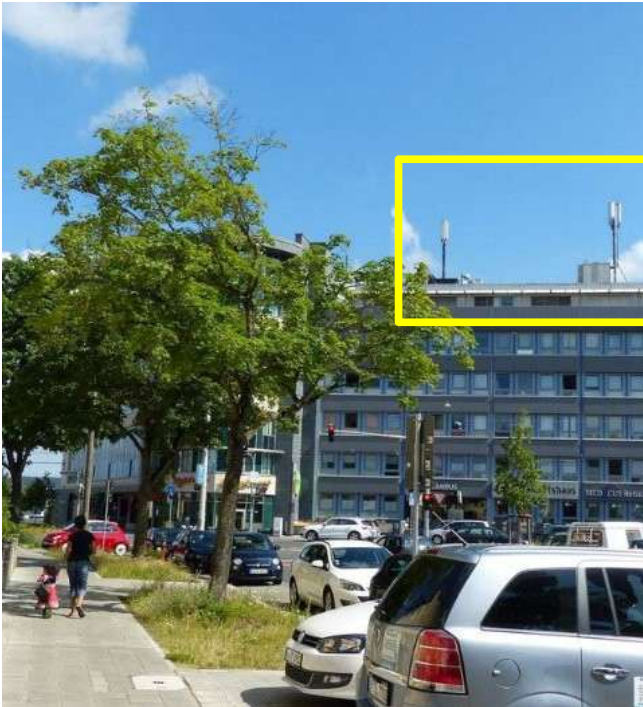
27 JUN 2017 Intersection of Bismarckstraße and Äußere Sulzbacher Straße. A row of Norway maple trees (view from the northwest)

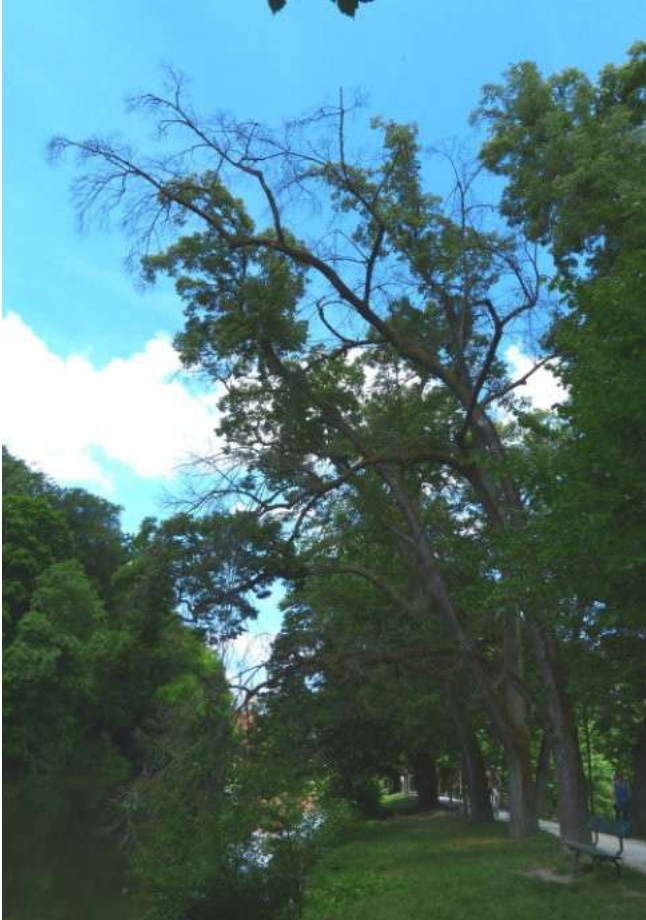
18 JUN 2017 Bürgerpark Hain (Hain Park). A linden avenue directly along the Regnitz River (view from the south) with a line of sight to four mobile phone base stations. Several linden trees were topped or cut down.

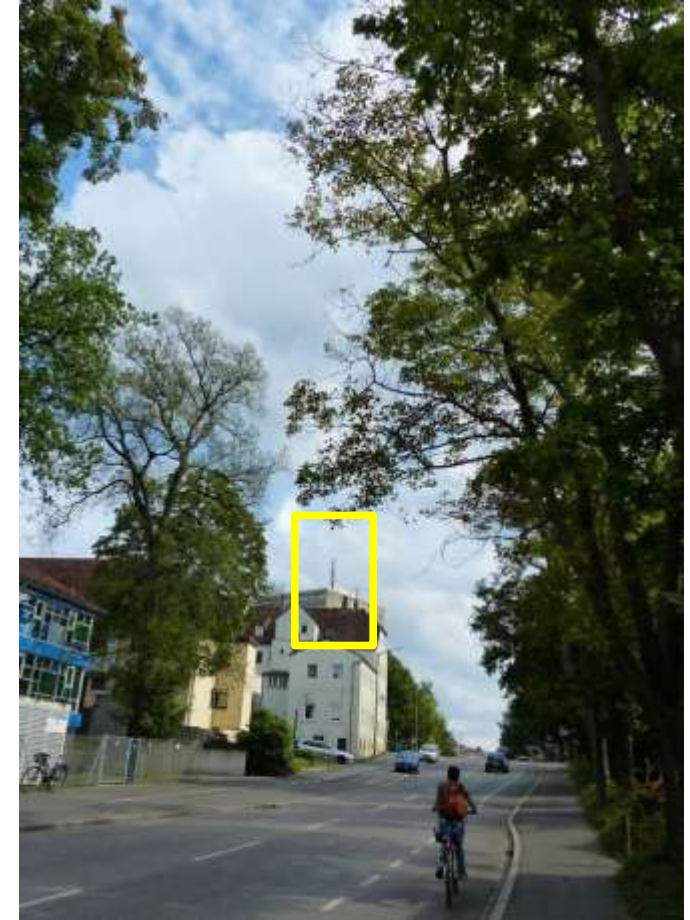
17 AUG 2017 Palmsanlage. Norway maple tree and other trees (view from the north). The mobile phone base station (yellow) is located at Bismarckstraße 1, at the university.

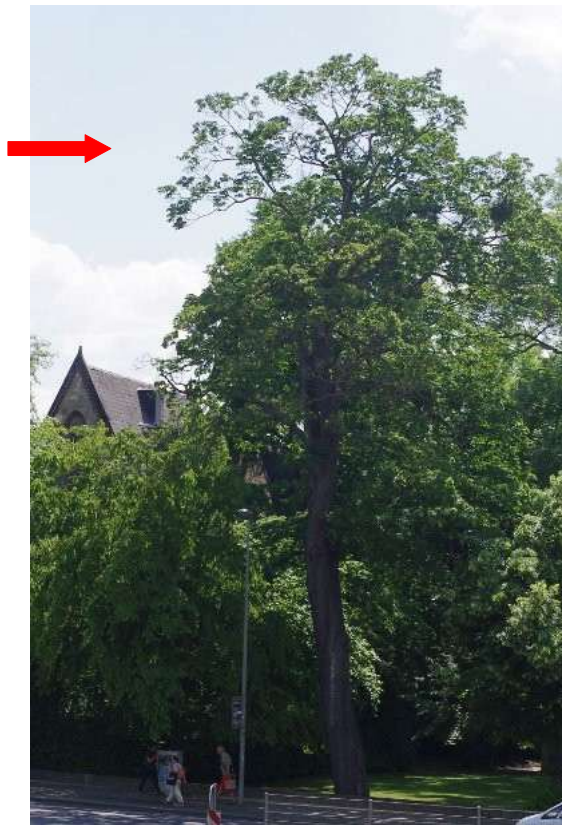
13 JUN 2023 Bürgerstraße.
Maple tree (view from the north).
The RF radiation from the mobile phone base station at the new city hall hits the top of the tree from the east.

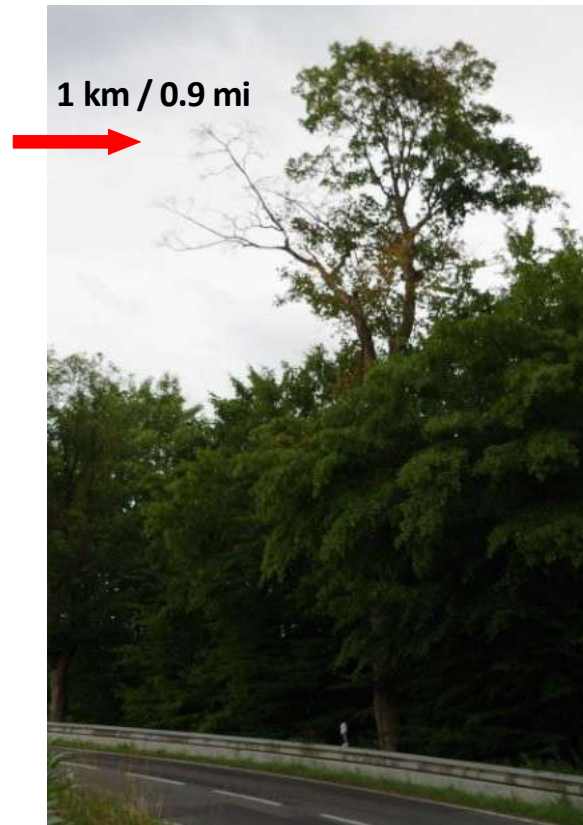
17 JUL 2023 Holzhäuser Straße, L3239.
Sycamore tree (view from the northeast).
The distance to the mobile phone base station at the Termenei parking lot is 1 km (0.9 mi). Damage on one side of the road was visible as early as 2019.

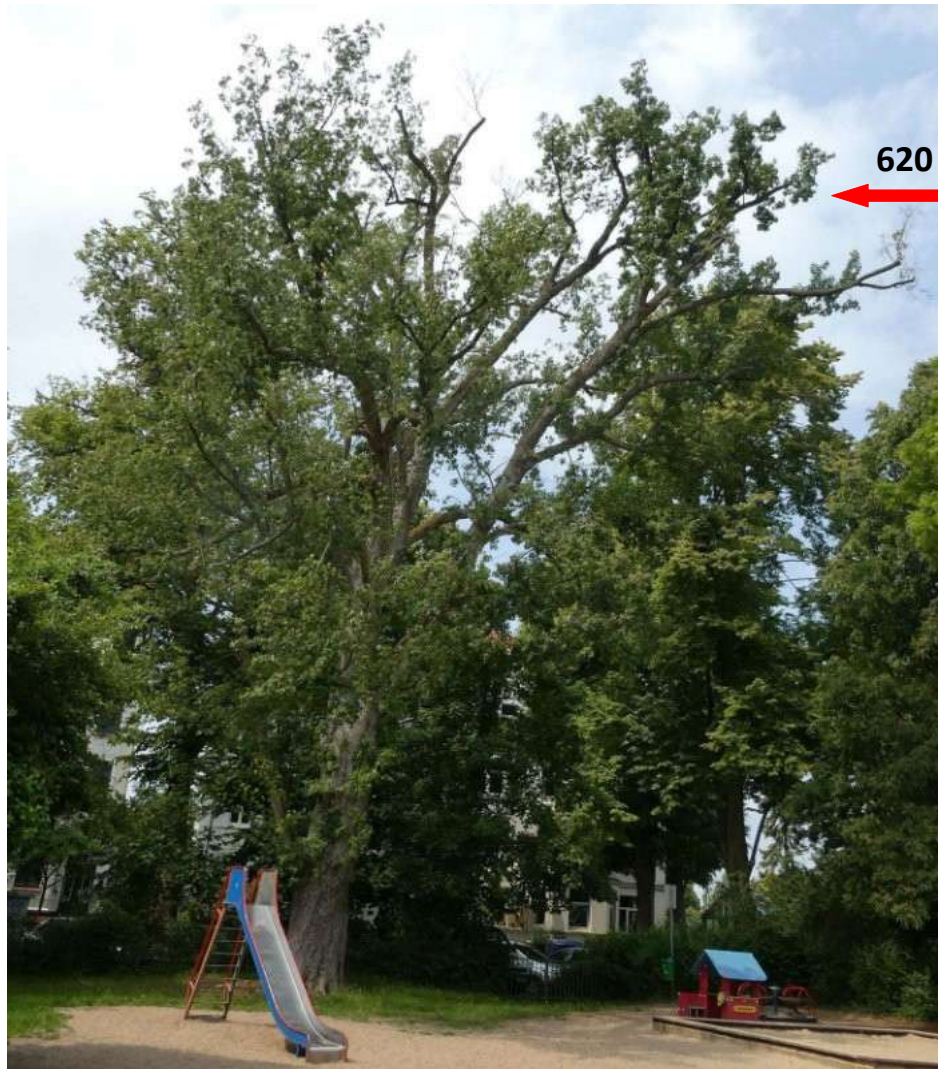
04 JUN 2025 Falkenwiese playground. Damaged, already cut-back silver maple tree (view from the east). There is a direct line of sight to the base station with **78 antennas** on the high-rise building at Schevenbarg 1, which is 620 m (2,034 ft) away.

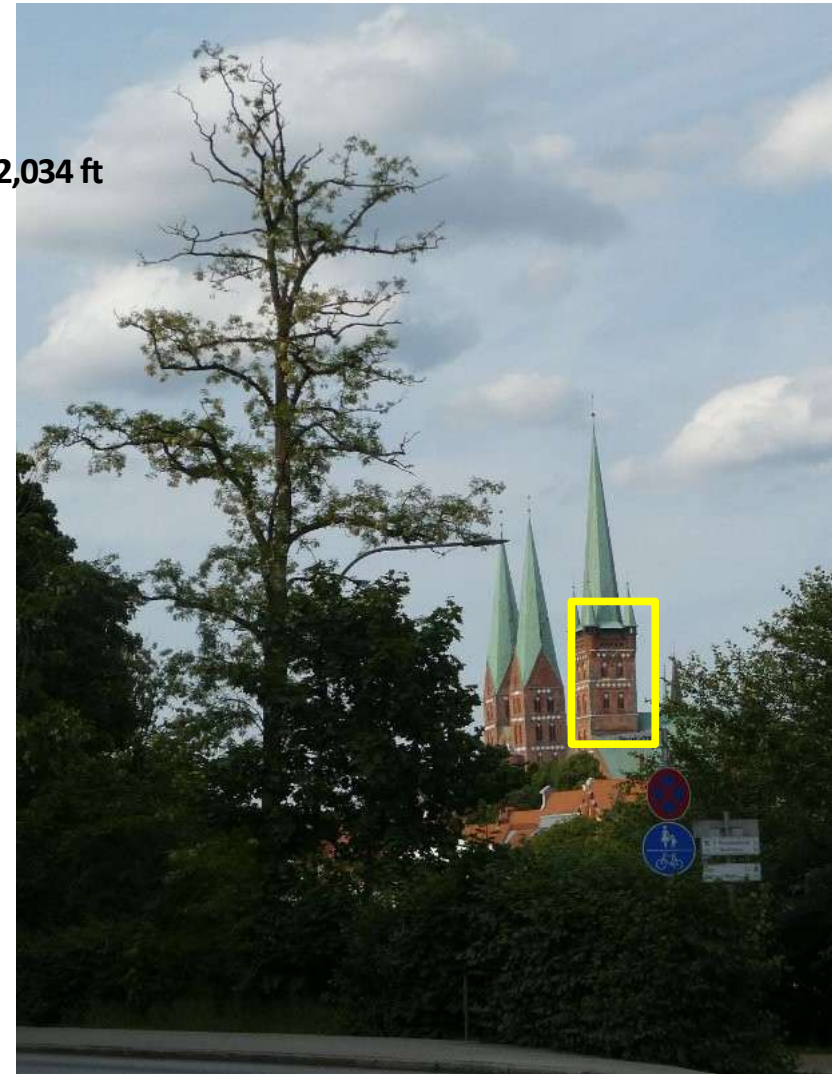
03 JUN 2025 Wallbrücke Bridge on Possehlstraße. Locust tree (view from the southwest). The locust tree is exposed to RF radiation from three base stations: St. Peter's Church to the north (480 m away), Mühlenstraße to the east, and the high-rise building "Behördenhochhaus" to the south.

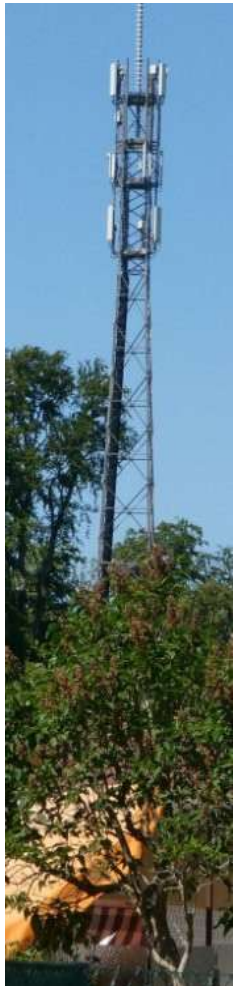
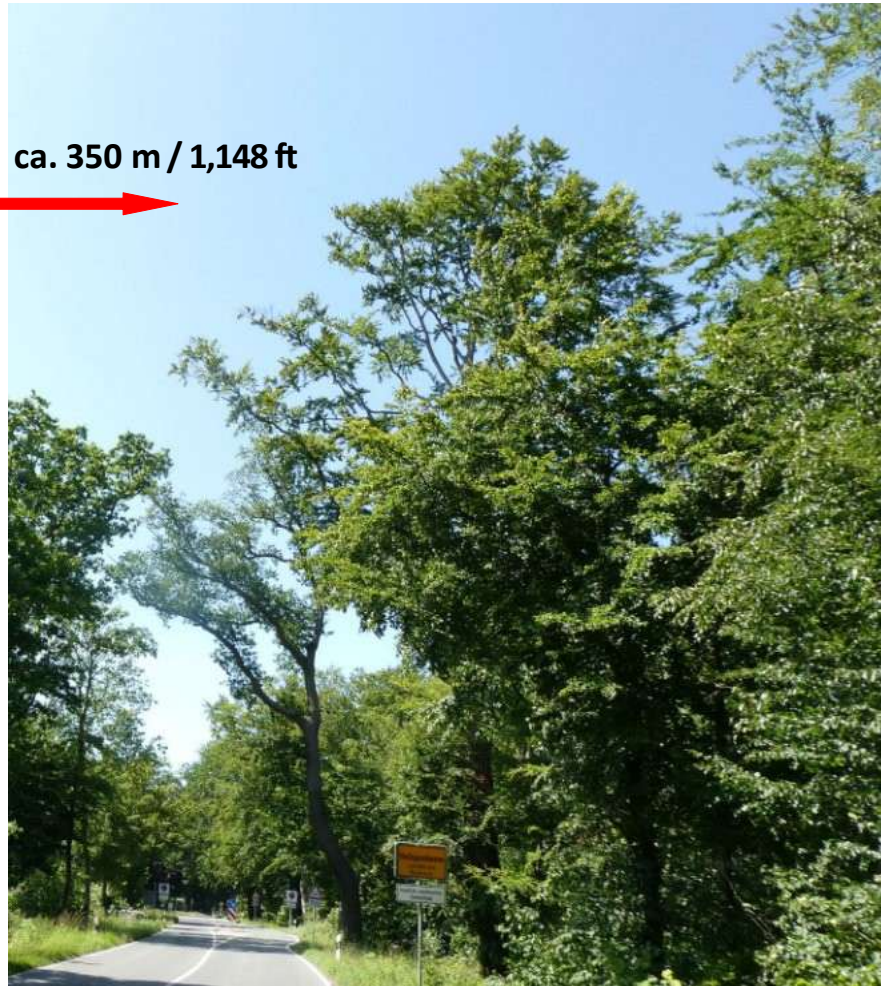
ca. 350 m / 1,148 ft

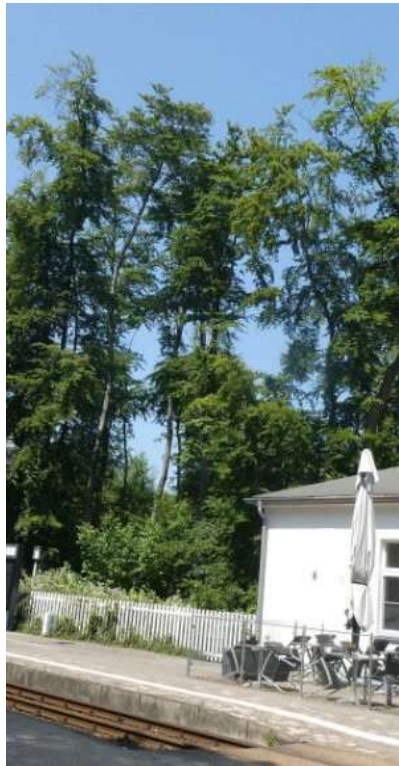
21 JUN 2025 Heiligendamm, train station (view from the south). The base station is 200 m (656 ft) away. All beech trees showed significant crown damage.

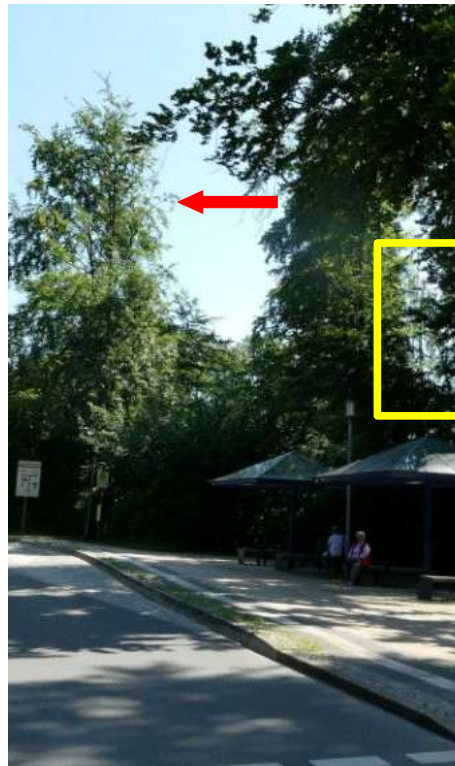
21 JUN 2025 Bus stop. Beech tree damaged on one side only (view from the north). The base station (yellow) is 180 m (590 ft) away and eleven 0° antennas radiate toward the north.
Measurement: 2,360 $\mu\text{W}/\text{m}^2$

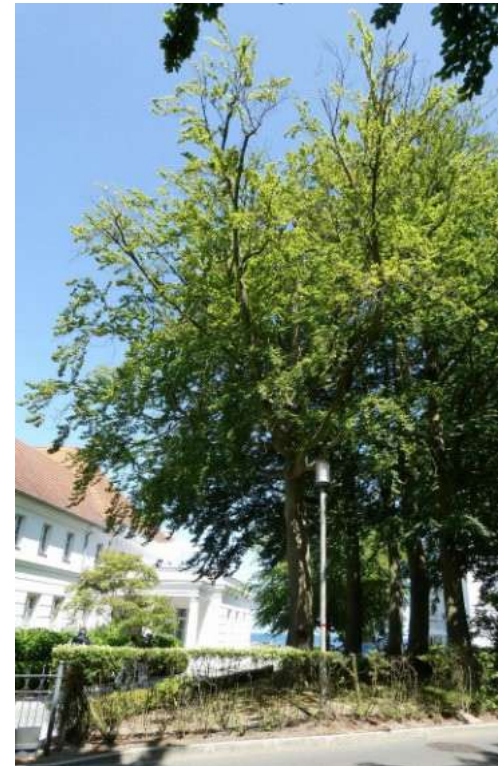
21 JUN 2025 Kühlungsborner Straße, hotel. Significant damage to the beech trees (view from the south)

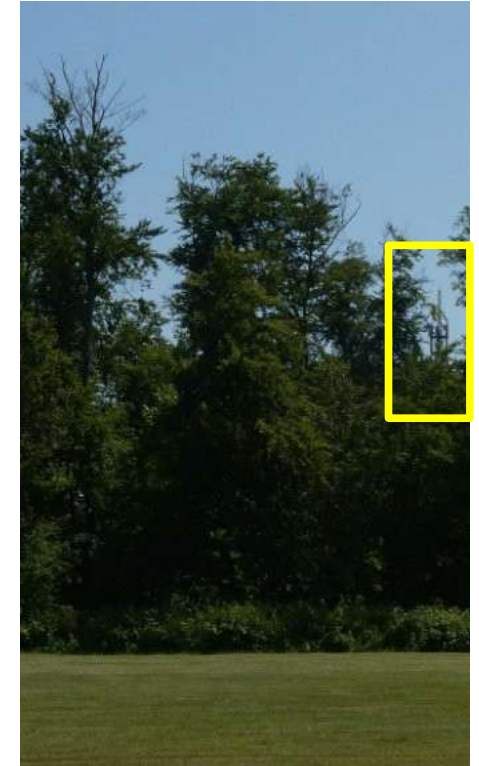
21 JUN 2025 A group of beech trees and the base station at the Median Klinik (view from the northwest), which is 200 m (656 ft) away. Three 280° antennas radiate toward the west.
Measurement: 7,400 $\mu\text{W}/\text{m}^2$

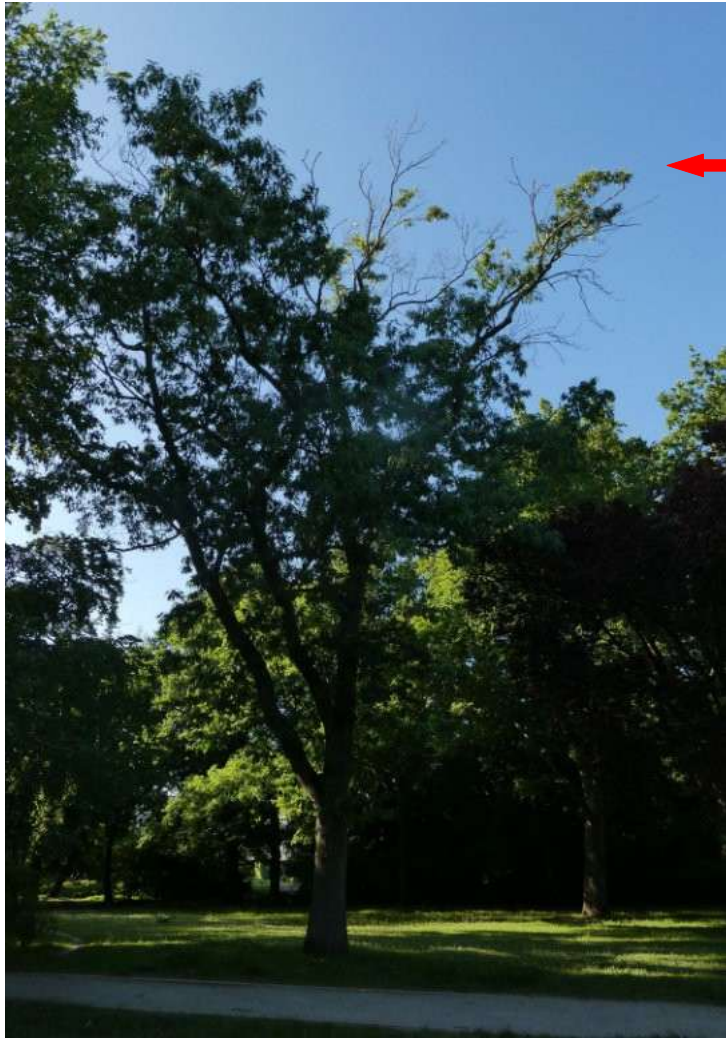
20 JUN 2025 Spa gardens, southeast corner. Red oak tree (view from the north) with significant crown damage, more on the right than on the left. Mobile phone base station radiation reaches the park from the southeast.

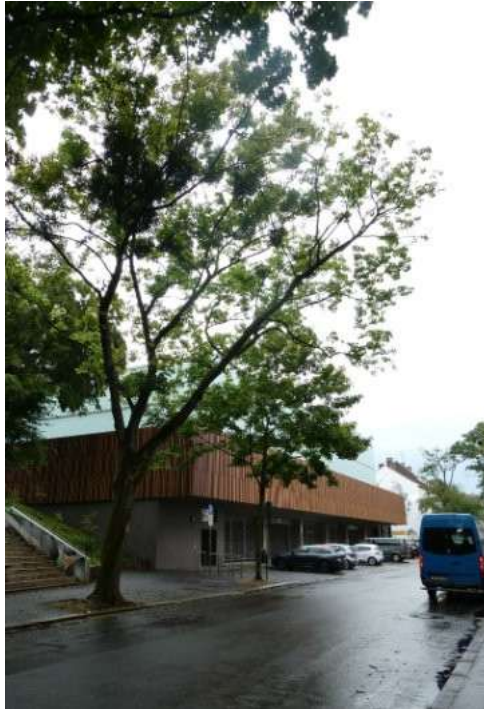
07 JUL 2025 Luisenstraße.
Maple tree (view from the west).
The tree is exposed to RF radiation
from the northeast and the
southeast.

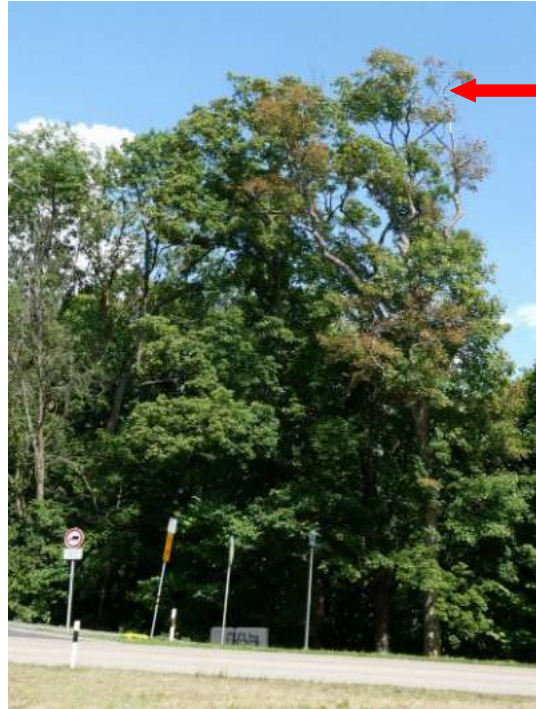
25 JUL 2025 Near the parking lot of
Wilhelmshöhe Palace and Bergpark.
Sycamore tree next to the sidewalk
(view from the west). For many years,
the group of trees has been exposed to
RF radiation from the south, and since
2020, from the west as well. By 2011,
the damage to the crowns was
noticeable. Branches could break off at
any time. Many trees in the Bergpark to
the west had to be cut back.

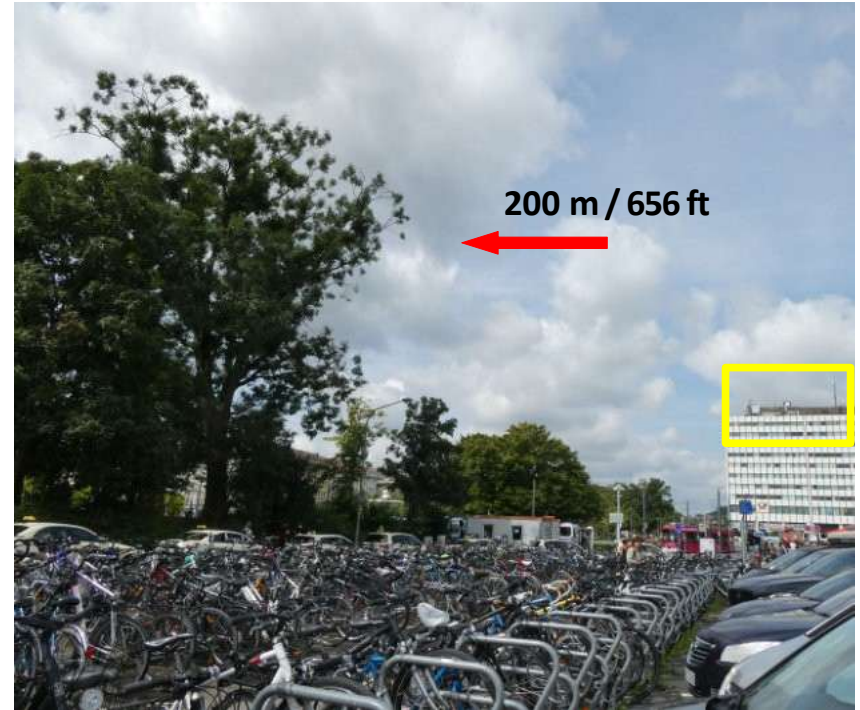
02 AUG 2025 Würzburg, Bahnhofplatz.
Red oak tree (view from the northeast). The damaged crown is
located above the area where taxis wait. Over the past 20
years, numerous trees in the radiofrequency field of this base
station (marked in yellow) have had to be cut down.

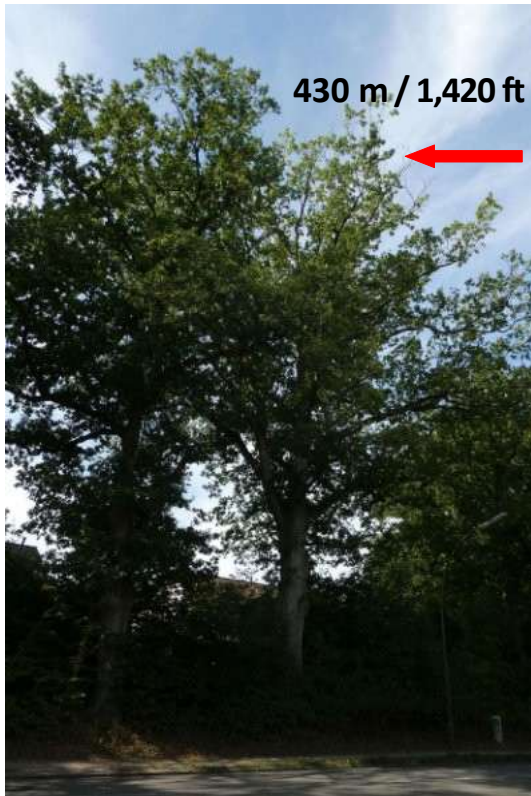
09 SEP 2025 At Volksdorfer Damm and Am Buckhornwald. Two oak trees (view from the east). RF radiation strikes the pair of trees from the northeast.

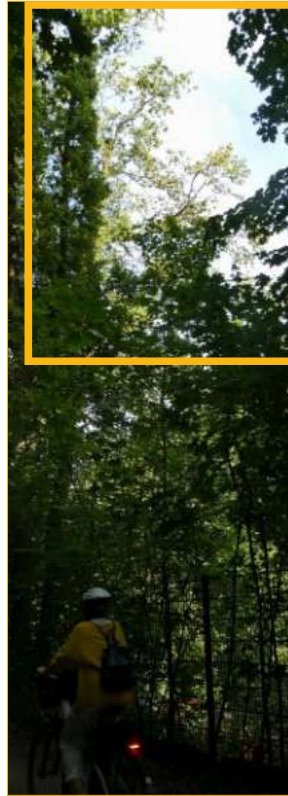
A detail from the photo left

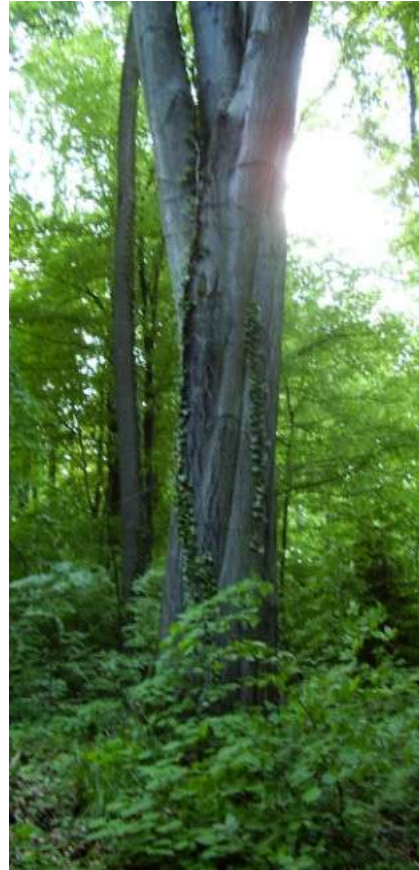
11 MAY 2008 Beech tree trunk with many longitudinal cracks

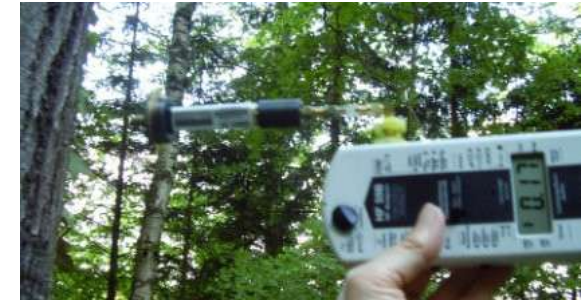
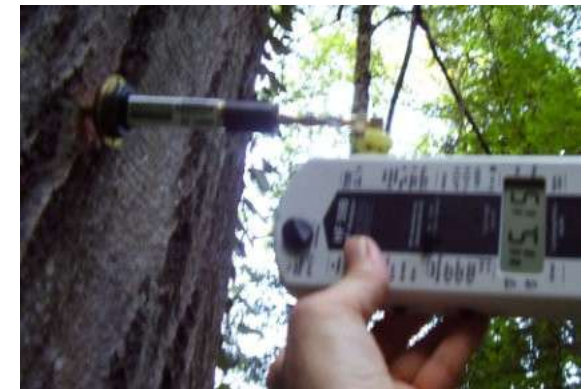
- Measurement in the air: $170 \mu\text{W}/\text{m}^2$
 - With trunk contact a significant increase!
- The measurement taken when the antenna touches the trunk cannot be used quantitatively because the device is calibrated for measurements in the air. However, the significant increase demonstrates how trees function as antennas.

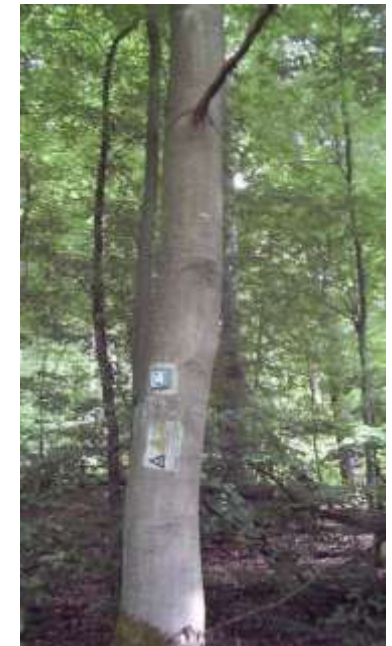
25 MAY 2008 Measurement
in the air and at the trunk:
4 $\mu\text{W}/\text{m}^2$

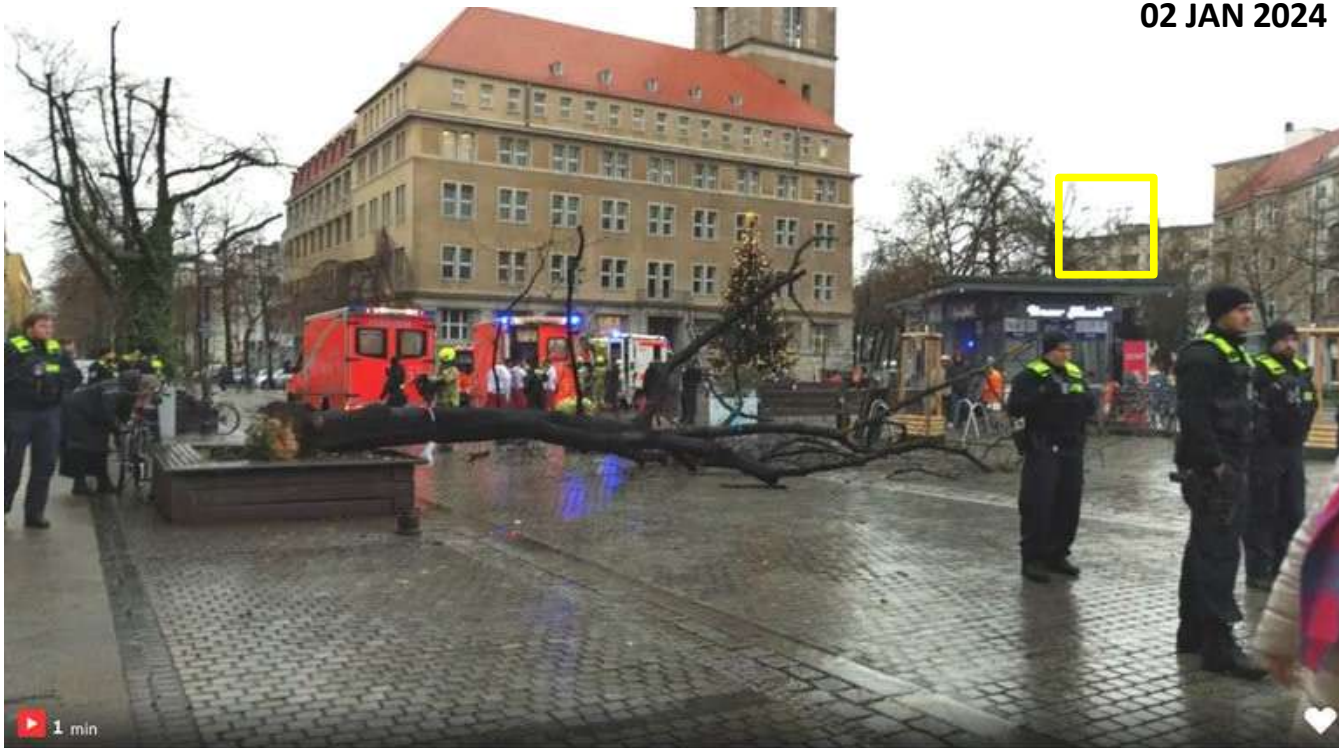
Berlin. On January 2, 2024, a red oak tree fell in calm weather in Breslauer Platz. Two adults and a child were seriously injured.
