Tree Damage Caused by Radiofrequency Radiation

Key Observations from 2005 to 2025 in Germany

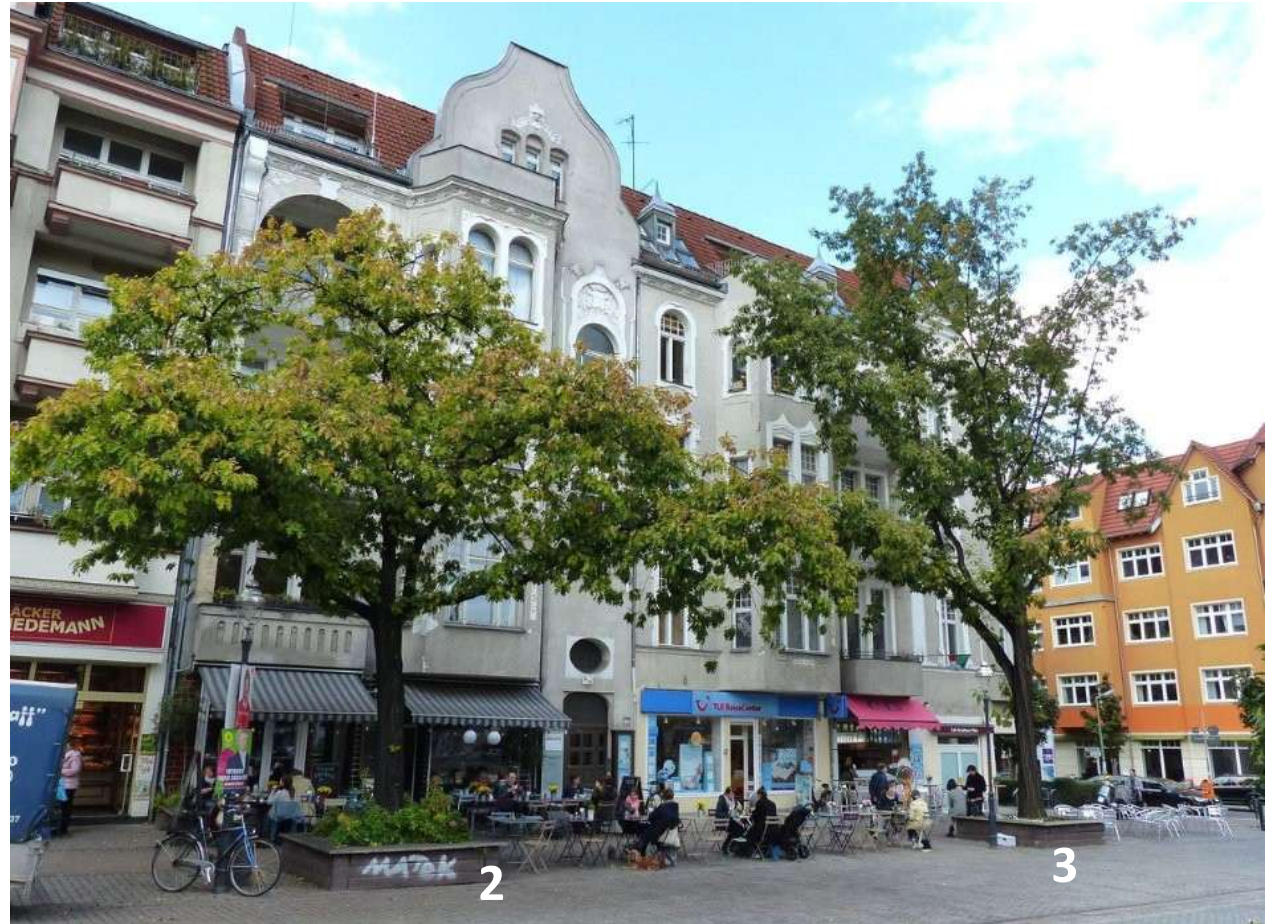
15 SEP 2017 Breslauer Platz, west side. Red oak trees No. 2 and No. 3 are located north of red oak tree No. 1 (view from the east). The oak tree on the left is only growing horizontally, not upward. The red oak tree on the right has significant crown damage, more on the east side than the west.

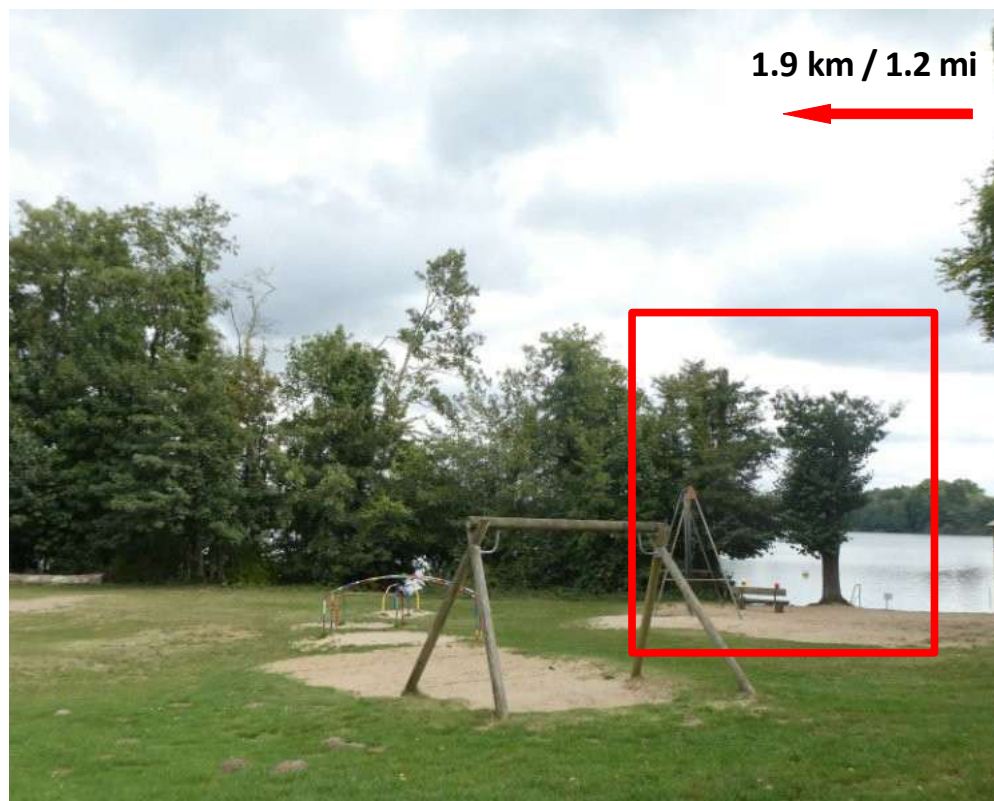
11 SEP 2025 Adlerhorst Campground, bathing area and playground (**from the west**). On the right, to the south, stand the two topped linden trees. The riparian vegetation in the middle shows signs of damage. The riparian vegetation on the left, to the north, is shielded by the vegetation to the south. Its foliage is dense.

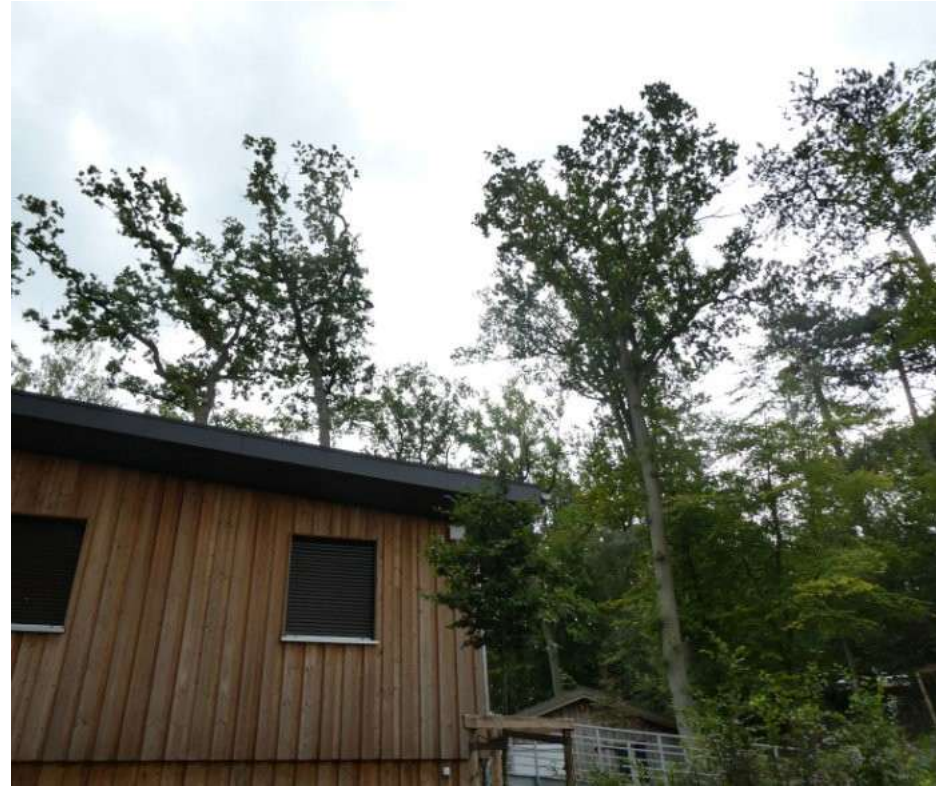
11 SEP 2025 Adlerhorst Campground (view from the north). A large proportion of the oak trees have already been cut back. Nevertheless, the trees show clear signs of crown damage, such as sparse foliage and dead wood.

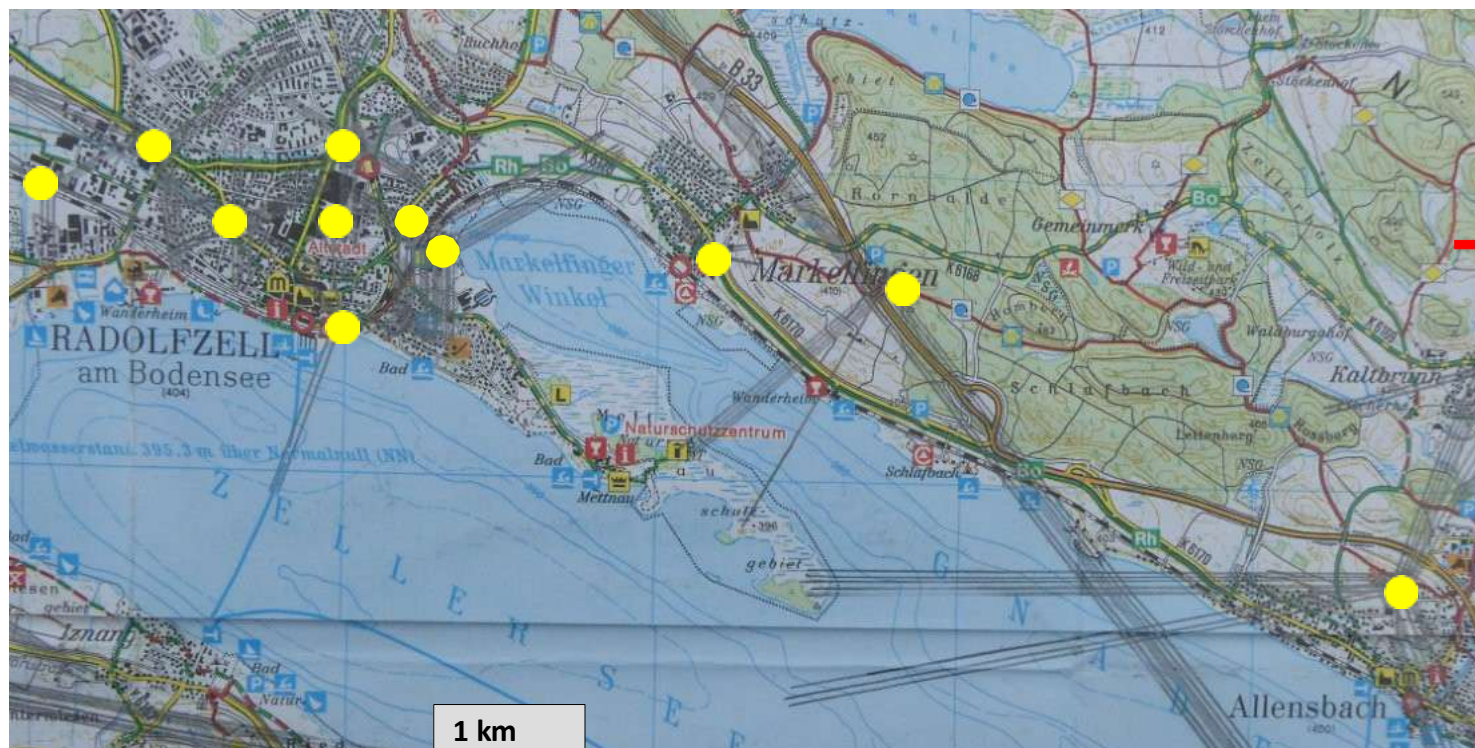
Section of Freizeitkarte 511, western Lake Constance, LGL, 2014. Added items: location of the mobile phone base stations (yellow) with the main beam directions of the sector antennas, as of 2022. The map shows four antennas transmitting from the federal highway B33 near Markelfingen to Mettnau Tower, as well as four antennas transmitting from Allensbach to the tip of Mettnau Peninsula.

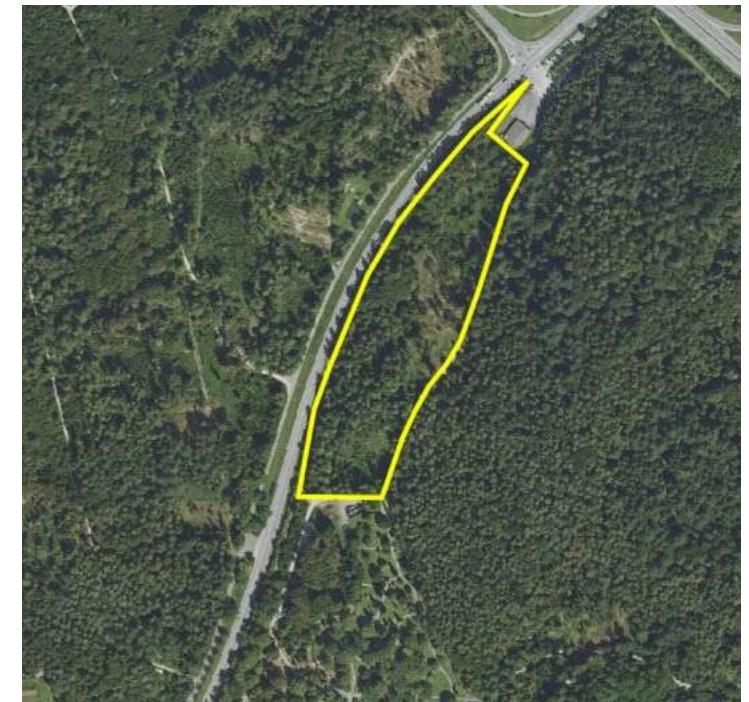
Photo: Stadt Radolfzell / Forstrevier Radolfzell

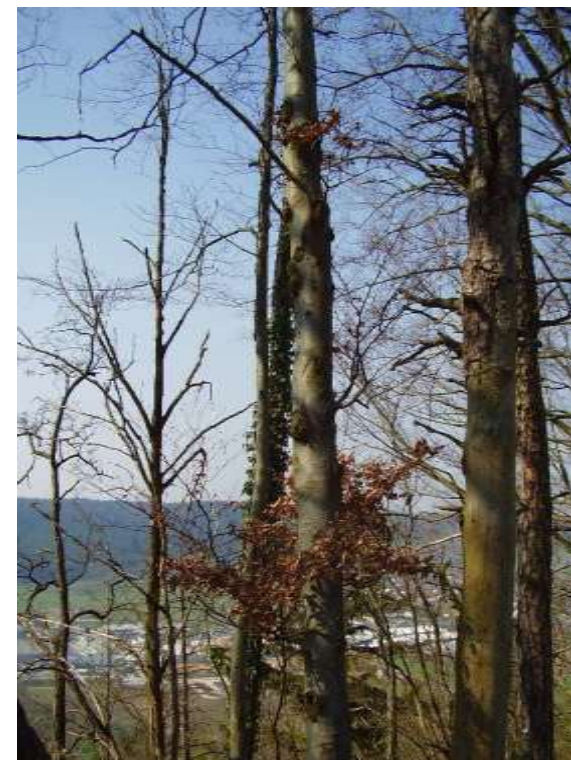
10 APR 2007 Damaged, young beech trees

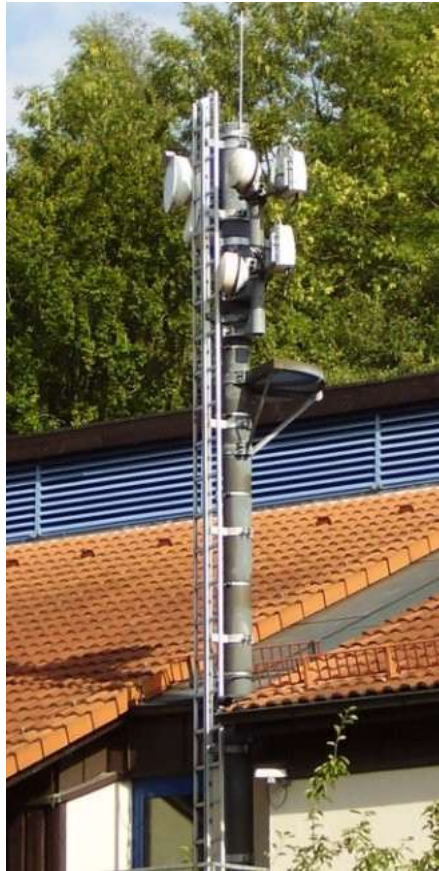
23 AUG 2006 Mobile phone base station with microwave radios in the municipality (see map, orange)

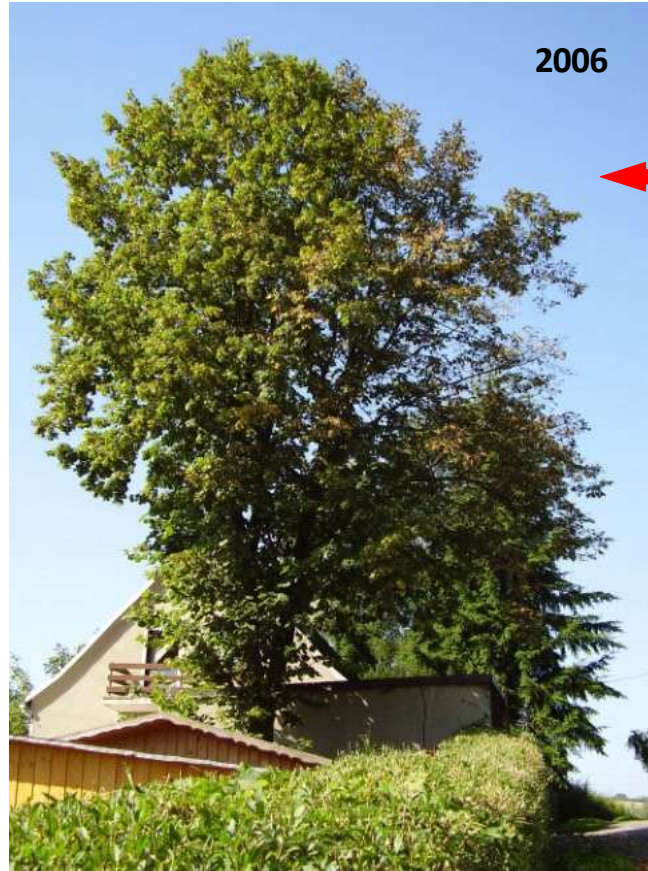
23 AUG 2006 Crown damage on one side

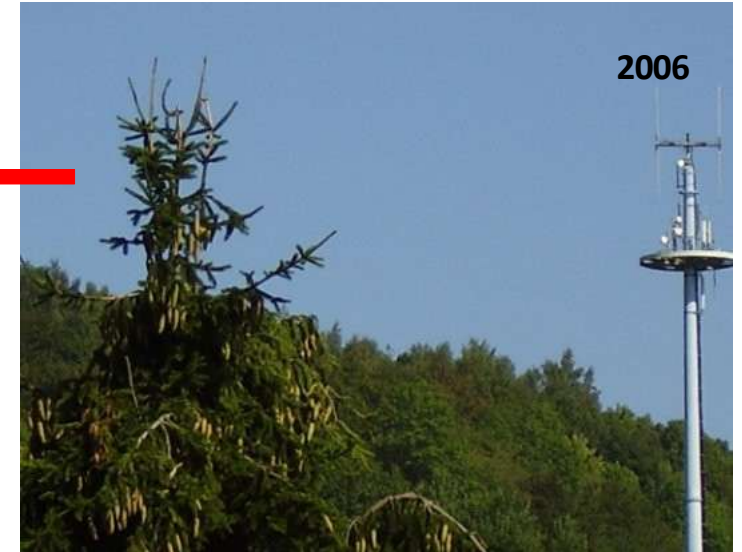
Mobile phone base station No. 890015, above Steinbach-Hallenberg

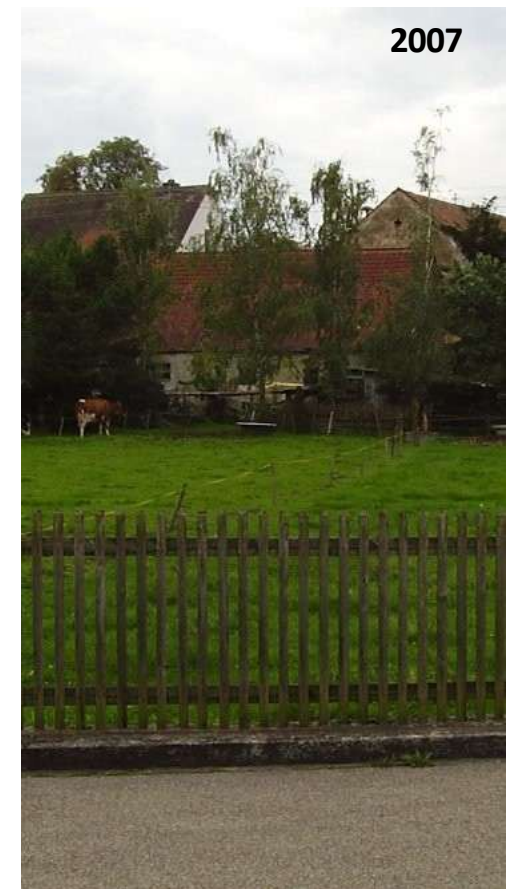
Weilersbach, Illness in 1999

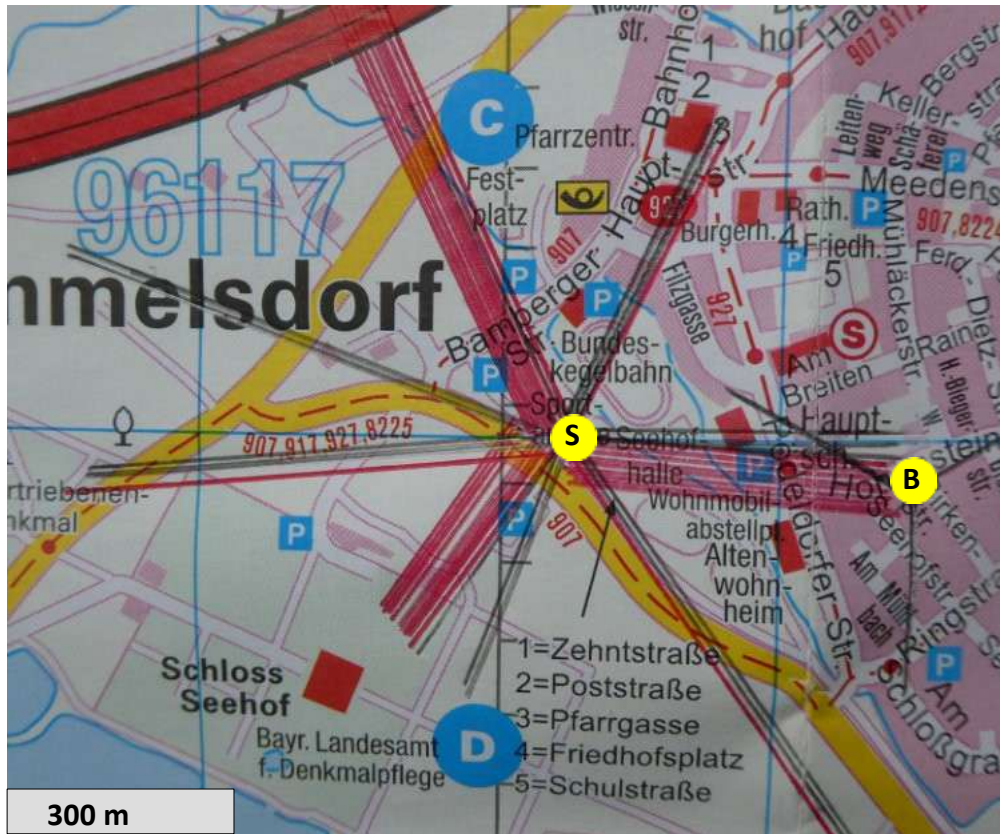
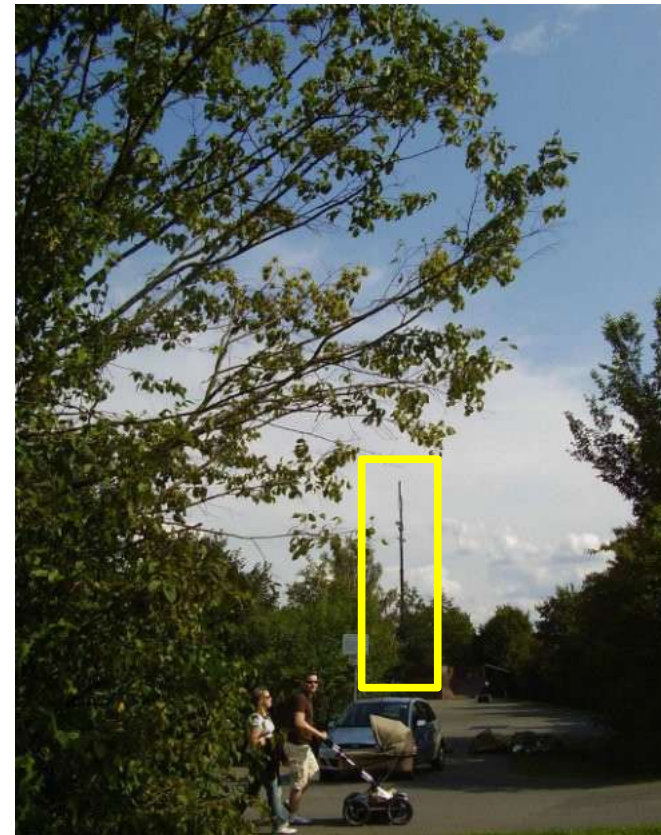
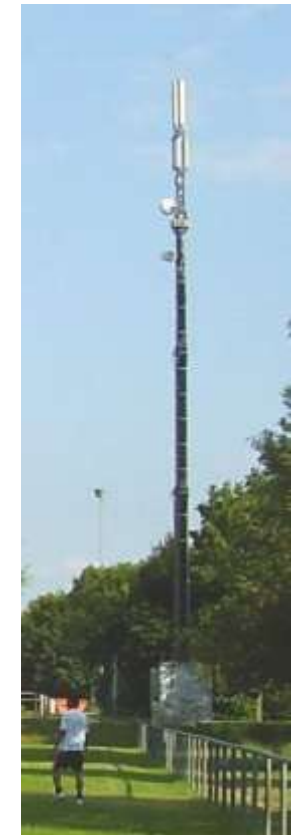
Section of the Bamberg City Plan, Falk.
 Added items: mobile phone base stations No. 671442 (sports field) und No. 671091 (Birkenstraße) with the main beam directions of the sector antennas.

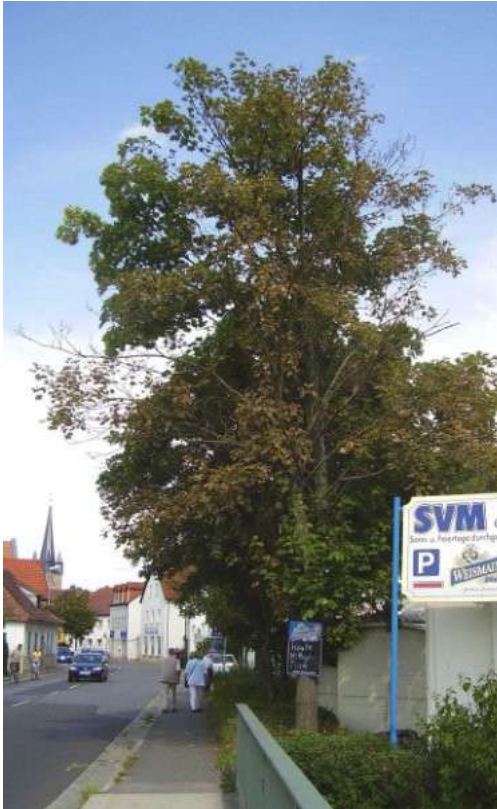
17 AUG 2008 Bamberger Straße. Maple tree (view from the southwest). The mobile phone base station is 170 m (558 ft) away.

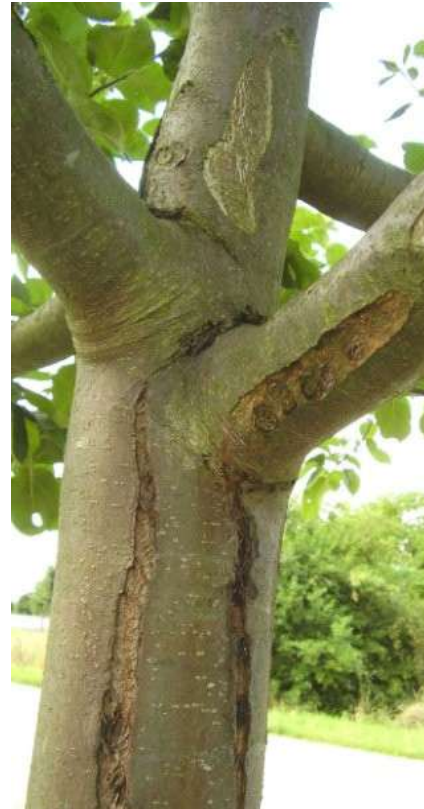
17 AUG 2008 During the same period, cracks appeared on the trunks and branches of apple trees and other tree species.

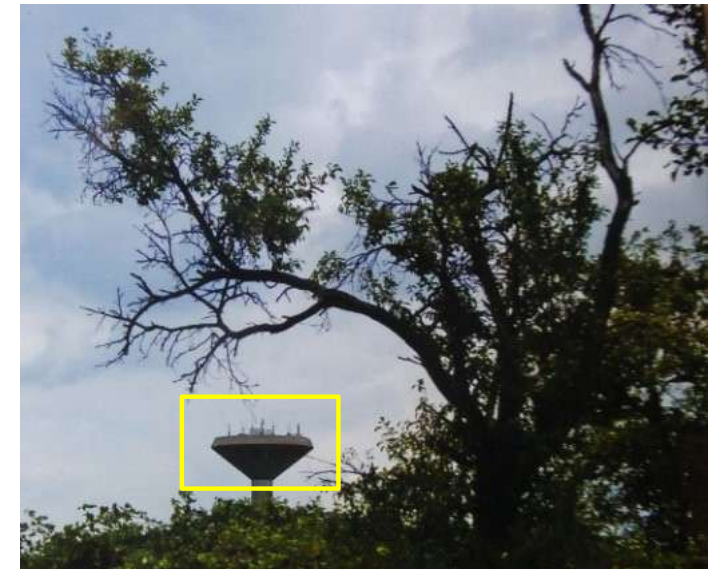
10 JUL 2007 Uttenhofen, water tower with base station. Damaged fruit tree (view from the south). Many trees were damaged.

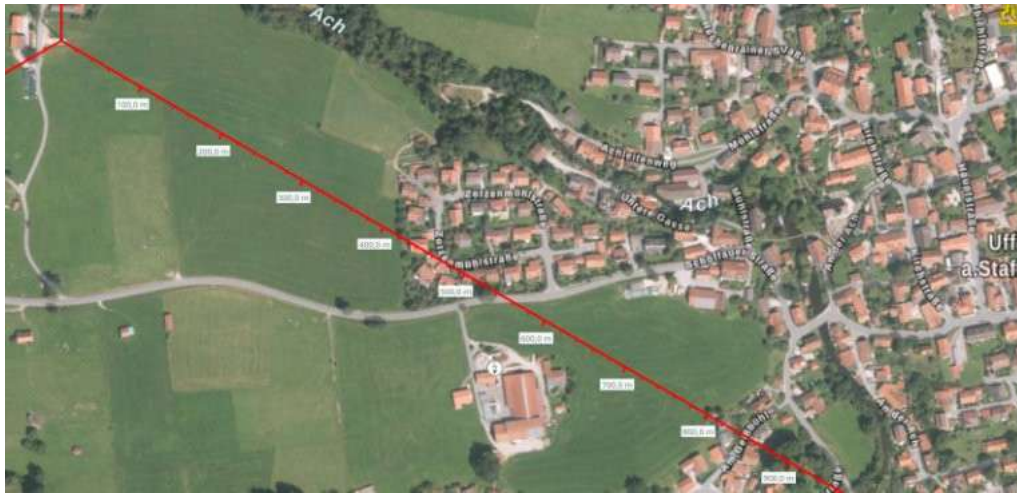
New Mobile Phone Base Station in Uffing, District of Garmisch-Partenkirchen, Started Operation in 2024

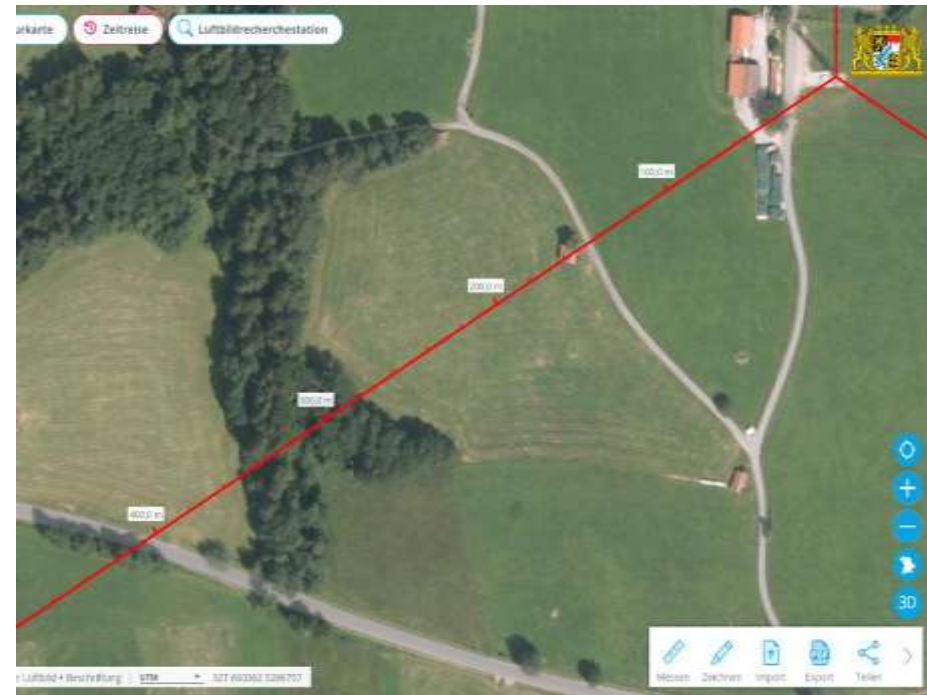
Main beam direction 240°

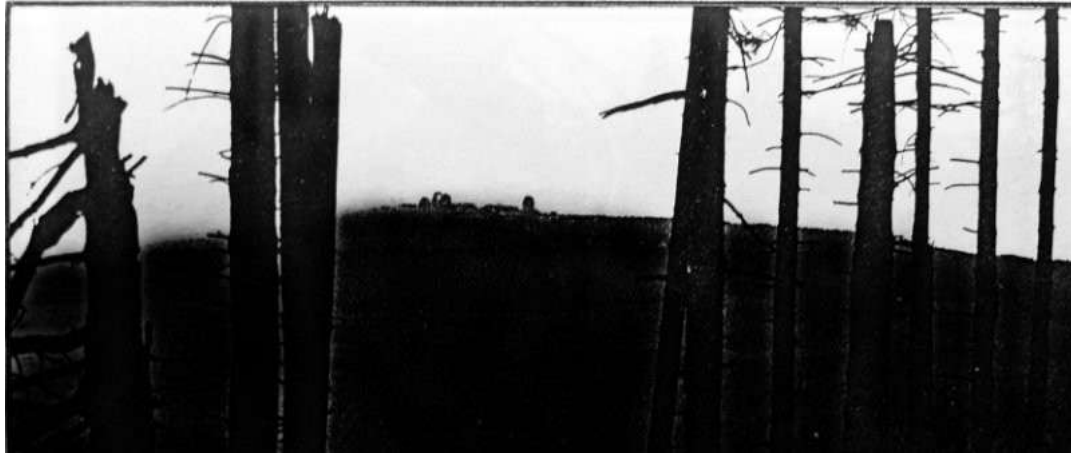
In the mid-1990s, the radar installations on Wasserkuppe Mountain were dismantled. In the years that followed, the forest on Stirnberg Mountain grew back.

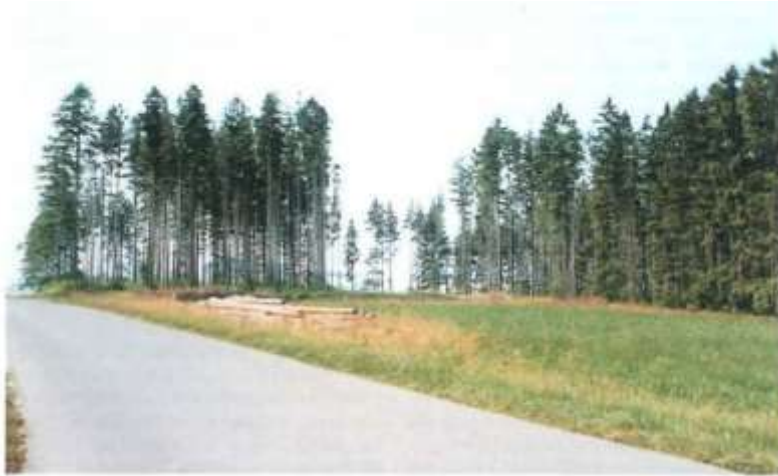
Source: *Bernatzky (1994). Baumkunde und Baumpflege.*

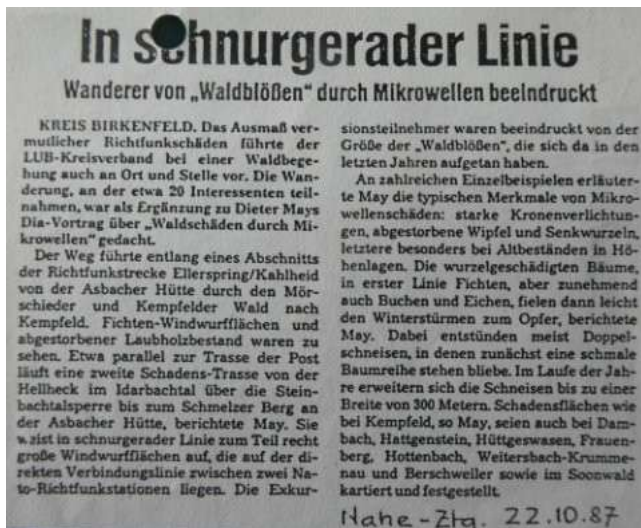
Photo and text by W. Volkrodt

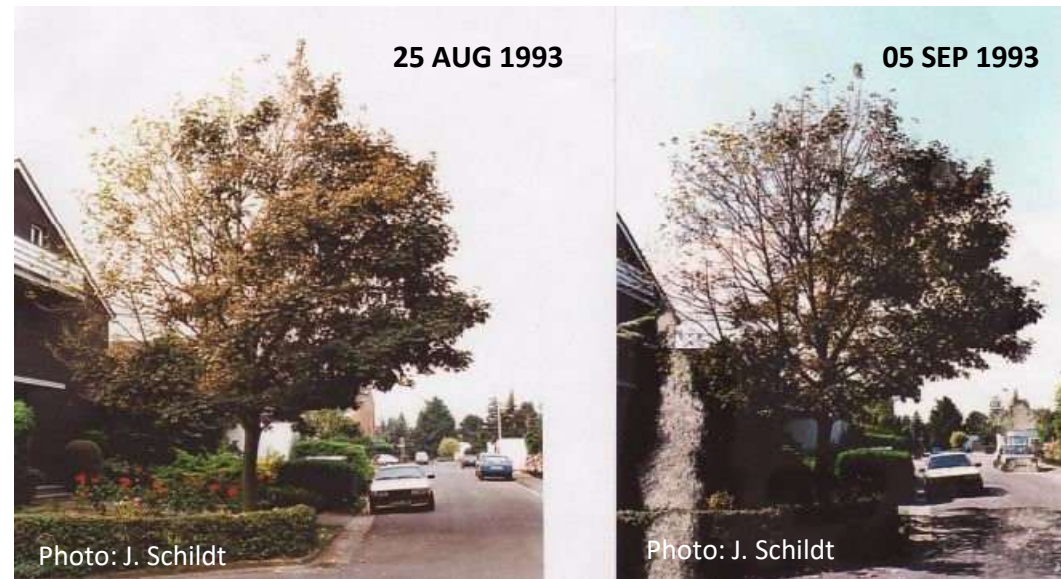
Wolfgang Maes, a journalist and building biology expert, observed that the leaves and needles of trees on wooded hills facing microwave radio, television, and military transmitters turned brown in several locations in Germany, northern Italy, and Switzerland.
